**CASE STUDY REPORT:
DAVID BROWER CENTER**

*Excerpted from Final Report submitted to California
Energy Commission, Public Interest Energy
Research Program, 2011*

Center for the Built Environment (CBE)
University of California, Berkeley

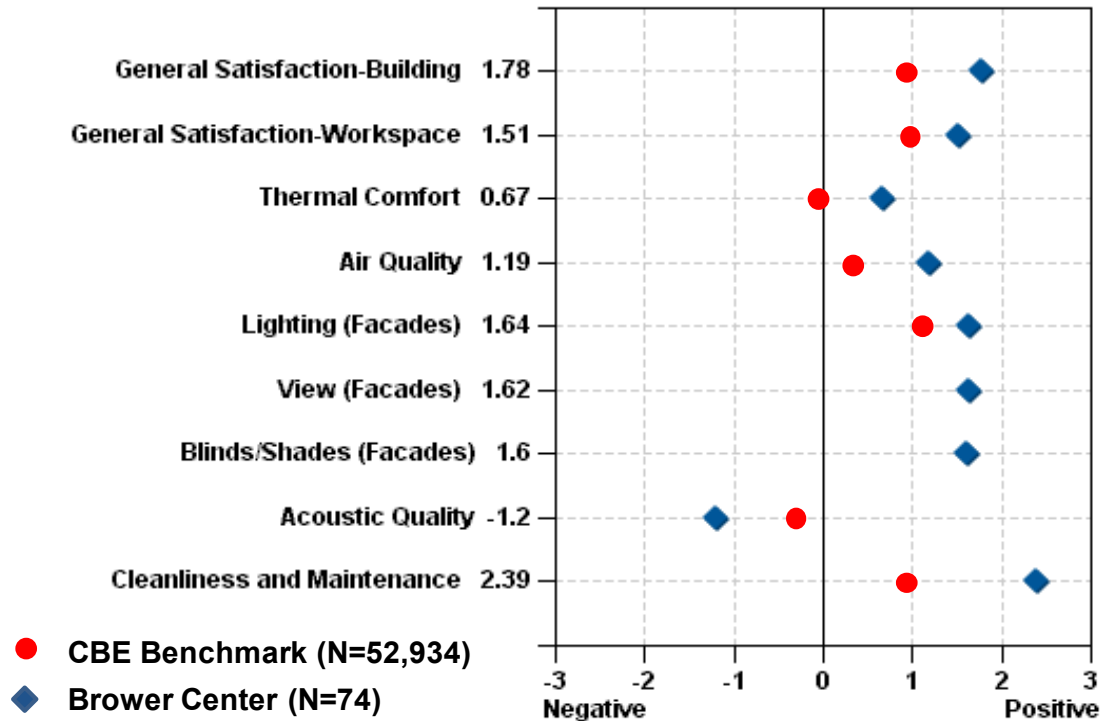
Figure 2: Average satisfaction ratings by category – Brower Center vs. CBE Benchmark. Survey conducted March 22 – April 9, 2010.

Figure 2 presents the average satisfaction ratings for each of the major environmental categories addressed by the survey questions. Results from the recent David Brower Center survey are compared against the large CBE Benchmark database, containing 52,934 individual survey responses collected from over 475 buildings since 1997. The ratings are presented in terms of the 7-point satisfaction scale, ranging from -3 (very dissatisfied) to +3 (very satisfied) with 0 being neutral. Results shown for each category represent the average score for the 2-4 questions that were asked pertaining to that category (see <http://www.cbesurvey.org/survey/demos2010/> for a list of typical questions). The results indicate an extremely positive response from the occupants of the Brower Center. With one exception, the ratings from DBC are all significantly higher than the CBE benchmark. For two categories, View and Blinds/Shades, there is no benchmark data because these represent two new question categories that were added for the DBC survey.

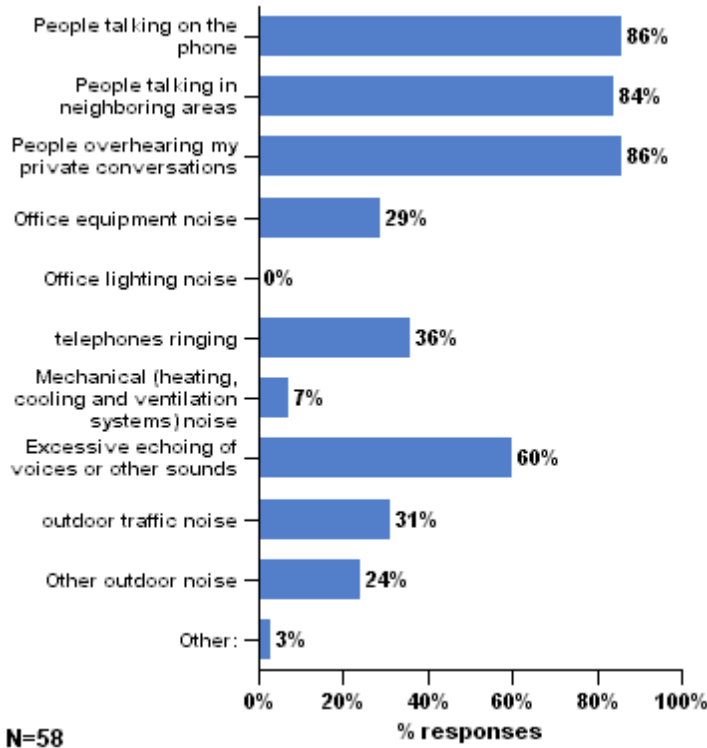
Figure 3: Reported causes of dissatisfaction with acoustic quality

Acoustic quality represents the one category that scored lower (-1.2) than the CBE benchmark (-0.3). The tenant office space in the Brower Center is primarily open plan with many exposed concrete (hard) surfaces, especially the radiant slab ceiling used for cooling and heating. Under these conditions, it is not surprising that occupants expressed dissatisfaction with noise privacy. Figure 3 shows a breakdown of the reported causes collected from survey respondents who expressed dissatisfaction with acoustic quality. The results confirm the expected performance with a large percentage (> 80%) identifying noise and distractions from other people in the neighboring area, as well as a majority (60%) citing echoing of voices and sounds (presumably from the hard building surfaces). The David Brower Center is investigating possible mitigation measures to improve acoustic quality. If interior design improvements are made (such as installation of more sound absorbing surfaces) a future survey and acoustic measurements could be used to quantify the amount of improvement.

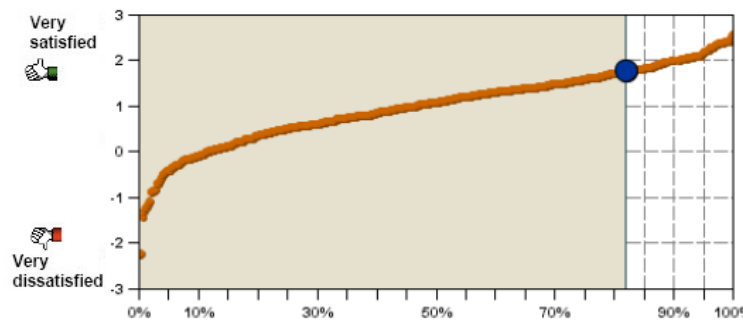
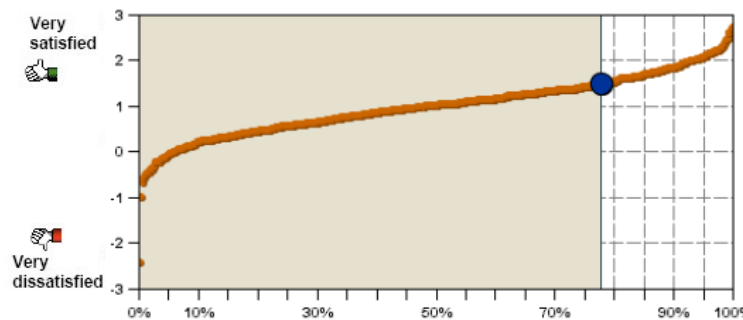
General Satisfaction-Building

82%
Percentile

1.78
Mean Response

87%
Satisfied

General Satisfaction-Workspace

78%
Percentile

1.51
Mean Response

84%
Satisfied

Figure 4: David Brower Center overall satisfaction rankings

In conclusion, despite the reported dissatisfaction with acoustic quality in the building, overall, the occupants were very satisfied. Figure 4 shows the overall satisfaction rankings for the two questions about “general satisfaction with the building” and “general satisfaction with the workspace.” For the general satisfaction with the building, the mean response (1.78) was greater than 82% of all buildings in the CBE benchmark database. For the general satisfaction with the workspace, the mean response (1.51) was greater than 78% of all buildings in the database.

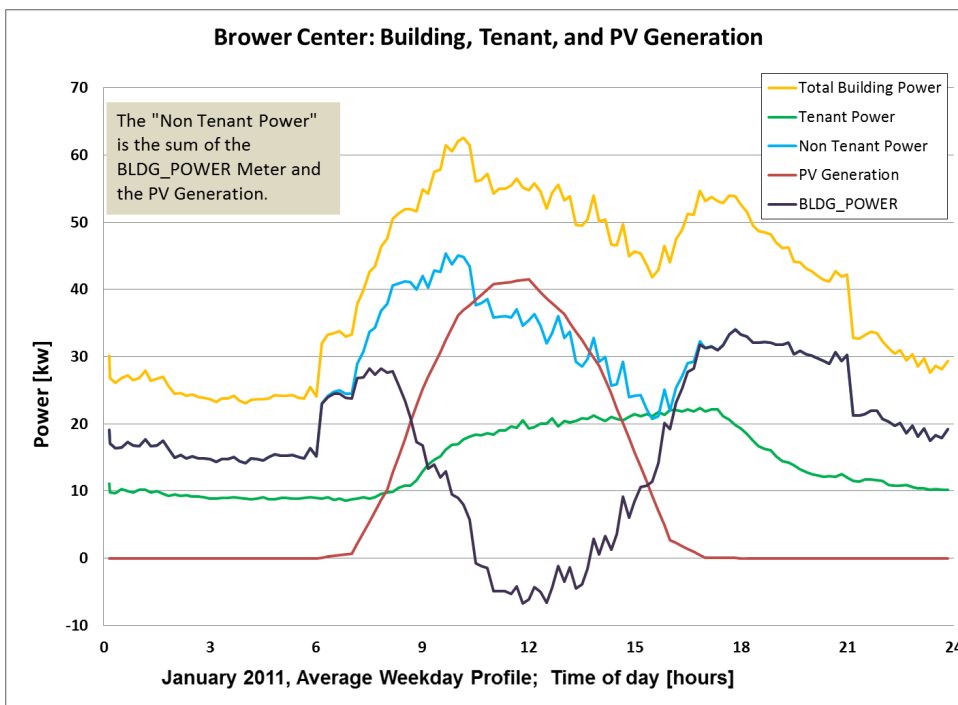
Figure 5: Average weekday power profiles, main panels, David Brower Center

Power data have been collected and analyzed for the month of January 2011. Figure 5 shows average weekday power consumption profiles for the major panels and meters based on all non-holiday weekdays during January. The results show that on average, the BLDG_POWER (which does not include the tenant power) is selling power back to PG&E for a few mid-day hours due to

the PV generation. The total building power usage is still positive at all hours because it also includes the two tenant meters (their sum is shown as “tenant power”). The non-tenant power profile is shown as the sum of the bi-directional BLDG_POWER meter and the PV generation.

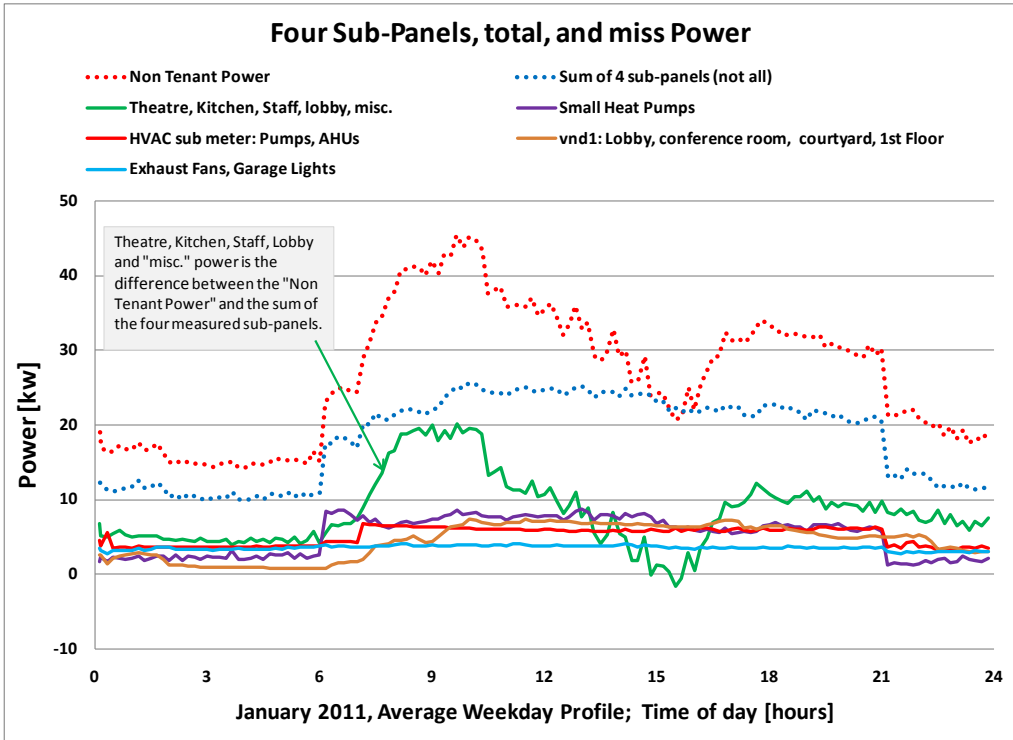
Figure 6: Average weekday power profiles, sub-panels, David Brower Center

Figure 6 presents average weekday power consumption profiles for all sub-metered panels underneath the BLDG_POWER (or BC PG&E Meter) meter. The highest profile (non-tenant power) is identical to that shown in Figure 5. The four sub-panels (VND-1, BC-MMHF1, BC-M, and BC-MHR) all exhibit fairly typical and steady day-time use profiles that never exceed 8.6 kW on any given hour. The sum of these four sub-panels is shown as the dotted blue profile. The difference between the non-tenant power and the total for these four sub-panels is shown as the green profile, which represents a variety of miscellaneous loads. Surprisingly, this miscellaneous profile reaches a maximum value around 20 kW (considerably higher than all individual sub-meters shown) during the morning hours before gradually decreasing to around zero by late afternoon. We are investigating the possible causes of this use profile. It seems likely to include lighting because the profile increases again in the evening, coinciding with nighttime hours during January.

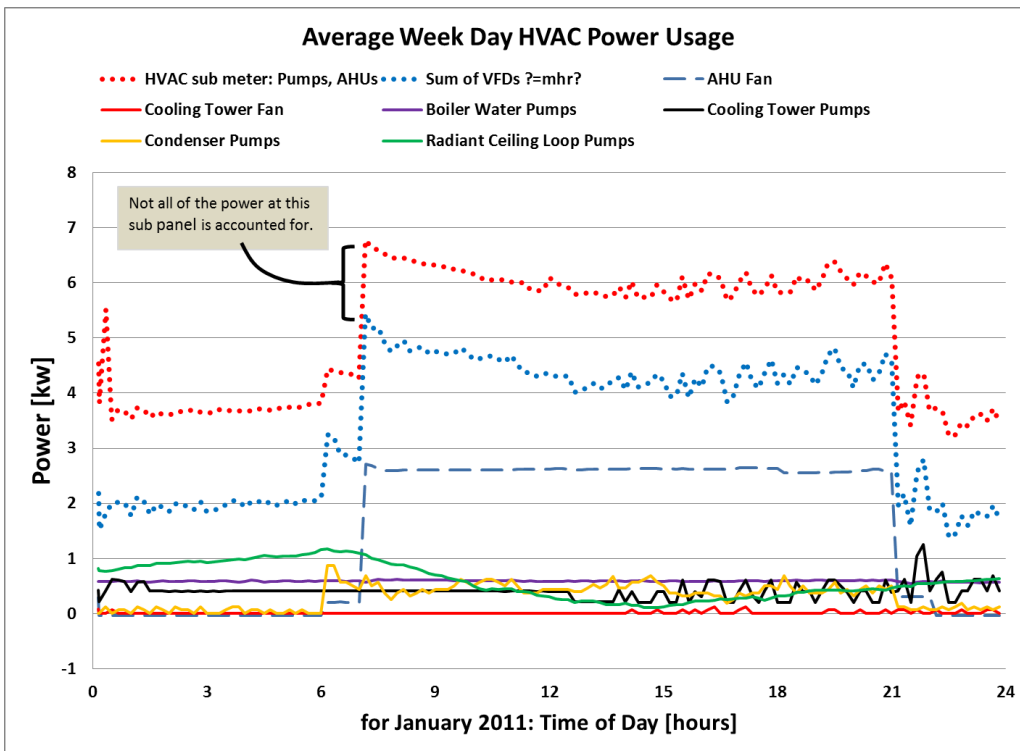
Figure 7: Average weekday HVAC equipment power profiles, David Brower Center

Figure 7 presents average weekday power consumption profiles for all HVAC equipment underneath the BC-MHR meter. With the exception of the AHUs (dashed dark blue line), all pumps and the cooling tower fan show low power usage for all hours of the day (mostly less than 1 kW). During January the cooling tower fan is turned off most of the time. The top two dotted profiles represent a comparison between the power measured at the HVAC panel (BC-MHR) and the sum of all HVAC components. We are investigating the cause of the difference.
