# LA JOLLA CHILDREN'S POOL

## BEACH MANAGEMENT AND WATER QUALITY IMPROVEMENT PROJECT

Coastal Environments  
2166 Avenida de la Playa, Suite E  
La Jolla, CA 92037  
1 August 1998

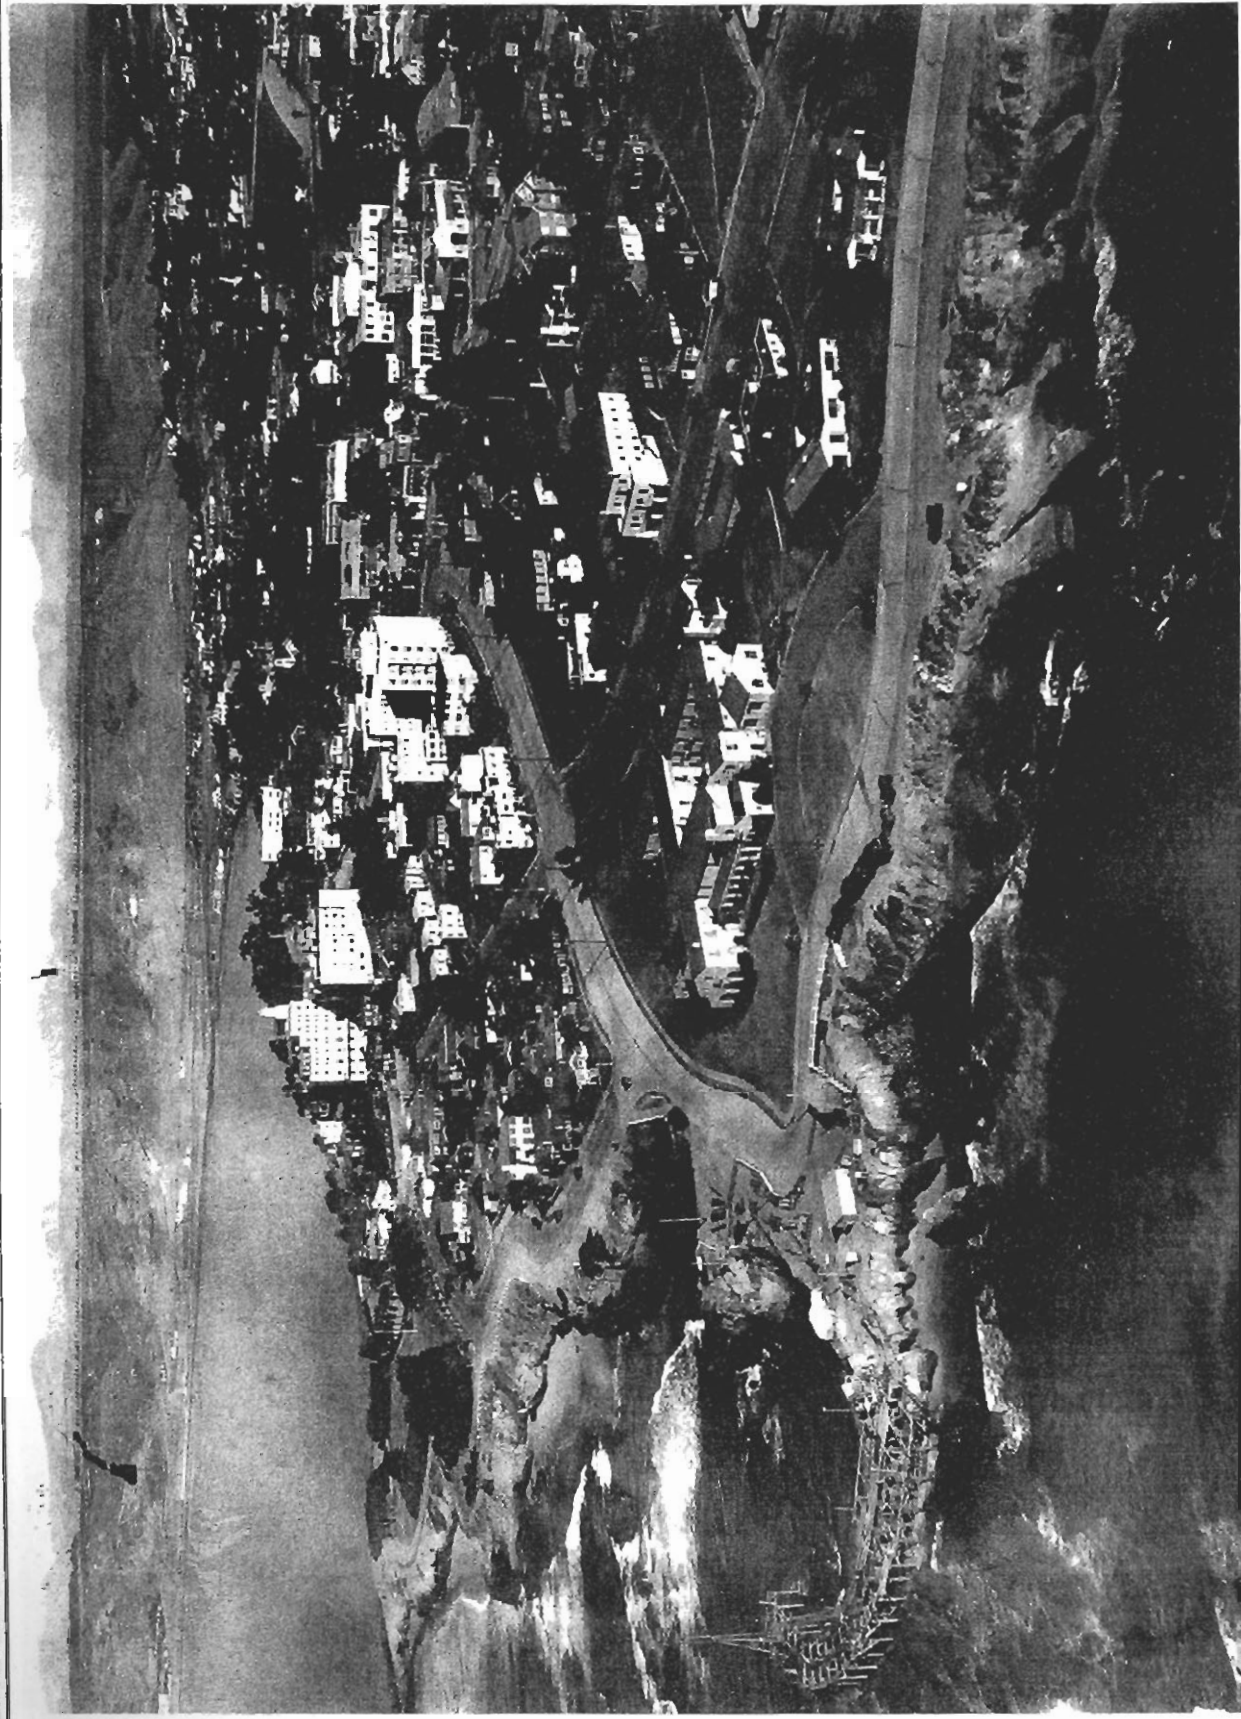
Figure 1. View of the Children's Pool in 1931 during construction of the seawall  
(Source: La Jolla Historical Society Photograph #90:18138-441-1).

The amount of sand on the pocket beaches in the area was somewhat reduced by the time the breakwater was built in early 1931, as shown in an aerial photo taken during construction (Figure B-2; #90:18138-441-1). The sand volume in Casa Cove cannot be seen in this picture. However, Figure B-3 is a ground photo (La Jolla Historical Society) taken on 15 June 1931 and shows a narrow beach inside the breakwater, and a large, calm-water swimming area. The photo was apparently taken near the mean sea level tide stage, judging from the number of steps (or benches) exposed between the top of the breakwater and the water surface in the picture (Savage, 1930). The dry-sand beach width extended seaward about 30% of the length of the breakwater at this time. This was estimated by counting the number of railing posts between the root of the breakwater and the shoreline (about 12), and dividing by the total number of posts (about 40).

The June 1931 photograph also indicates that about seven steps were exposed above the mean-sea-level (MSL) shoreline. The top of the sluices is located between steps 6 and 7, suggesting that the sluice openings on the inside of the breakwater are located at the approximate position of the MSL shoreline at the time of construction. Therefore, the sluices likely were initially partly open, and partly covered by sand. The sluices were built at a convenient gap in the bedrock reef structure. The top of the openings is at approximately elevation +0.5 ft (NGVD) and the bottom at -5.5 ft (NGVD). We surmise from this evidence that the sluices may have been built where they were to preserve the beach width at more or less this position, that is, at a location about 1/3 of the way along the length of the breakwater. These photos also show that the beach elevation at the sluices was about 7.5 ft lower than it is at the present time (Testing Engineers - San Diego, 1998).

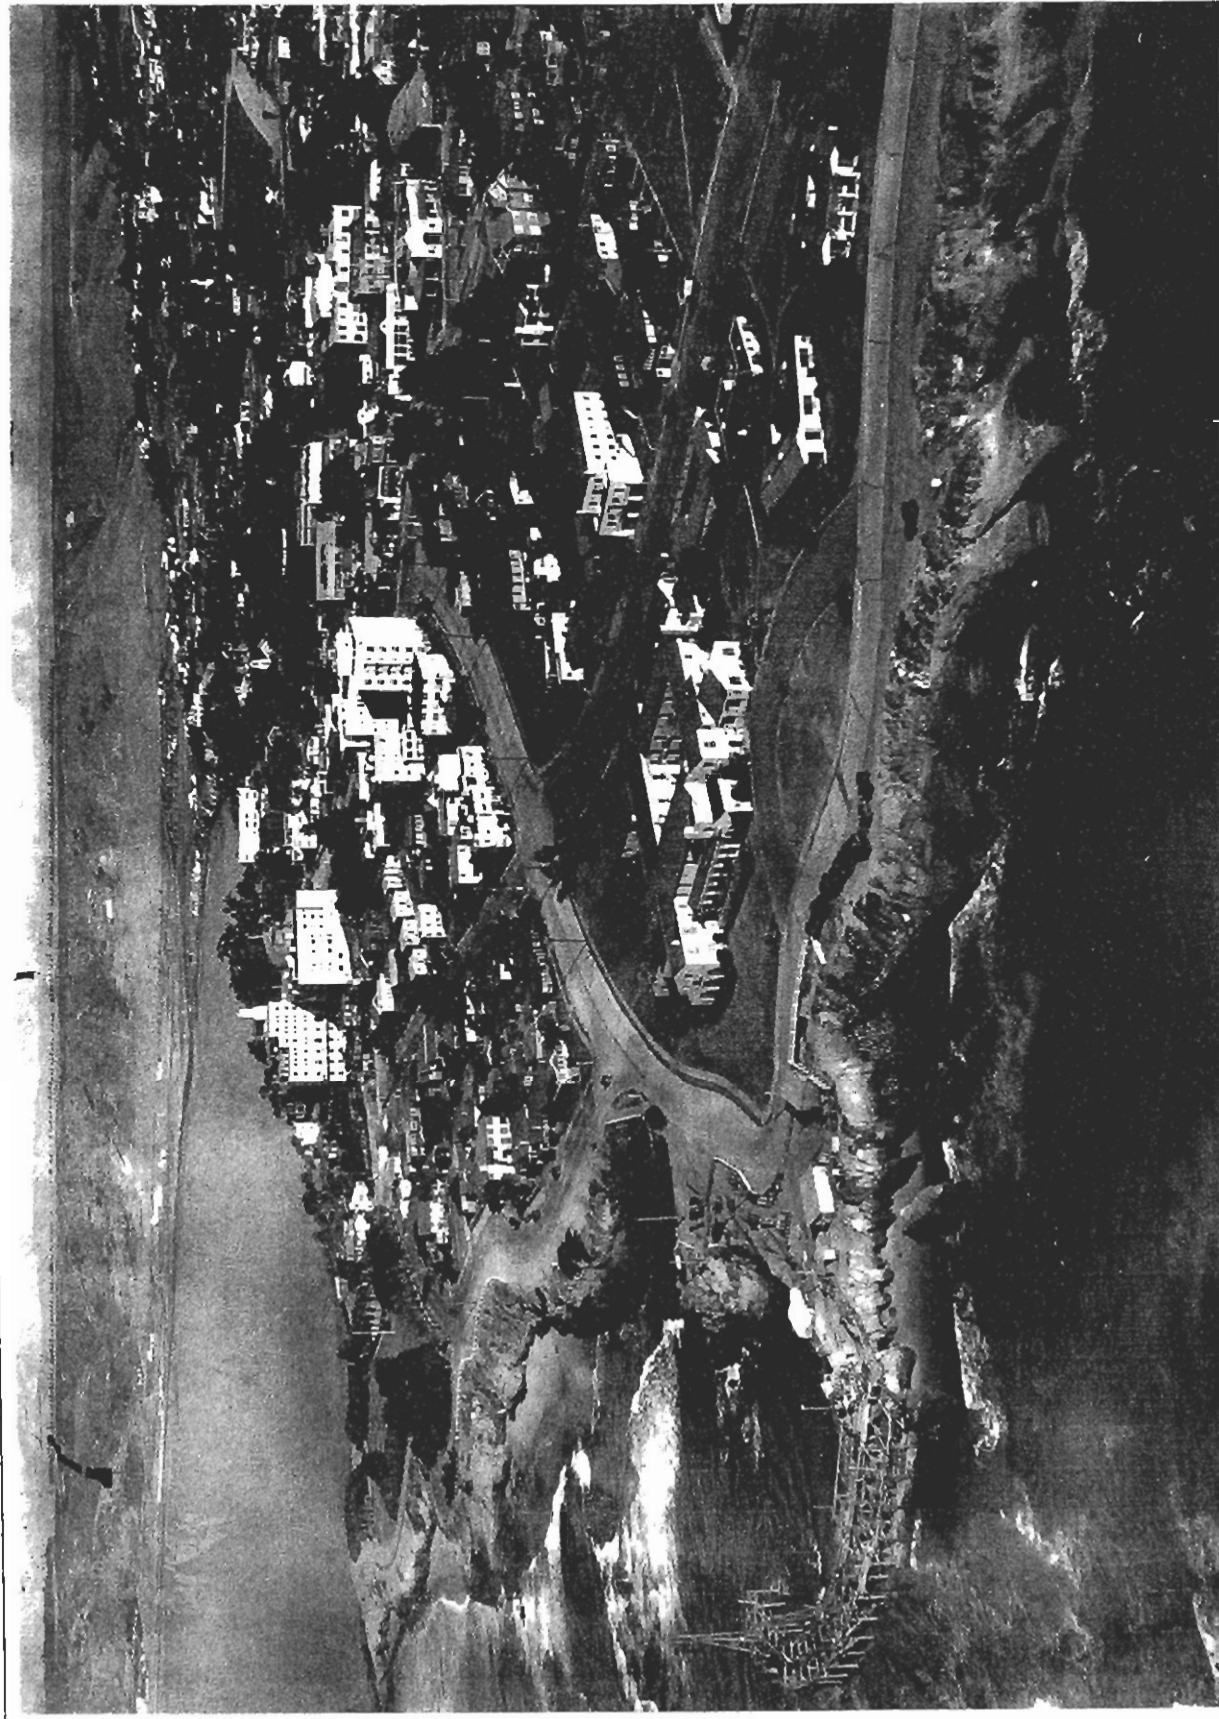
Figure B-2. View of the Children's Pool in 1931 during construction of the seawall  
(Source: La Jolla Historical Society Photograph #90:18138-441-1).

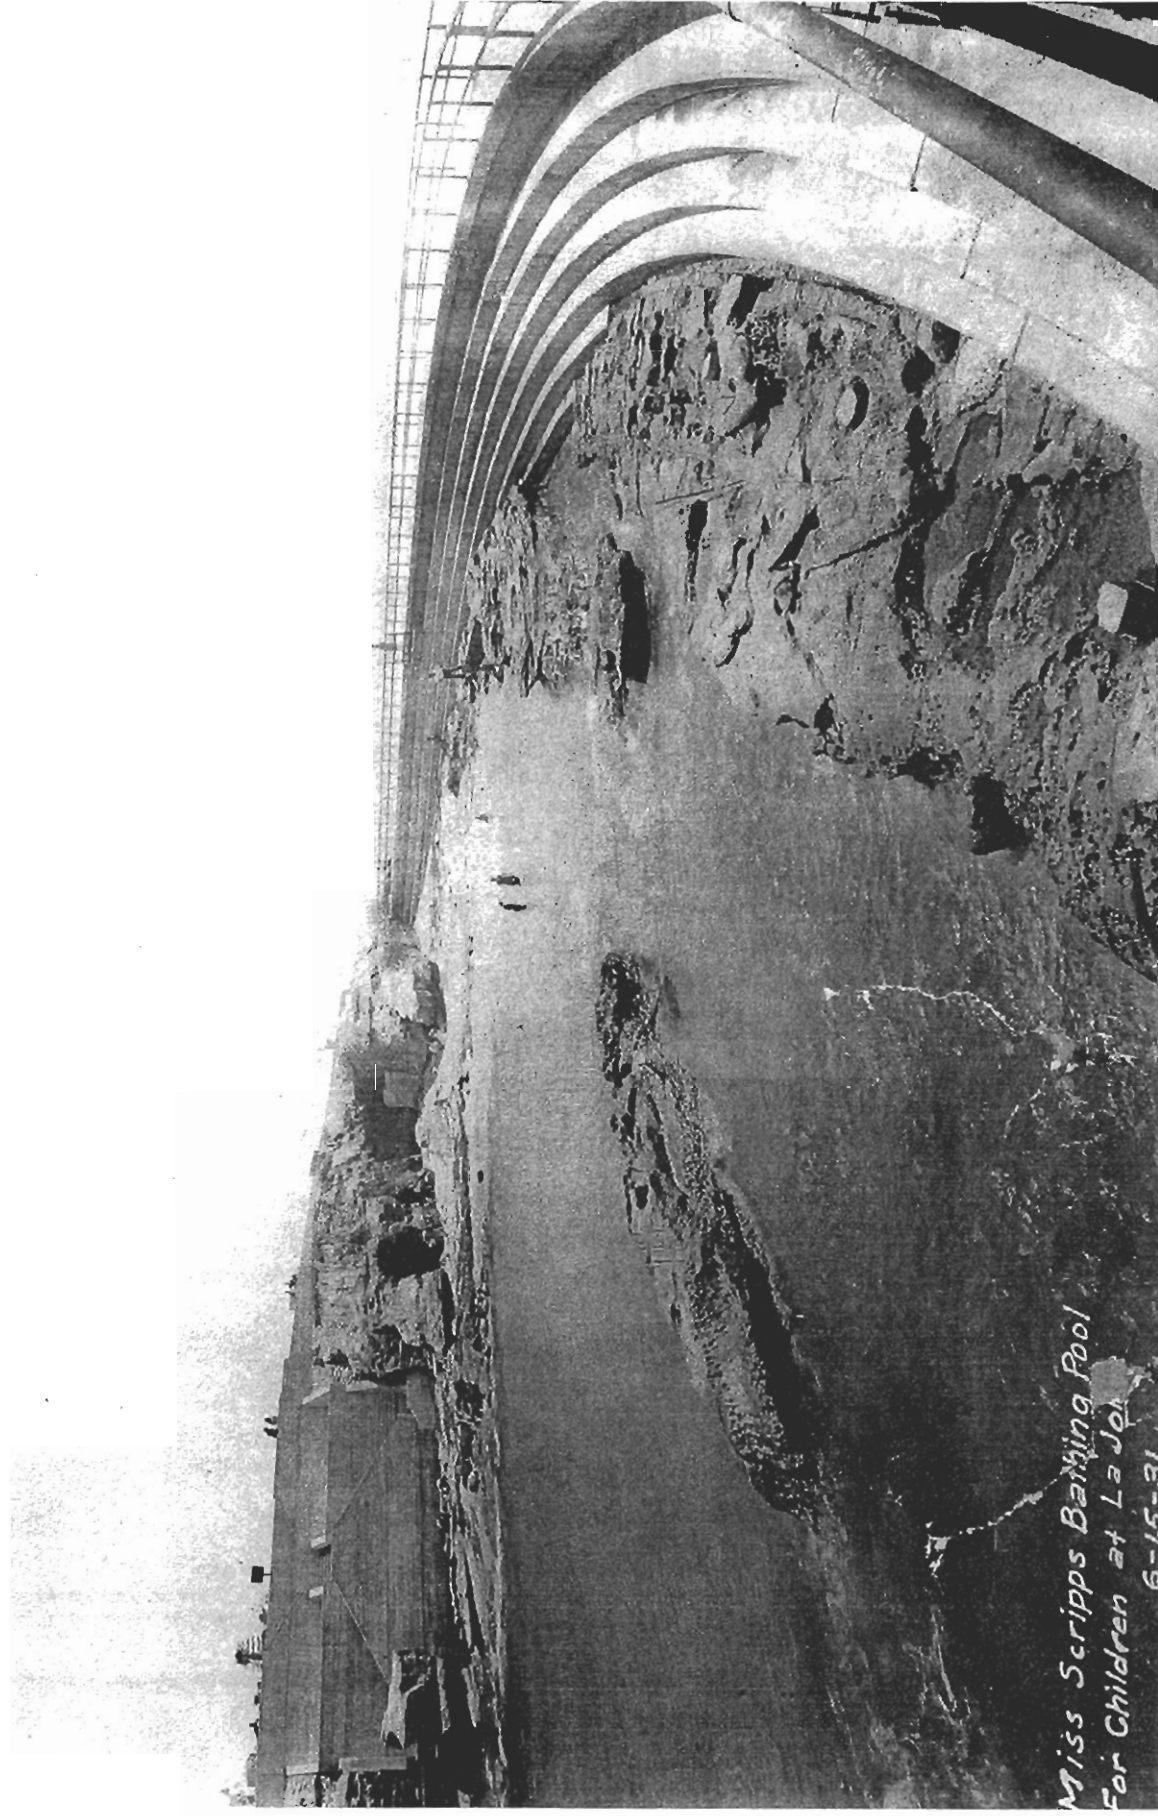
Figure B-3. Miss Scripps Bathing Pool for Children at La Jolla, June 15, 1931  
(Source: La Jolla Historical Society).

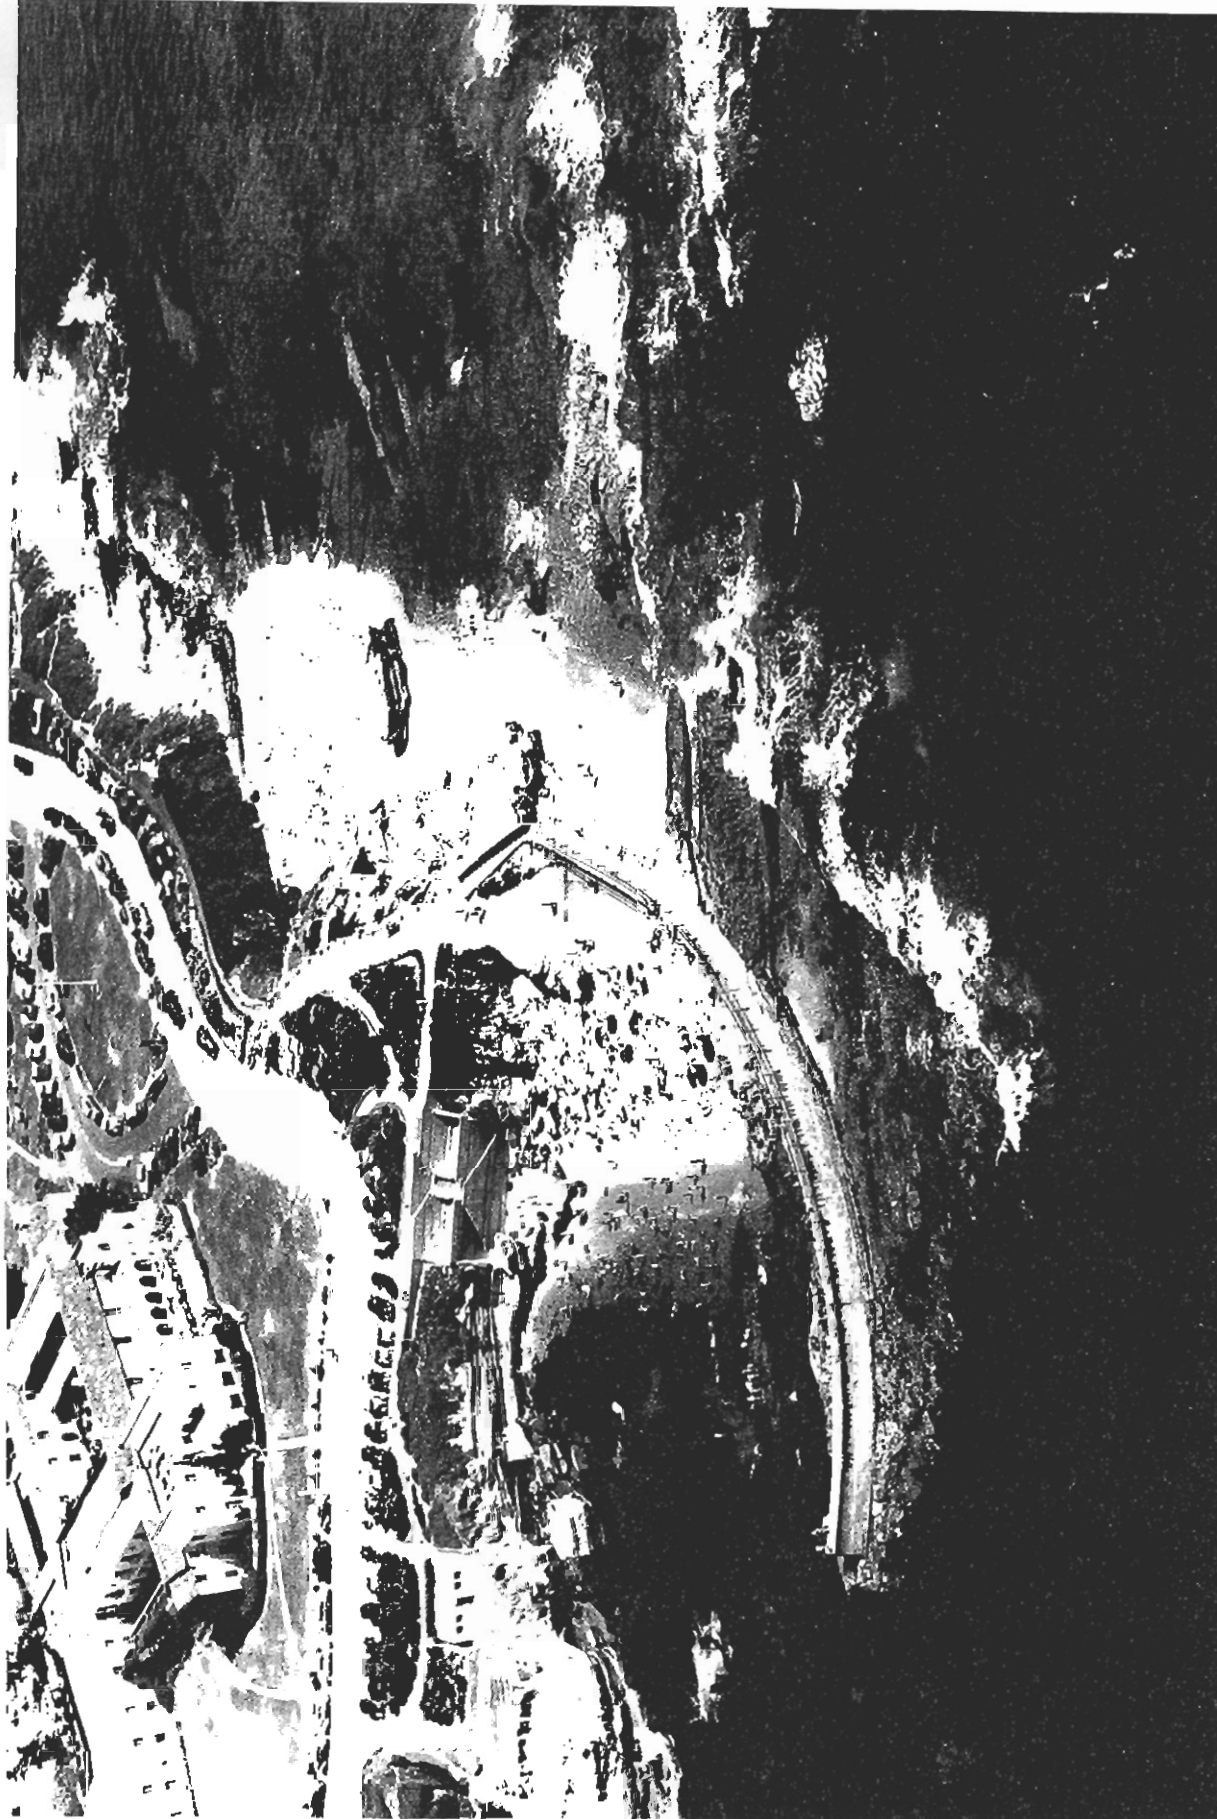
Figure B-6. View of the Casa de Mañana and the Children's Pool on May 21, 1948  
(Source: La Jolla Historical Society).

twice as wide as the distance from the breakwater root to the sluices. In May 1948 (Figure B-6), and July 1953 (Figure B-7; #UT 8248-15), the beach reached approximately 60% (24 posts) of the breakwater length. A new railing was constructed along the seawall after the old railing was severely damaged by the 1982/83 cluster storms. By about 1989 (Cameron and Morgan, 1990), the beach width was about 75% (50 posts out of about 67 at this time) of the breakwater length (Figure B-8). Finally, by early 1998, the shoreline extended to about 80% (55 posts) of the length of the breakwater (Figure 2).

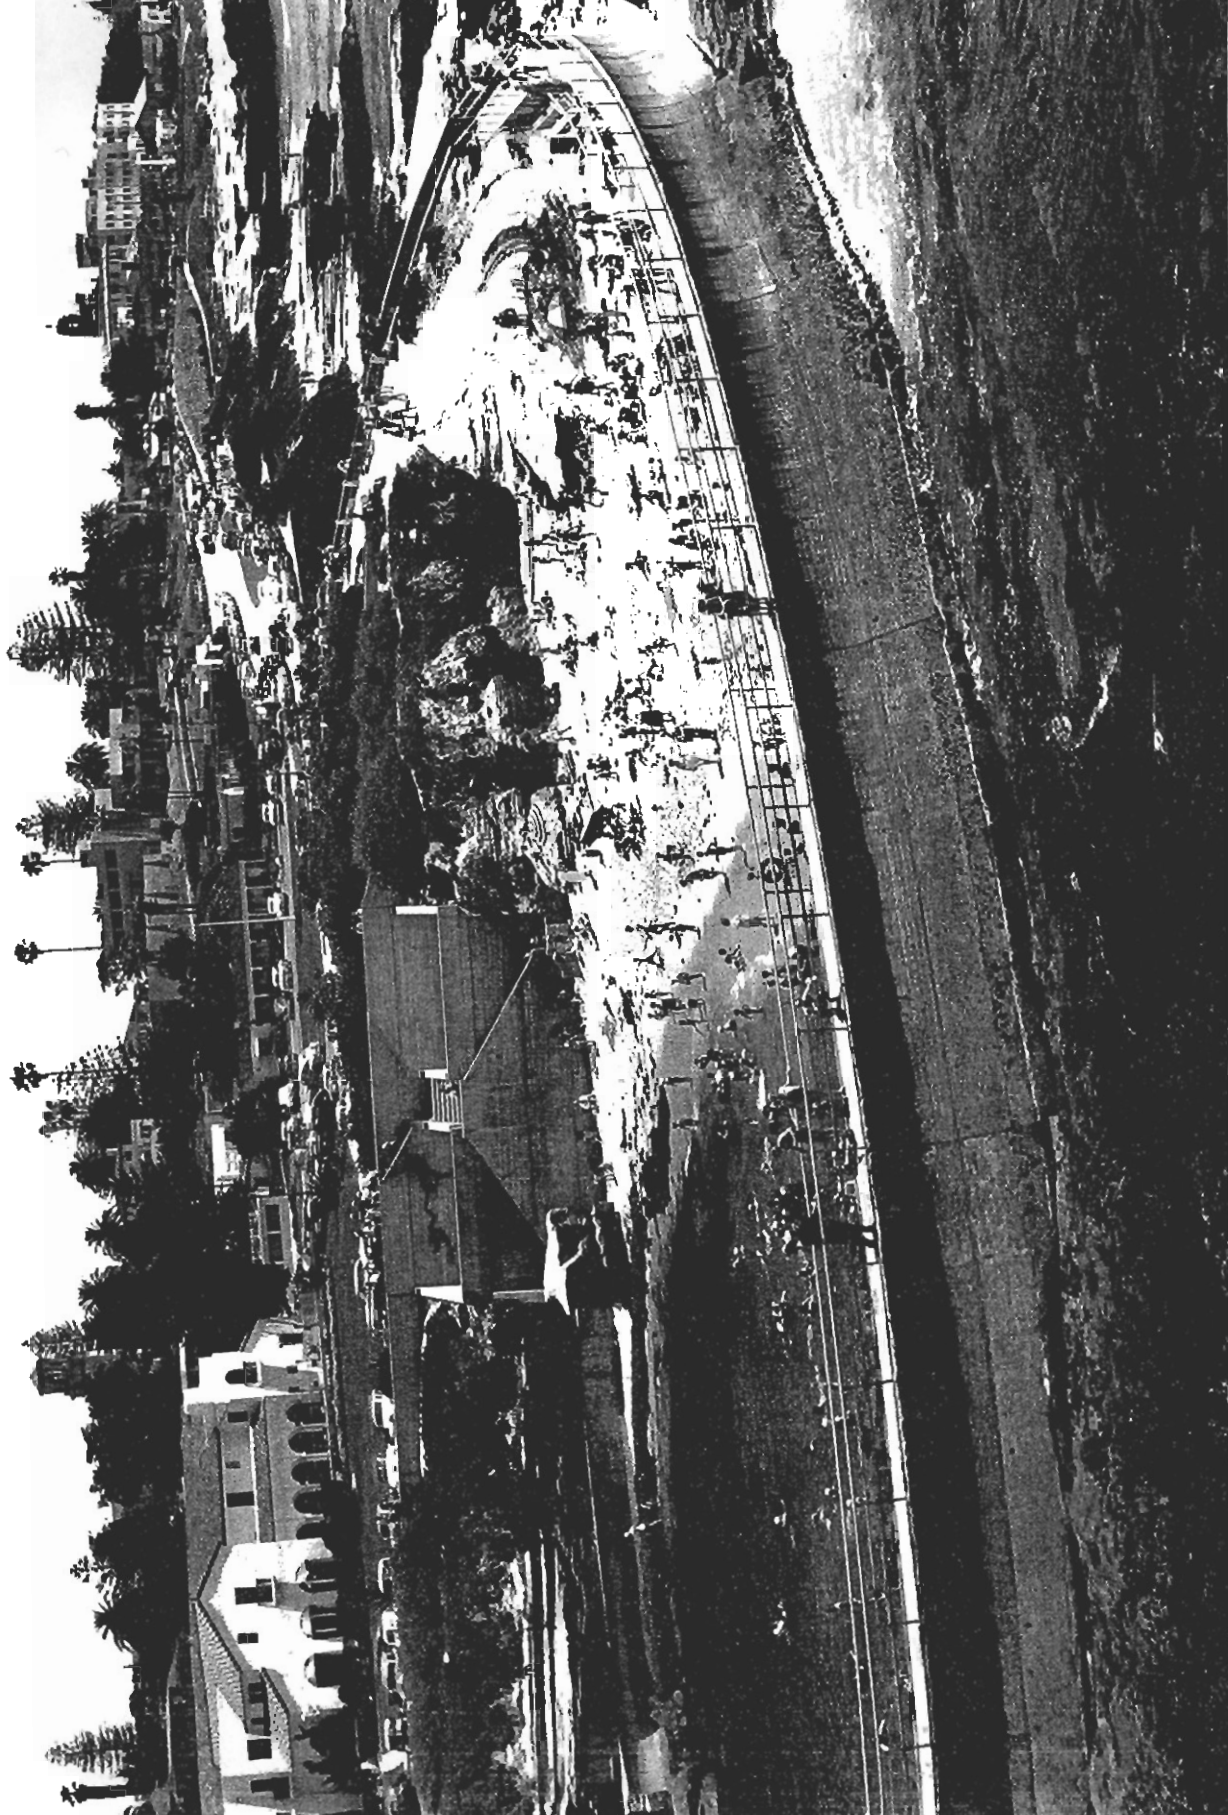
Figure B-7. View of the La Jolla Children's Pool on July 12, 1953  
(Source: La Jolla Historical Society Photograph #UT 8248-15).

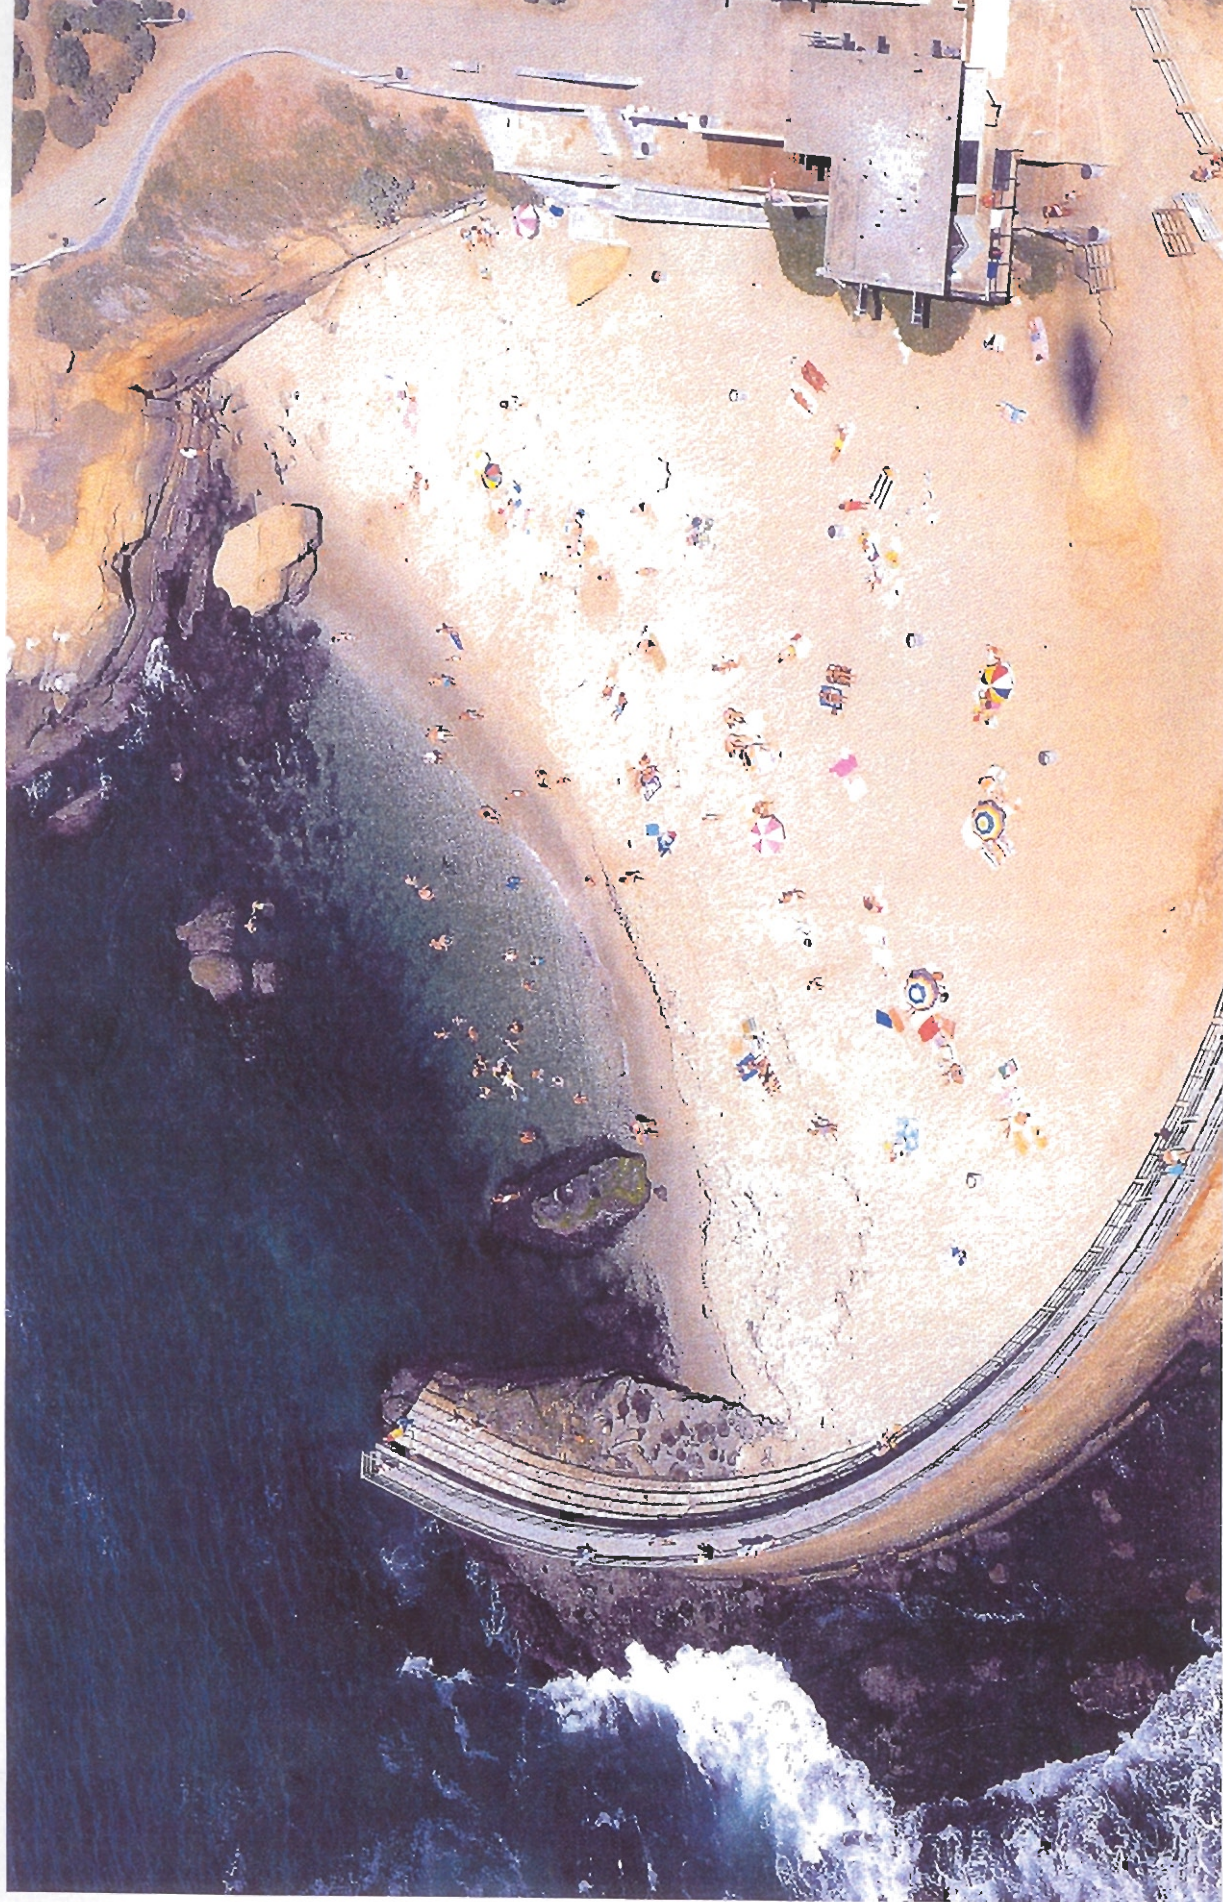
Figure B-8. La Jolla Children's Pool in 1989 (Source Cameron and Morgan, 1990).
