Characterization of free-standing hydride vapor phase epitaxy GaN

Applied Physics Letters, 78(16)

Characterization of free-standing HVPE GaN

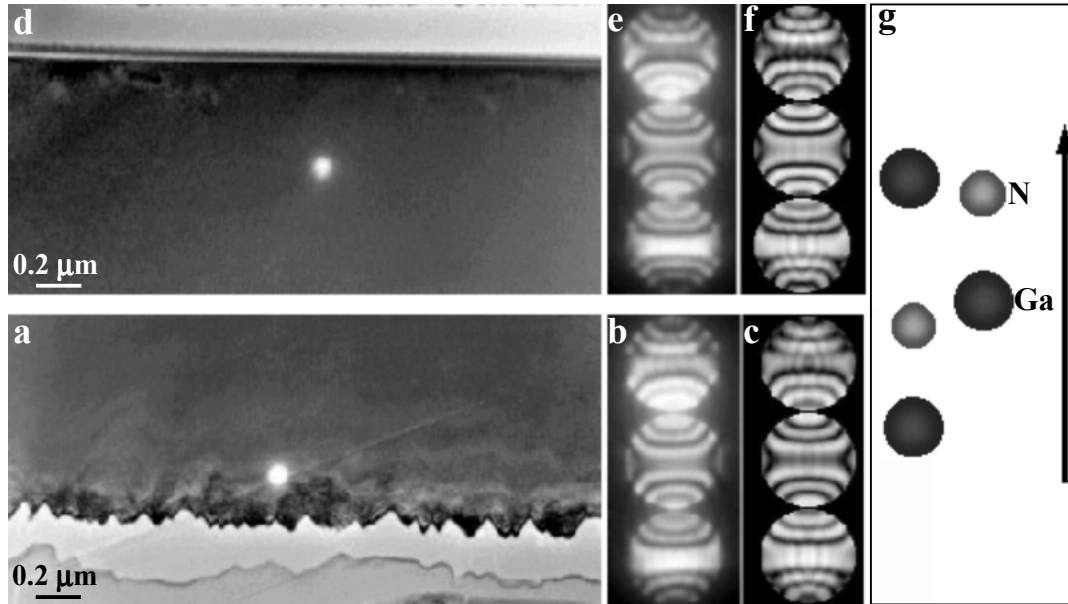
Fig.1. TEM micrographs taken near surfaces (a) previously attached to the substrate and (d) top surface of the template. Experimental $[11\bar{1}00]$ CBED patterns (b and e) taken from marked areas shown in images a and d, respectively. Simulated (for 185 nm and 200 nm, respectively) CBED patterns (c and f). Distribution of N and Ga atoms along the c-axis (g). Growth direction is shown by arrow.

TEM study of cross-sectional specimen revealed that the surface of the side, which was juxtaposed to the substrate was of relatively poor quality as expected from the application of mechanical polishing only and representing interfacial region between the GaN epitaxial layer and the sapphire substrate (see Fig.1a). The roughness of this surface was about 0.1 μm . Besides, the sub-surface layer of about 0.2-0.3 μm was severely damaged containing many defects.

The analysis of Convergent Beam Electron Diffraction (CBED) patterns obtained on the side previously next to the substrate indicates that it is of [000 $\bar{1}$], N-polarity which means that a long bond along the c-axis is from N to Ga (see Fig.1). The polarity determination by CBED is consistent with chemical etching experiments in which the N-face etched very rapidly in hot phosphoric acid (H₃PO₄). In addition, Schottky barriers fabricated on this surface exhibited a much reduced Schottky barrier height (0.75 eV vs. 1.27 eV on the Ga-face), only after some 30-40 μm of the material was removed by mechanical polishing followed by chemical etching to remove the damage caused by the first mechanical polish¹⁶.

likely that the surface was damaged during mechanical polishing as observed in cross-section (Fig.1a). An additional very short ion milling was performed in order to remove this highly defective sub-surface layer. Only after such a procedure, was the sample adequate for studying the defect distribution within the layer. A bright field image of this sample is shown in Fig.2a. Some dislocations (indicated by arrows) threading across the layer into the surface are visible edge-on. The density of these dislocations determined from the plan-view sample was estimated to be about $4 \pm 1 \times 10^7 \text{ cm}^{-2}$. These threading dislocations were observed also in cross-section. Few of them are clearly visible in bright field images as shown in Fig.3. The density of these dislocations determined from cross-section was found to be about $3 \pm 1 \times 10^7 \text{ cm}^{-2}$. This value is in good agreement, within experimental error, with the value obtained from the plan-view sample. For comparison, a density of about $1 \times 10^7 \text{ cm}^{-2}$ was obtained by etching the N-face in H_3PO_4 for 15 seconds at 160°C followed by counting the etch pits on several Atomic Force Microscopy (AFM) images. The agreement between these two very different techniques lends confidence concerning the densities reported here.

In contrast to the N-polarity side, which was previously attached to the substrate, the opposite surface was very flat (Fig.1). There were only some defects visible close to the sample surface, but since in the neighboring "dummy" silicon we observed severe damage, these defects might be an artifact of TEM sample preparation. The majority of these defects appear in cross-section configuration on the c-plane and therefore they should be visible in plan-view as loops or half-loops. However, this was not observed supporting the notion that these defects were due to sample preparation.

The intensity distribution within the CBED pattern measured on this face of the template indicates that it is of [0001] orientation which implies a Ga polarity and means a long bond along the c-axis is from Ga to N direction (see Fig.1). This is in agreement with wet chemical etching experiments in that the etch rate in hot H_3PO_4 was negligible. Additional confirmation was obtained from Schottky barriers formed on this surface with barrier heights of about 1.27 eV, as opposed to about 0.75 eV on the etched N-face.

Fig.1. TEM micrographs taken near surfaces (a) previously attached to the substrate and (d) top surface of the template. Experimental $[1\bar{1}00]$ CBED patterns (b and e) taken from marked areas shown in images a and d, respectively. Simulated (for 185 nm and 200 nm, respectively) CBED patterns (c and f). Distribution of N and Ga atoms along the c-axis (g). Growth direction is shown by arrow.

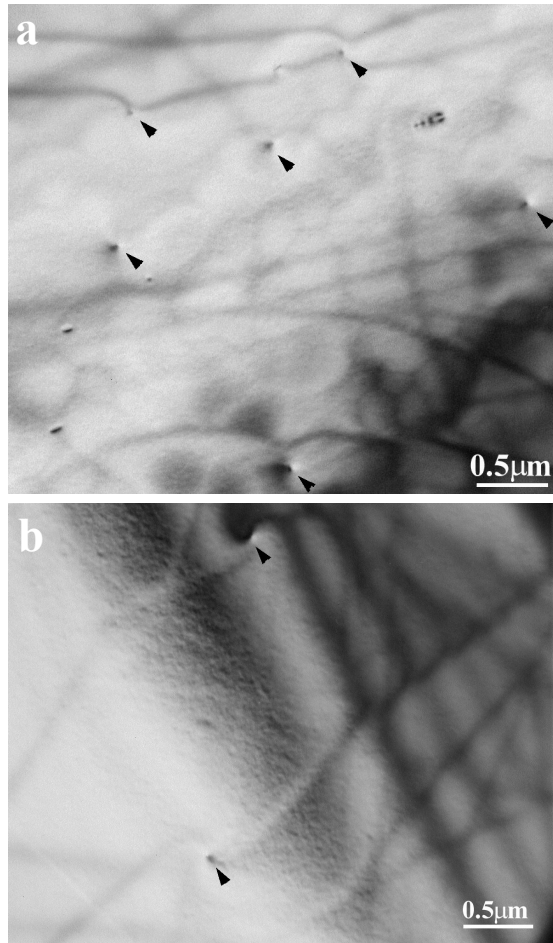
Fig.2. Bright-field TEM micrograph of a plan-view sample prepared for the N-face (a) and Ga-face (b), respectively. Visible edge-on dislocations are marked with arrows.

TEM studies of a plan-view specimen prepared for the Ga-face side revealed a nearly defect-free surface. Very few dislocations were found on this surface. Two such dislocations marked by arrows are shown in Fig.2b. Based on the plan-view study, the density of these dislocations was estimated to be less than $1 \times 10^7 \text{ cm}^{-2}$, however due to the very low statistics there is a relatively large uncertainty for this estimation. In cross-sectional study we could not find any threading dislocation within the electron transparent area and based on this information we estimated that density of these dislocations is less than about $0.5 \times 10^6 \text{ cm}^{-2}$.

Fig.2. Bright-field TEM micrograph of a plan-view sample prepared for the N-face (a) and Ga-face (b), respectively. Visible edge-on dislocations are marked with arrows.

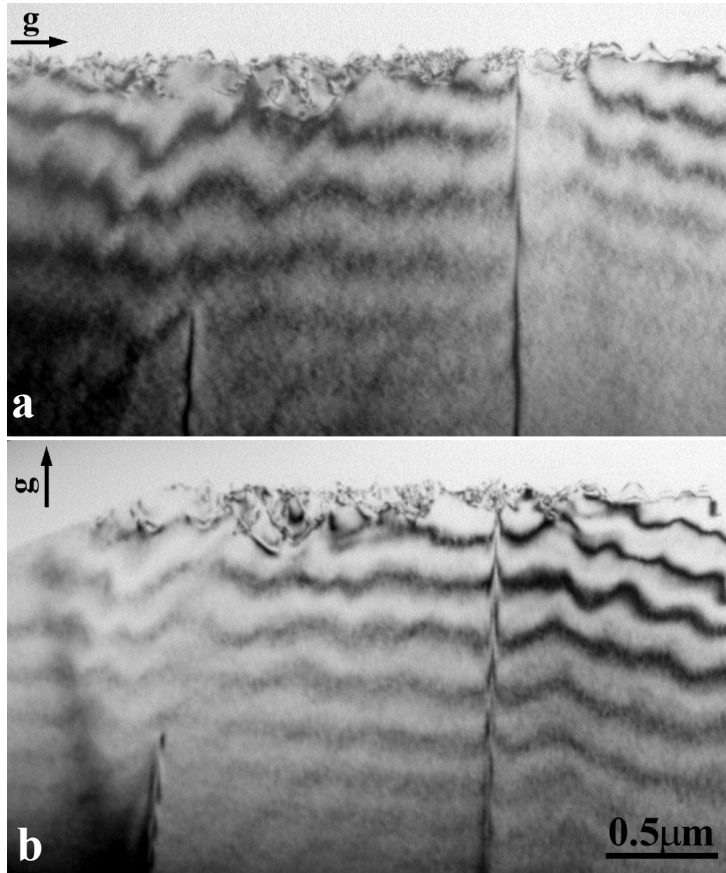
Fig.3. Bright field TEM micrographs of a cross-section sample near the N-face side for the g-vectors perpendicular (a) and parallel (b) to the c-axis. Note that both dislocations are visible in both images.

Our study suggests that most of these threading dislocations are of mixed Burger's vector because they are visible on bright field images with g-vector parallel and perpendicular to the c-axis (see Fig.3). However, one needs to be careful with such a conclusion because of the very low statistics (very few dislocations observed within the electron transparent area).

Fig.3. Bright field TEM micrographs of a cross-section sample near the N-face side for the g-vectors perpendicular (a) and parallel (b) to the c-axis. Note that both dislocations are visible in both images.
