Building Technologies & Urban Systems Division  
Energy Technologies Area  
Lawrence Berkeley National Laboratory

# Through the looking glass: analyzing barriers to adoption of advanced rooftop unit controls through human-centered observational research

Energy Technologies Area  
August 2024

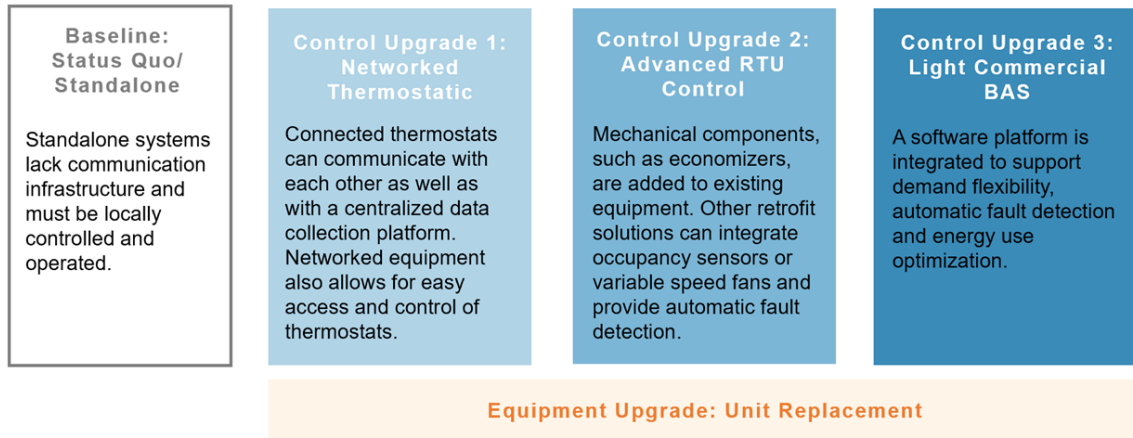
Figure 2: Descriptions of each control upgrade categories. Each site selected for observation was installing RTU control equipment that fits into one or more of these categories.

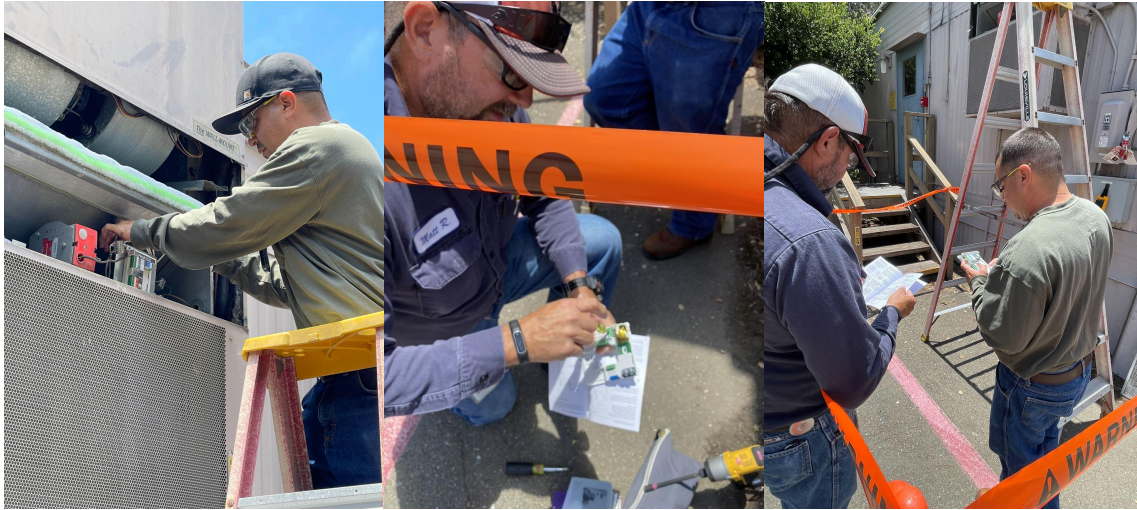
At LBNL, the installation of the economizer controller also presented installation challenges. The IC could not establish a connection to the newly installed economizer controller and spent roughly 45 minutes troubleshooting the issue. When the team returned the next day, the IC had determined through manufacturer documentation that the new economizer controller was not compatible with the other equipment. Luckily, the compatible component was already on site and the ICs were able to install and calibrate the economizer, but this added time to the initial 45-minute installation and troubleshooting process. Photos from the installation are shown in Figure 4.

Figure 4. Images of the installation and troubleshooting process at LBNL.

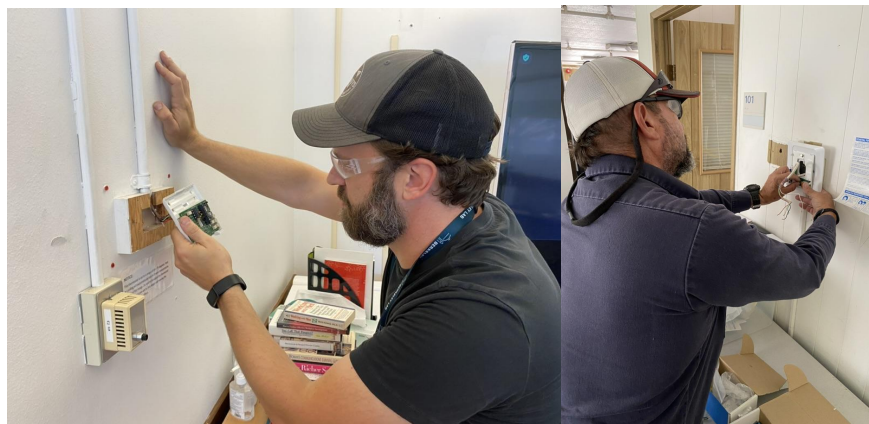
3. Due to a high number of interacting components and slow dynamics, the commissioning processes for HVAC controls is long and tedious. In all of the observations we conducted, configuration of thermostats, especially the ones that provided additional capability (i.e., demand-controlled ventilation or occupancy sensors) took the longest time. To address these issues, a simplified and clear commissioning process can reduce the time and effort required to configure and commission new devices. Images in Figure 6 show ICs inspecting thermostat wiring.

Figure 6. Images of ICs installing networked thermostats.
