Field Investigation of Duct System Performance in California Light Commercial Buildings (Round II)

Wm. Woody Delp, Nance E. Matson, Darryl J. Dickerhoff, and Mark P. Modera, Lawrence Berkeley National Laboratory, Berkeley, CA

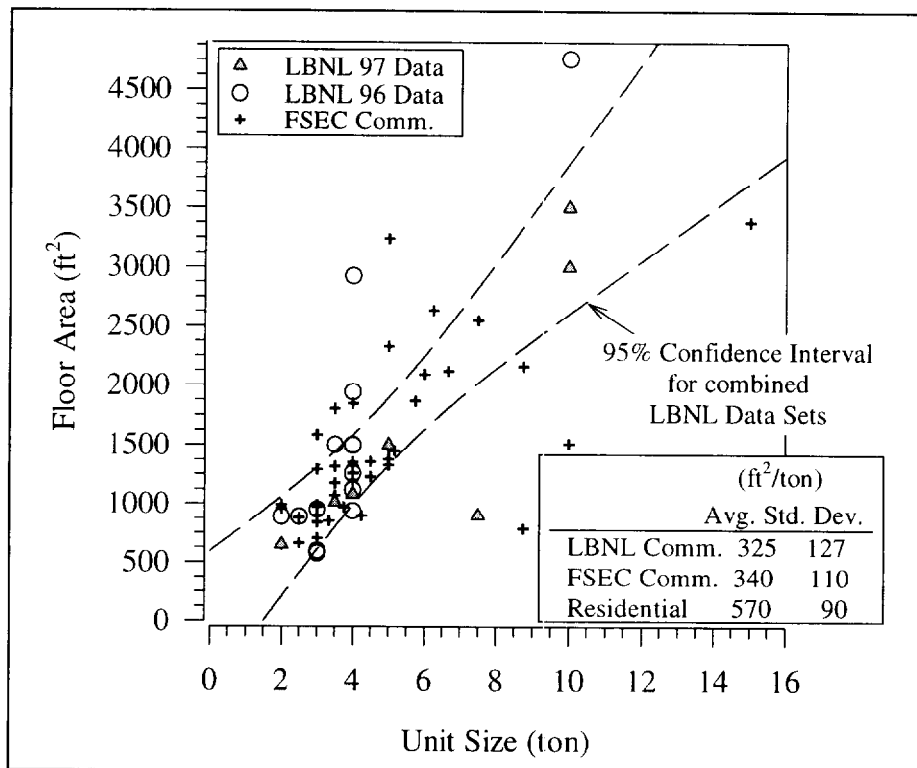
Figure 1. Floor area -vs- unit size: using the 1996 and 1997 LBNL and FSEC (Cummings, et al., 1996) commercial data along with residential (Jump, et al., 1996) summary information. The FSEC unit size is derived from the total installed capacity in the building divided by the number of units.

Figure 1 shows the floor area versus the unit size, for both the LBNL and the FSEC data sets. The important point here is the floor area served by each unit. This figure shows that the California (LBNL) buildings are similar to those in Florida (FSEC). Light-commercial buildings frequently have a greater load density (ton/ft^2) than single-family residential homes, due to internal loads such as equipment, lights, and people. Unfortunately with many light-commercial buildings accurate load information is not available during design, and contractors/engineers resort to a rule-of-thumb approach to equipment selection, often resulting in oversized equipment. (Less than half of the systems tested had any plans.) It is worth noting the values in the figures are installed capacities, and do not necessarily correspond to actual space loads.

The twenty-five systems had an average unit size of 4.9 tons, this compares with the FSEC data of 4.5 tons, and the residential of 2.9 tons (Jump, et al., 1996).

The average floor area served by each unit was 1,575 ft² for the current study, 1,400 ft² for the FSEC buildings, and 1,800 ft² for the residential buildings. Since the area served by each commercial unit is smaller than residential, and the units have a greater capacity, commercial buildings have larger units on a floor area basis than residential buildings. The commercial buildings averaged between 325 and 340 ft²/ton while the California residential buildings averaged 570 ft²/ton. Assuming duct loss mechanisms scale with capacity, this indicates light-commercial buildings potentially have greater duct losses on a building floor area basis than residential buildings.

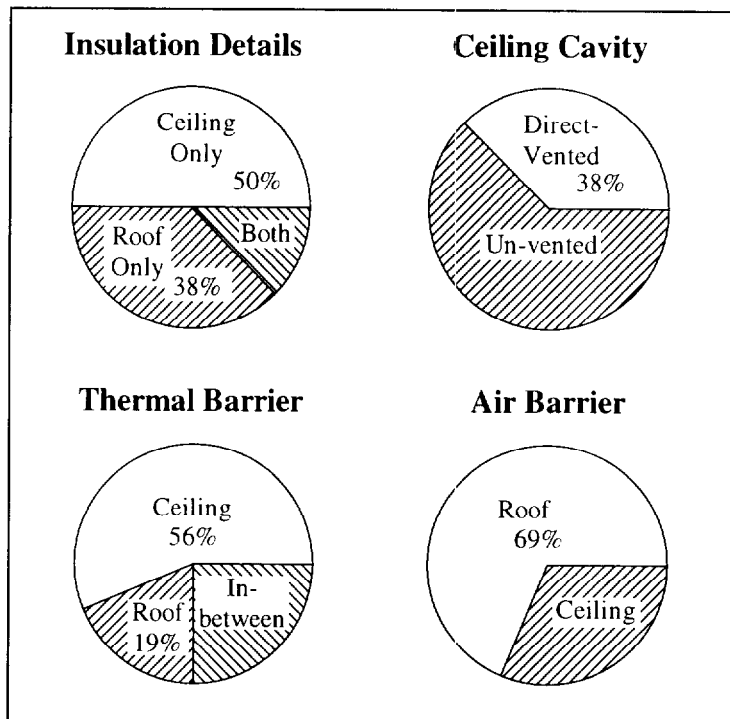
Figure 2. Building thermal and air barrier characterization for the 1996 and 1997 LBNL commercial buildings.

In order to understand the dynamics of duct losses, details of the building need to be determined. Figure 2 summarizes many of the characterization details pertaining to the buildings. All the buildings had a drop ceiling with the duct runs in the ceiling cavity. Because of this, two critical building details are the location of the thermal and the air barrier. Fifty percent of the buildings had insulation placed at the roof deck, 38% on the ceiling tiles, and the remainder had insulation at both locations. Thirty eight percent of the buildings had a directly vented ceiling cavity. In these buildings, the lay-in acoustical ceiling tiles formed the major air barrier. In 56% of the buildings the primary thermal barrier was at the ceiling tiles, which implies that the ducts are entirely outside the conditioned space. In 25% of the buildings the ceiling cavity acted like a buffer zone, with the temperature floating between the room and outside temperatures. With these buildings, the thermal barrier is in-between the roof and ceiling. In the remainder of the buildings the thermal barrier was at the roof, however even in these buildings, the ceiling cavity temperature was slightly higher than the room.
