Field Quality Analysis as a Tool to Monitor Magnet Production

Field Quality Analysis as a Tool to Monitor Magnet Production*

R. Gupta¹, M. Anerella, J. Cozzolino, D. Fisher, A. Ghosh, A. Jain,
W. Sampson, J. Schmalzle, P. Thompson, P. Wanderer, E. Willen
Brookhaven National Laboratory, Upton, NY 11973, USA

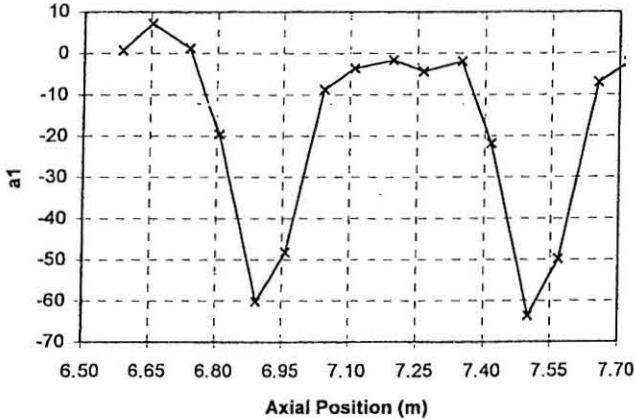
Figure 1: The axial variation in the skew quadrupole harmonic in RHIC 80 mm aperture dipole DRG189 in the suspected region.

The magnet was transported from the vendor to the Laboratory for more measurements and analysis. The measurements were repeated with another one meter long rotating coil with smaller axial steps, to derive the axial profile of field harmonics with better resolution. Fig. 1 shows the axial variation in the skew quadrupole harmonic derived from such a procedure based on the 0.15 m step size. The sextupole harmonic was also measured directly with a Hall probe array (effective length ~1 mm) to verify the procedure used.

The RHIC magnets use two types of 0.15 m long RX630 insulators between the coil and the yoke. Those used in the body have a pole to compress the coils and those used in the ends have no pole. Based on Fig.1 and based on the parts used in magnets, it was postulated that end-type of pole spacers may have been inadvertently used in two places in the body of the magnet. Furthermore, calculations showed that with missing compression (and therefore a change in the effective turn thickness), the turns have moved upward symmetrically towards the vertical axis with a maximum displacement of 1.7 mm. This was consistent with the expected uncompressed coil size. The magnet was partly disassembled to verify this scenario and upon inspection it was indeed found to be the case. A magnet with such a large discontinuity in the superconducting coil is expected to have a poor quench performance, and was not accepted for RHIC. A similar error was discovered in another magnet, DRG226.

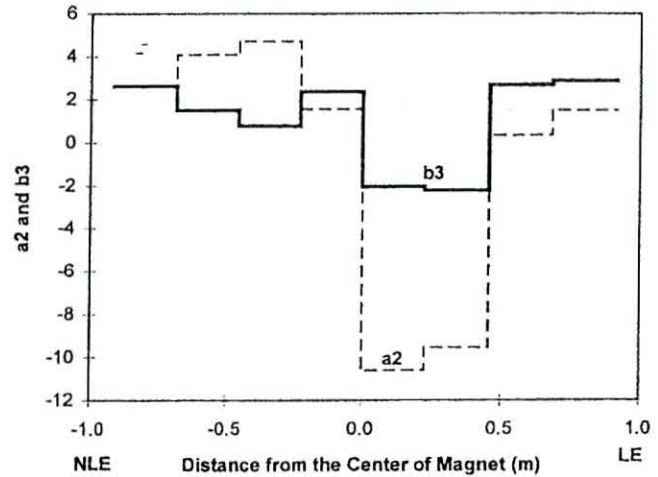
Figure 2: The axial variation in skew sextupole and octupole harmonics in RHIC 130 mm aperture quadrupole QRJ105.

The field quality in the lead-end and non-lead end halves of 2.1 m long (magnetic length), 130 mm aperture RHIC insertion quadrupoles is separately obtained from a series of measurements with a 2.78 m long coil. The magnet QRJ105 was found to have large differences in harmonics in the two halves. These differences could not be explained by the allowed tolerances in parts and assembly. The harmonics were measured in smaller steps of 0.225 m with the same measuring coil. The axial variation in a_2 and b_3 , obtained using a procedure similar to the one discussed in the previous section, is shown in Fig. 2. A discontinuity (or a change much more than what can be explained by allowed tolerances) in the section between 0.0 to 0.5 meter can be seen in the lead-end half. The magnet symmetry arguments, similar to those used in the last section (in quadrupoles a_2 reflects up-down

asymmetry), indicate that the two coils in the upper half have moved closer to the vertical axis of the magnet. The coldmass was disassembled and a visual inspection revealed that a ~ 0.45 m long part of 0.36 mm thick shim on the vertical axis on the upper half had fallen off. The measured and computed change in harmonics affected by this symmetry are given in Table II. Given the normal measurement errors and construction tolerances, a deviation was neither expected nor observed in the harmonics not listed in this table.

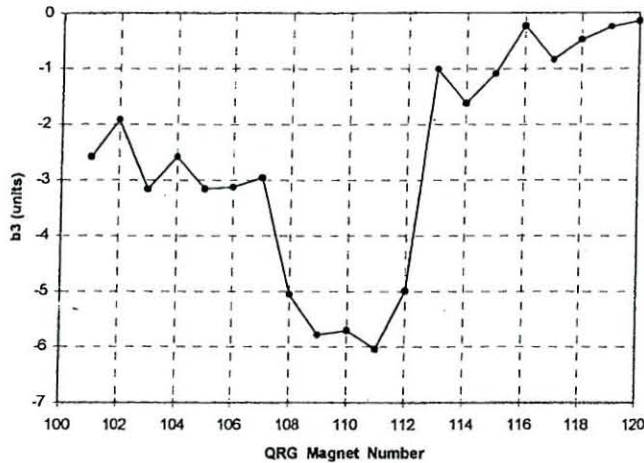
Figure 3: The measured octupole harmonic with the magnet number (first magnet named QRG101) in RHIC 80 mm aperture quadrupoles.

Since 80 mm aperture RHIC arc quadrupoles (4-fold symmetry) are collared like dipoles (2-fold symmetry), a large positive octupole term ($b_3 \sim +7$ units at 25 mm radius) is created. To compensate for this asymmetry, the coil-to-midplane gap on the horizontal and vertical axes were made 0.25 mm and 0.15 mm respectively [6]. The measurements (see magnets 101-107 in Fig. 3) indicated that this difference had over compensated the asymmetry, leading to a negative value of b_3 . A request was made to the vendor to decrease this asymmetry by 0.025 mm which was also expected to help reduce the b_5 harmonic at injection. However, the change was made in the wrong direction and the asymmetry was increased. The measured b_3 (see magnets 108-112) showed an increase in the magnitude. This, and the new value of the b_5 harmonic confirmed that the change was indeed in the wrong direction. The problem was corrected in the subsequent magnets and the desired harmonics were obtained (see magnets 113 and onwards).

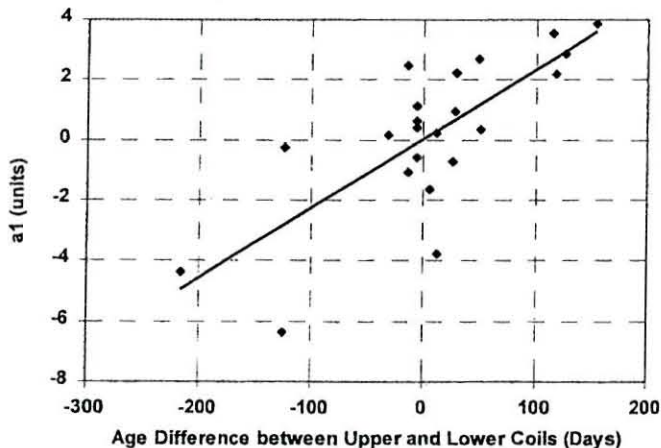
Figure 4: A correlation plot with a least square fit between the skew quadrupole and the age (from curing to collaring) difference between the upper and lower coils in 100 mm aperture RHIC insertion dipoles.

During the warm magnetic measurements of RHIC 100 mm aperture insertion dipoles, it was found that the RMS variation in the skew quadrupole harmonic (~ 2.5 units) was larger than the value obtained in 80 mm aperture arc dipoles (1.6 units). Since the two are built using similar design and construction techniques, one should expect a similar or smaller value in insertion dipoles due to their larger aperture. This large RMS was later traced to the storage of the coils for greatly varying periods of time prior to collaring. This allowed the coil azimuthal size to grow with time. The two coils in a particular magnet were matched in azimuthal size to 0.025 mm based on the size measured just after curing. In Fig. 4, we make a correlation plot between the difference in age (from coil curing to collaring) between the top and bottom coils and the measured a_1 . One can conclude from Fig. 4 that the storage time between curing to collaring played a role.

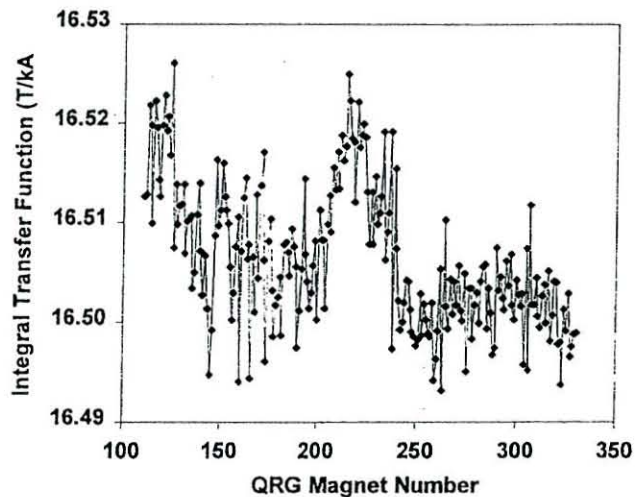
Figure 5: The measured integral transfer function with the magnet number in RHIC 80 mm aperture quadrupoles.

A pattern of variation was observed in the integral transfer function of 1.1 m long (magnetic length) 80 mm aperture arc quadrupoles (see Fig. 5). A careful examination of coil mechanical parameters revealed a similar pattern in coil length. This was later traced to an incorrect method employed by the vendor's subcontractor in assembling coil end parts. This resulted in the large variations of the coil ends and hence the overall coil length. Fig. 6 shows a correlation between coil length and integral transfer function. The assembly method was later corrected and the variations were reduced starting around magnet sequence number 240 in the magnets as shown in Fig. 5.

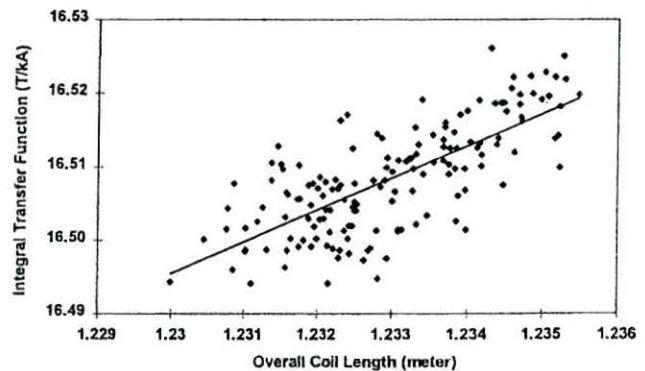
Figure 6: A correlation plot with a least square fit between the integral transfer function and the coil length in 80 mm aperture RHIC arc quadrupoles.

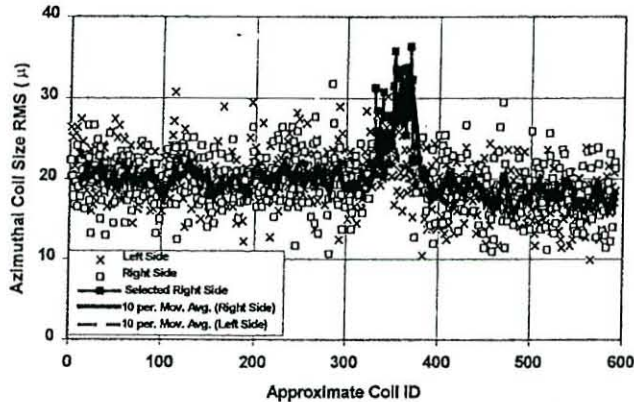
Figure 7: The standard deviation in the left and right azimuthal sizes of the RHIC arc dipole coils.

In the middle of the production run of RHIC 80 mm aperture arc dipoles, a large axial variation in several field harmonics was observed in the body of a number of magnets. The harmonics which showed large variation were the odd normal and the even skew. By symmetry arguments, one can conclude that at certain places along the length, the left and the right coil do not have the same azimuthal size. By exam-

ing the harmonics carefully, the axial position, that was the source of this behavior, was located. The vendor was notified, who in turn reported overlapping curing shims in the press. This was corrected and the axial variation in the coil size (see Fig. 7), which had increased between approximate coil id numbers 320 to 370, returned to nominal values. The axial variations in harmonics also returned to their nominal values.

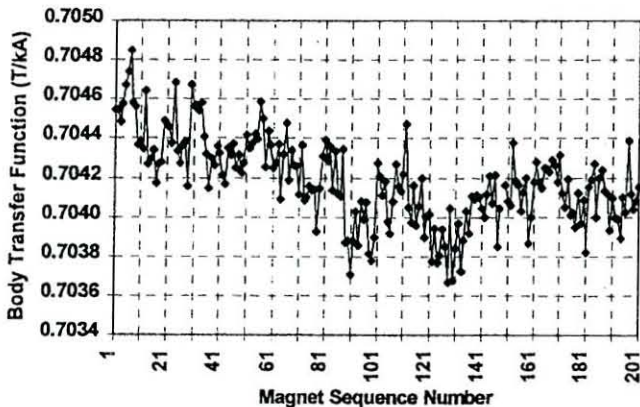
Figure 8: A trend plot of the transfer function in the body of the RHIC arc dipoles.

In 80 mm aperture RHIC arc dipole magnets, the collaring load at which the yoke midplane closure takes place is monitored [3]. This is related to the azimuthal pre-stress on the coil and it depends on coil sizes, yoke inner diameter and the size of the RX630 phenolic spacer between coil and yoke. During the production after magnet sequence number 89, a low value of yoke midplane closure pressure was observed. Simultaneously, a lower value of transfer function in the magnet body was also observed (see Fig. 8). The two were correlated and determined to be caused by a change in RX630 insulator thickness, stemming from an unapproved change to the mold by the vendor's subcontractor. The mold was corrected and the problem was fixed starting with magnet number 137. Due to scheduling issues, parts from the existing inventory were used between magnet number 108 to 136 after inspection.

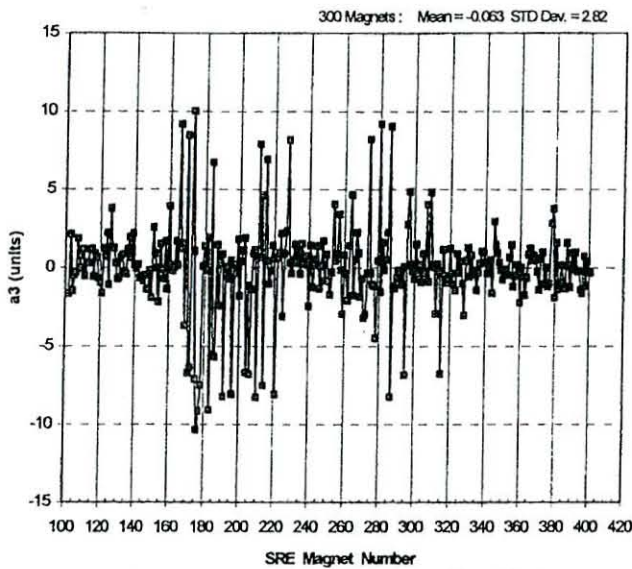
Figure 9: The measured skew octupole harmonic with the magnet sequence number in RHIC arc sextupoles.

The skew octupole term (a_3) in the sextupole magnets is an indicator of the top-bottom asymmetry. In the case of the RHIC sextupoles, the mean value of a_3 is zero by design and the measured value for most magnets lies within ± 2 units. Several magnets in the production, when measured warm, were found to have a_3 between 5 to 10 units, which is well outside the normal range (see Fig. 9). Nothing unusual was found in the geometric or electrical parameters of the coils in these magnets. Moreover, cold tests of some of these sextu-

poles revealed that the a_3 became quite small in the expected range of operation and practically disappeared at high fields. The large a_3 was later traced to the use of iron from two different heats for the upper and the lower yoke halves. The low field permeability value of the yoke in one particular heat was quite different from others. This explains the large measured value of a_3 harmonic only at very low fields. The sign of a_3 also correlated with whether the upper or the lower yoke half was from this heat. A value of 5 to 10 units is not of concern from the point of view of accelerator performance, however, the procedure shows the strength of the field quality as a technique to detect the deviations in the parts used in manufacturing magnets.
