Investigation of Tire/Pavement Noise for Concrete Pavement Surfaces: Summary of Four Years of Measurements

Work Conducted as Part of Partnered Pavement Research Center Strategic Plan Element No. 4.39:
Field and HVS Evaluation of Noise Benefits of Open-Graded and Other Quieter Surfaces

University of California
Pavement Research Center
Davis and Berkeley

| DOCUMENT RETRIEVAL PAGE | | UCPRC RESEARCH REPORT NO.: UCPRC-RR-2013-12 | |

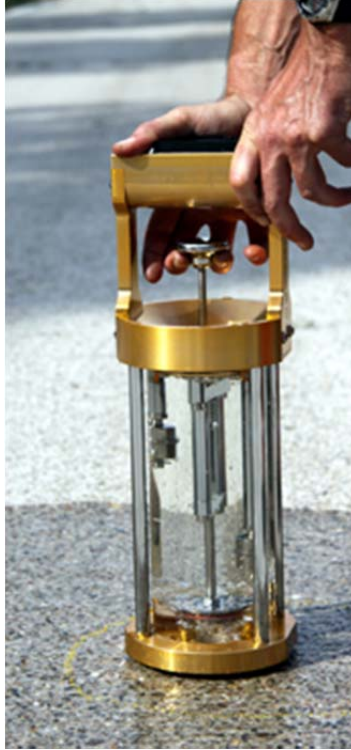
Figure 3.3: Outflow meter.
(Courtesy of KLARUW Systems)

The outflow meter (OFM) (Figure 3.3) is a device that measures the rate at which a known quantity of water, under gravitational pull, escapes through voids in the pavement texture of the structure being tested. The time required for the water to run out is referred to as *outflow time*. Use of the OFM provides a measure of a pavement's ability to relieve pressure from under vehicle tires, which provides an indication of the potential for hydroplaning under wet conditions. The reciprocal of the outflow time is highly correlated with MPD except when a surface is highly porous. The OFM can also be used to detect surface wear and predict correction measures.

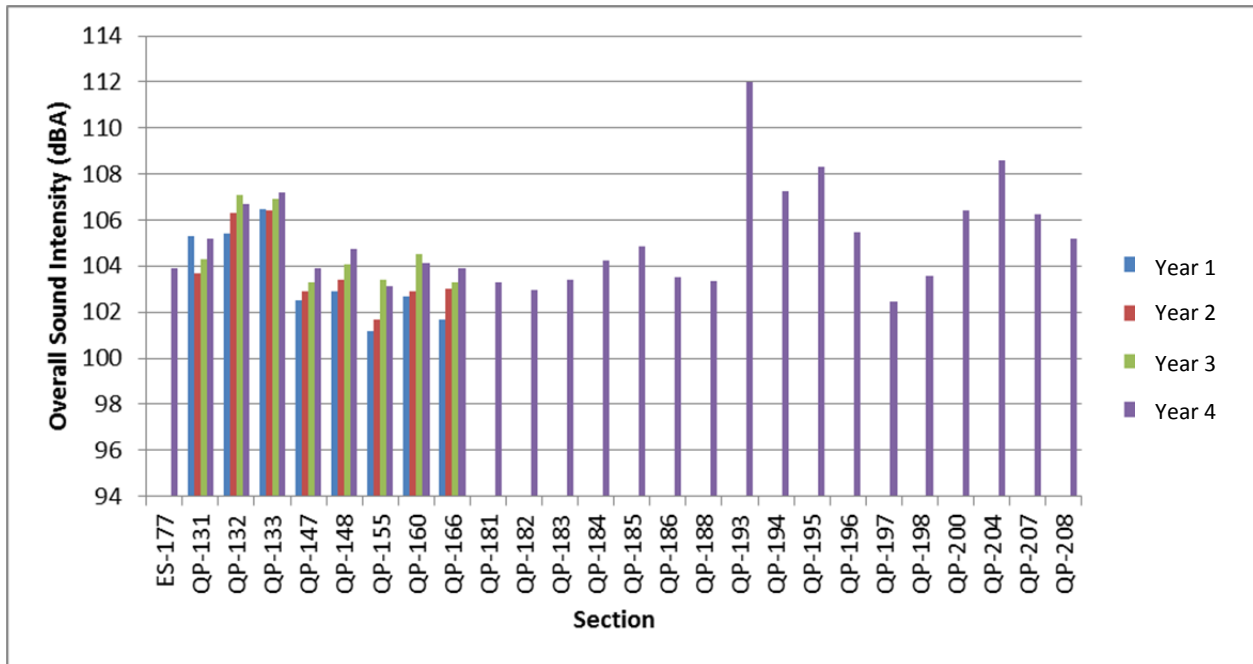
Figure 4.1: Overall sound intensity for all 27 diamond-ground (DG) sections over four years.

The overall OBSI noise measurement results for the diamond-ground sections are shown in Figure 4.1, ordered by section number. (*Note:* an examination of Section QP-193 in Siskiyou County revealed that it had excessive chain wear and therefore abnormally high sound intensity values; as a result it was excluded from the analyses in this report.) Of the 27 diamond-ground sections measured in Year 4, eight had also been measured over the previous three years. At the time of measurement in the first three years of testing, the DG sections ranged in age since last retexturing from 0.3 to 13.4 years, and in the fourth year of testing they ranged from 0.3 to 15.5 years. In the fourth year of measurements, the interquartile ranges, which indicate the range of the middle 50 percent of the measurements, fell between 103.5 and 106.3 dBA.

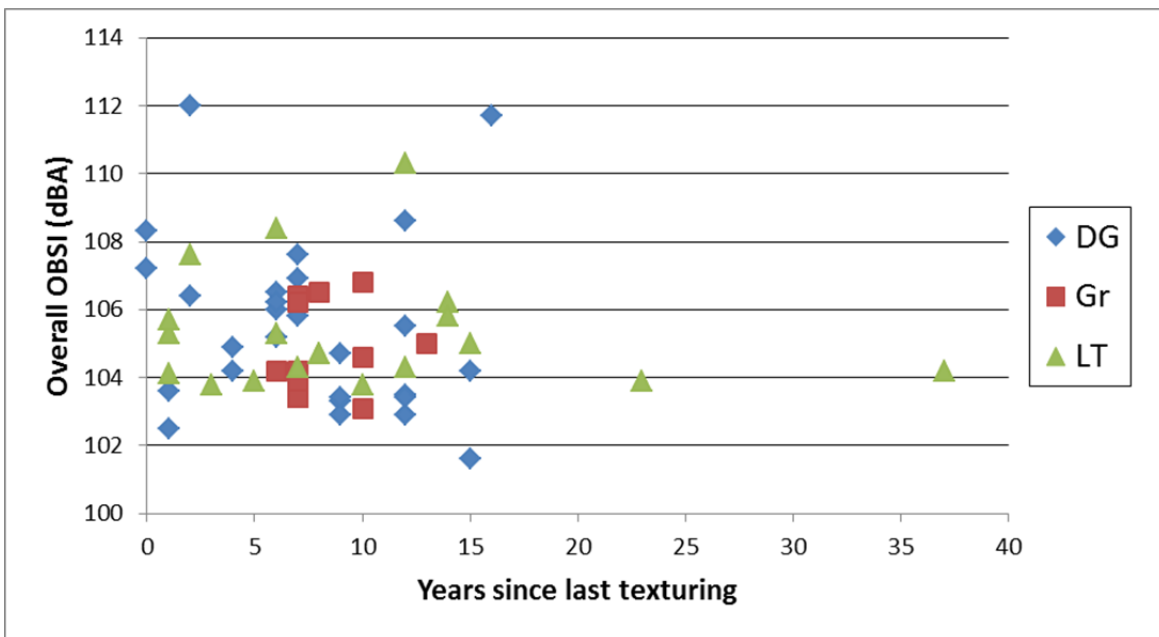
Figure 5.1: Overall OBSI in fourth year of measurement versus years since last texturing. (Note: DG=diamond ground, Gr=diamond grooved, LT=longitudinally tined)

Although there was an overall trend of increasing noise for many sections over the four years of testing—due to changes in both the pavements and potentially unaccounted for differences in testing—a plot of overall OBSI in the fourth year of measurement versus the number of years since last texturing (Figure 5.1; data in Appendix A) indicates almost no correlation between noise and years of trafficking. The plot in Figure 5.1 includes two longitudinally tined sections (QP-100 and QP-101) with ages greater than fifteen years that had relatively low noise levels, about 104 dBA. There is no apparent reason to exclude these two sections from the analysis. It can also be seen that most of the sections had OBSI levels between 103 dBA and 108 dBA, regardless of texture type.

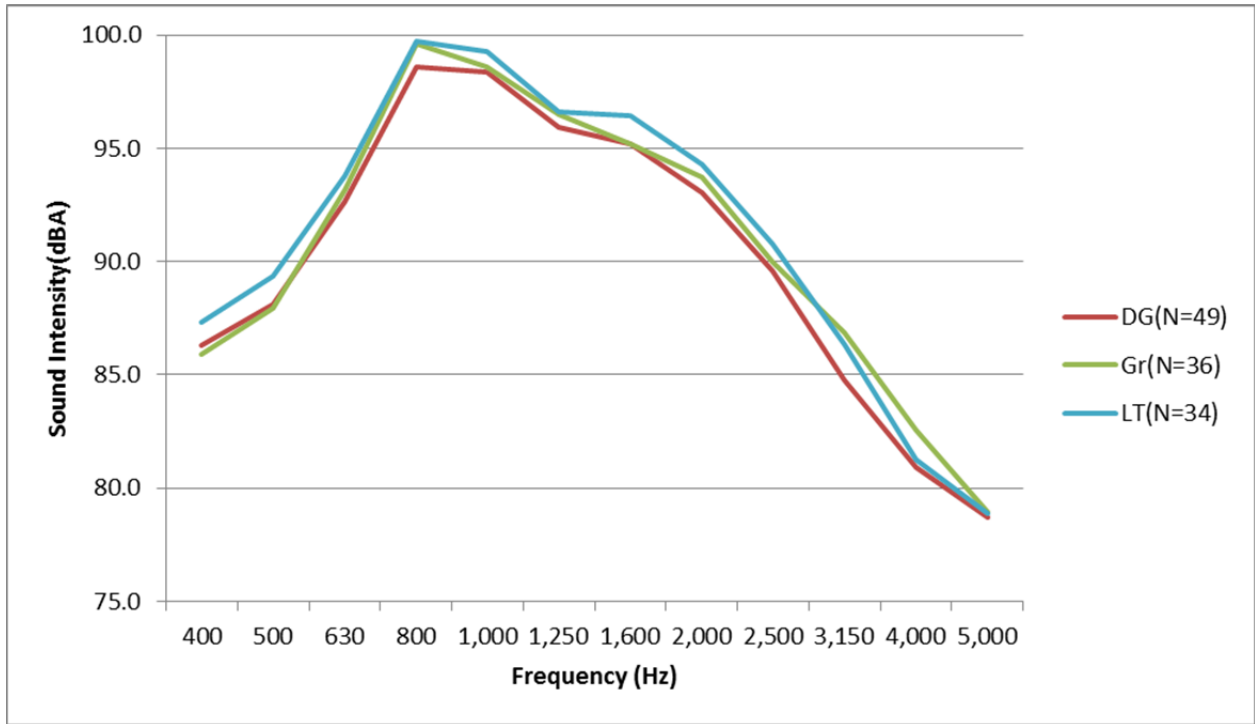
Figure 5.3: Comparison of average OBSI spectral content.
 (Note: DG=diamond ground, Gr=diamond grooved, LT=longitudinally tined; numbers in parentheses indicate the total number of sections.)

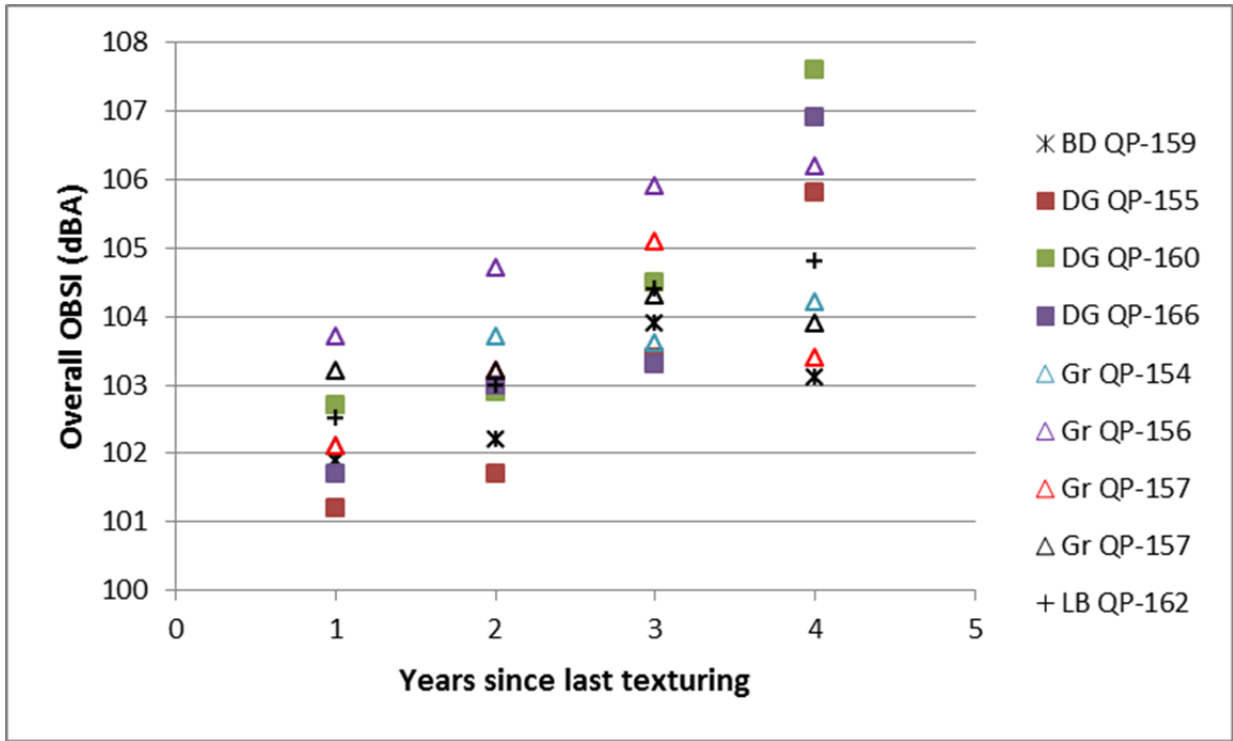
Figure 5.6: Overall OBSI for four years of testing on Mojave test sections.
 (Note: BD=burlap drag; DG=diamond ground, Gr=diamond grooved, LB=longitudinally broomed)

The results of four years of testing on the Mojave test sections, which were built in 2005 and last textured in 2006, are shown in Figure 5.6 in terms of overall OBSI (data for this plot is included in Appendix A). Over the four years of the study, the average values were 102.8 dBA for the burlap-drag section, 103.7 dBA for the three diamond-ground sections, 103.9 dBA for the four diamond-grooved sections, and 103.7 dBA for the longitudinally broomed section. From these results it can be seen that on average the overall OBSI was similar for all the textures, although there was a range of almost 5 dBA between the quietest and the noisiest in the fourth-year results. In the fourth year, the diamond-ground sections were generally noisier than the diamond-grooved sections, the opposite of the first three years of measurement.

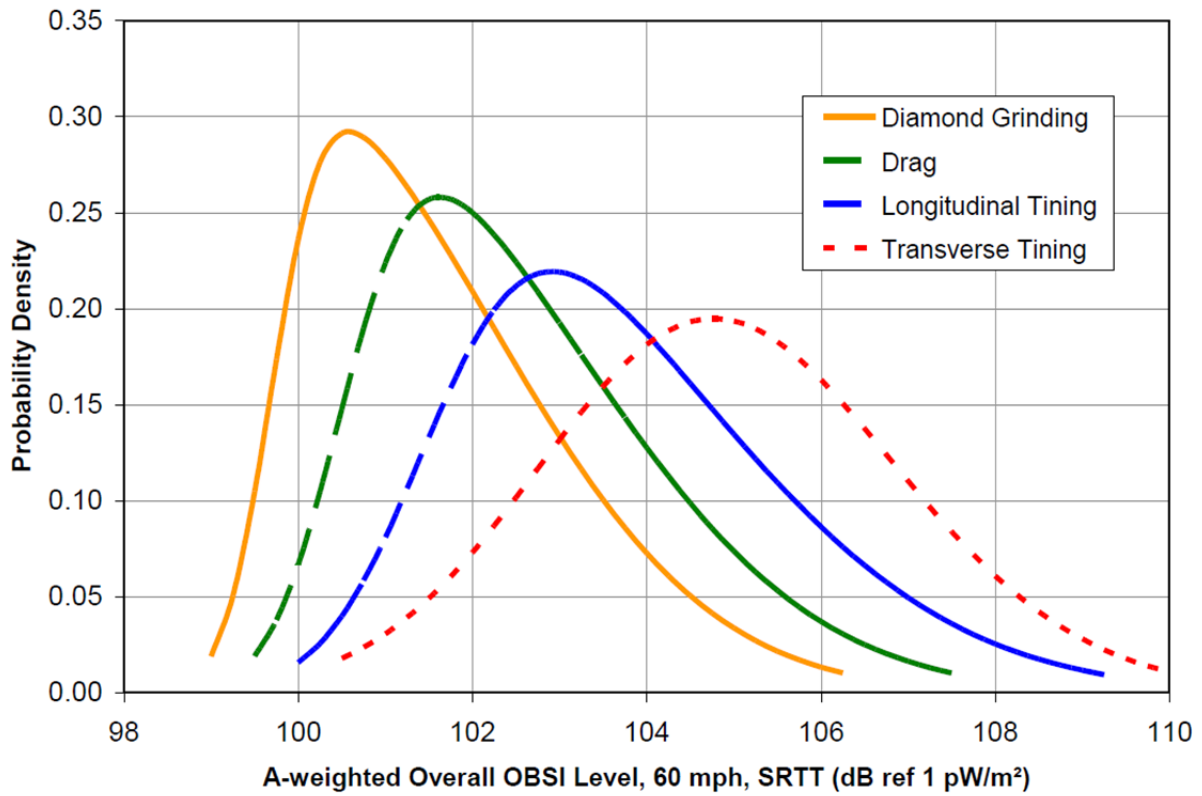
Figure 5.7: Probability distributions of OBSI noise levels for concrete pavement textures as reported by the National Concrete Pavement Technology Center in 2010 (10).

Another research study was conducted by the National Cooperative Highway Research Program (NCHRP) in 2009 (11). The NCHRP study measured the noise levels of different texture types in the following states: Alabama, California, Colorado, Florida, Illinois, Indiana, Iowa, Kansas, Michigan, Minnesota, Missouri, North Carolina, North Dakota, Pennsylvania, Texas, and Wisconsin. It can be seen in Table 5.5 that the measured noise levels in the NCHRP study and this research study are very close.

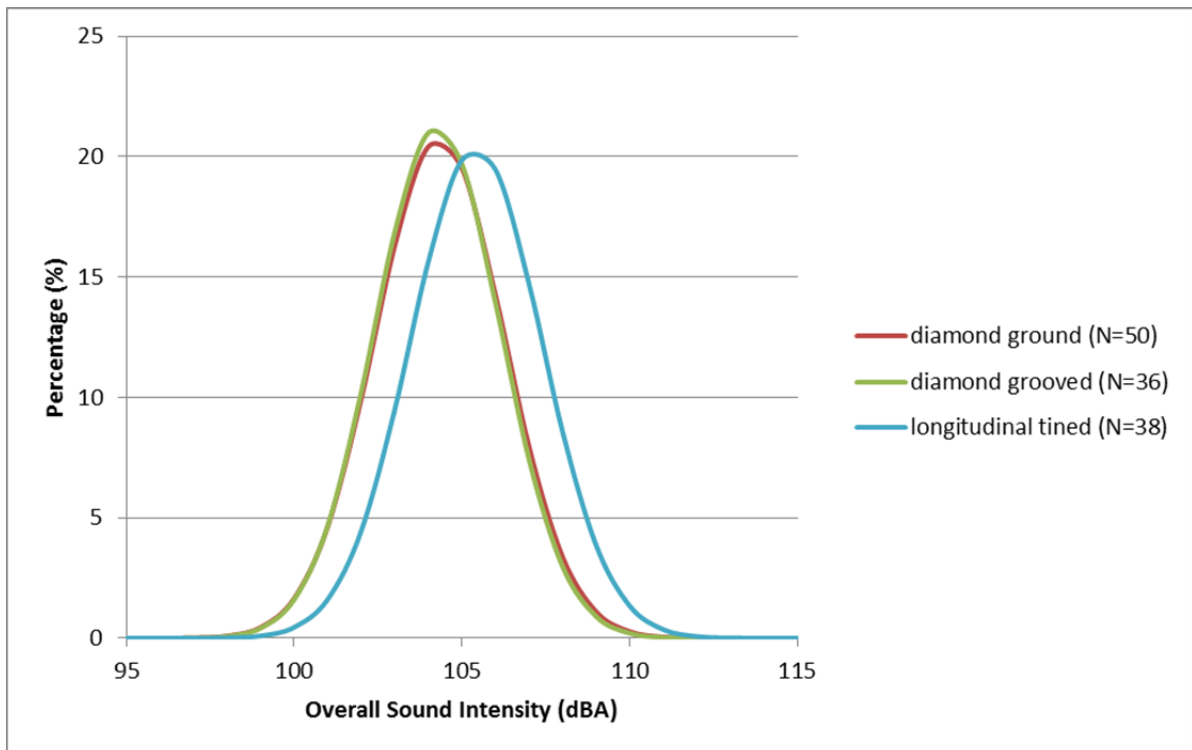
Figure 5.8: Distributions of OBSI noise levels over four years of measurement. (Note: numbers in parentheses indicate the total number of sections.)

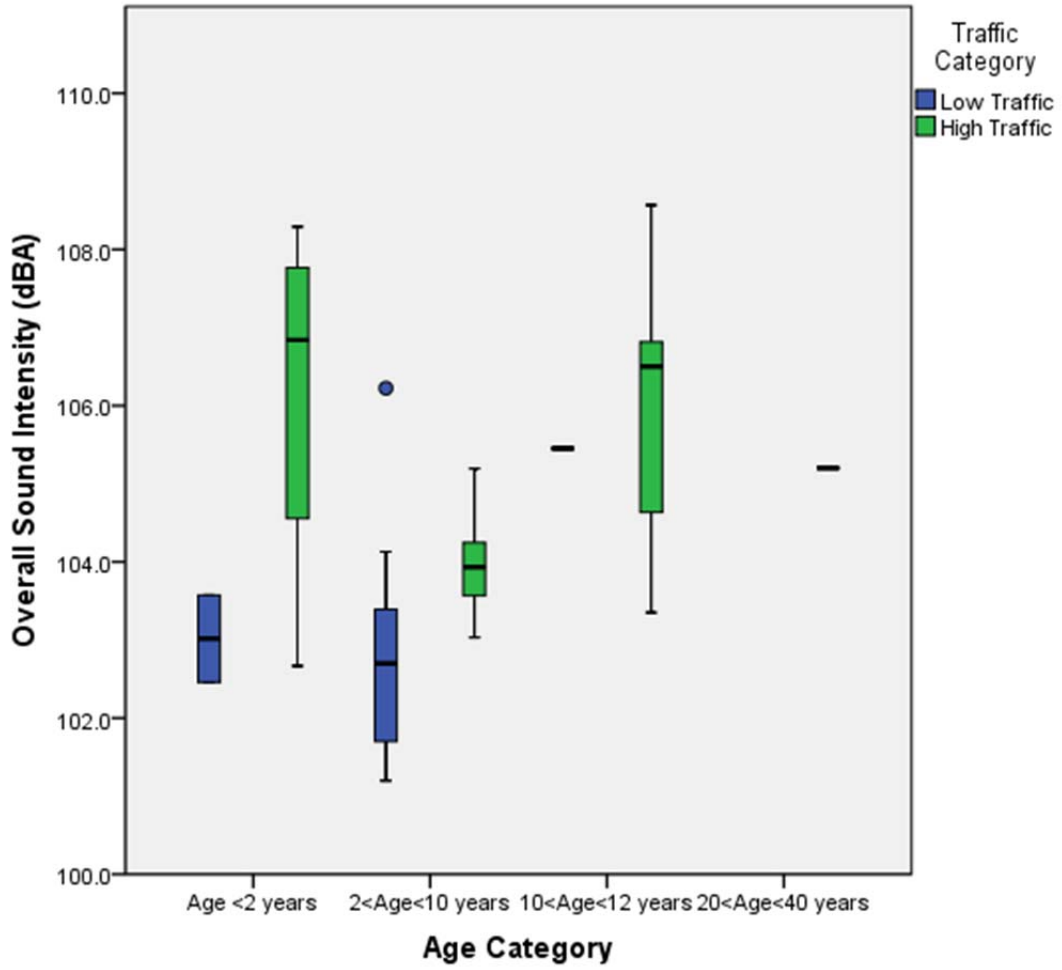
Figure 5.10: Effect of texture age and traffic category on the overall sound intensity for diamond-ground sections.

The effect of pavement age and traffic category was investigated for each individual texture type, although the sample sizes were small. Figure 5.10, Figure 5.11, and Figure 5.12 show the overall sound intensity for diamond-ground, diamond-grooved, and longitudinally tined sections, respectively. For each texture type, the overall sound intensity of the sections with high traffic volume was generally a little higher than that for sections with low traffic volume. The overall sound intensity generally increased as the pavements aged, however there does not appear to be a strong correlation with time for the sections included in the study, as could also be seen in Figure 5.1. The increase of sound intensity with pavement age might be due to pavement distresses other than texture abrasion, such as cracking.

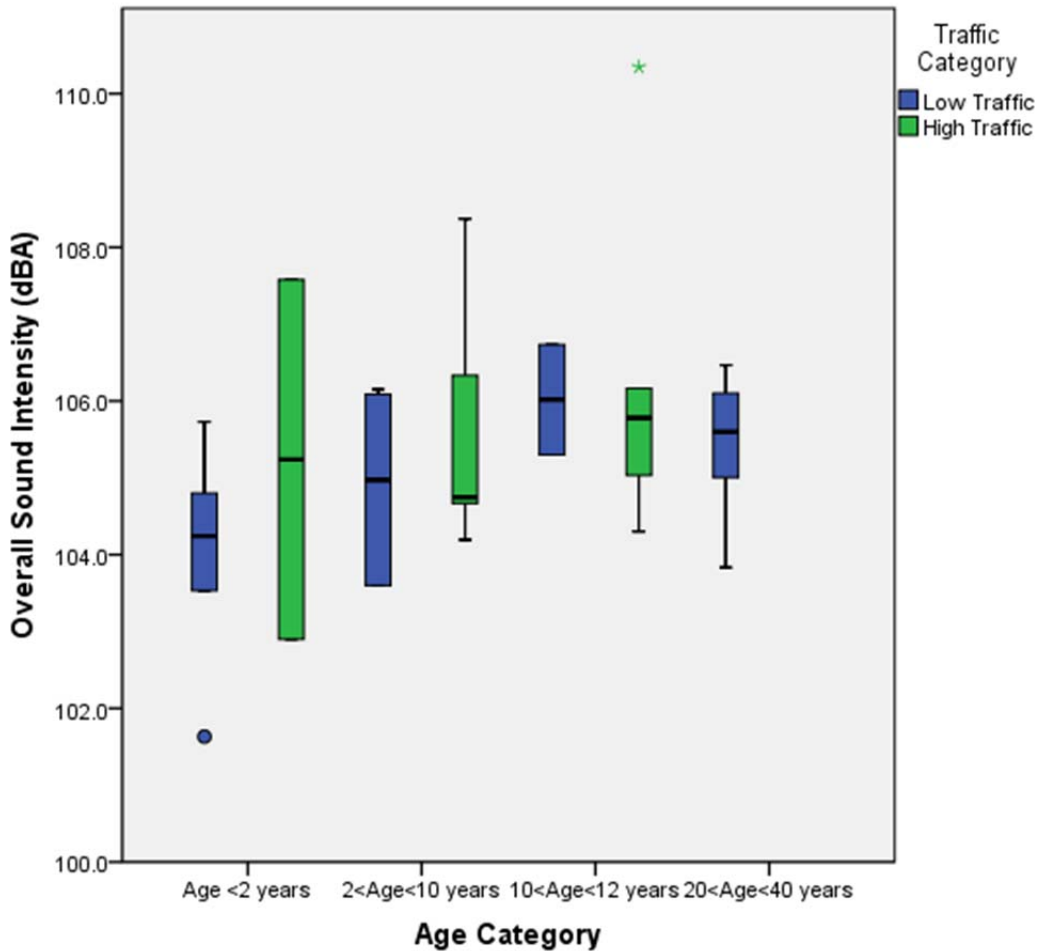
Figure 5.12: Effect of texture age and traffic category on the overall sound intensity for longitudinally tined sections.

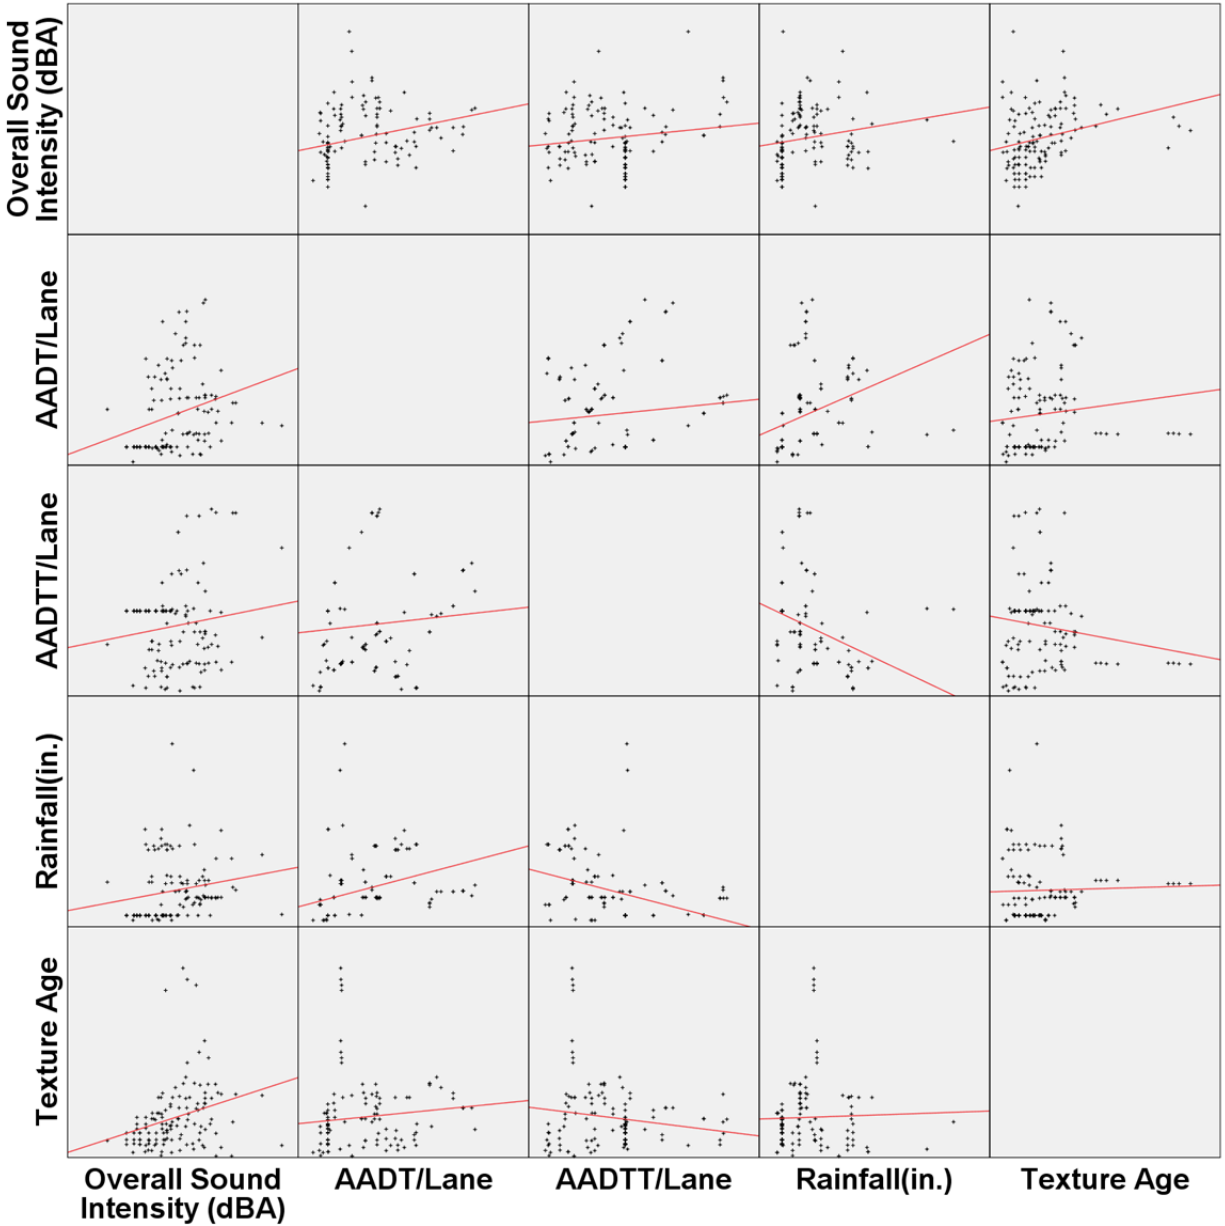
Figure 5.13: Scatter plots of overall OBSI versus traffic, rainfall, and age.

Figure 5.13 shows scatter plots of overall OBSI versus AADT/lane (total traffic), AADTT/lane (truck traffic), annual rainfall, and texture age. From the first row of plots where OBSI is the dependent variable it can be seen there is a trend of increasing OBSI with both increasing AADT and increasing AADTT, and that there is a tremendous amount of scatter. The same can also be seen for overall OBSI and rainfall. In all of these cases, the trend is as expected, with increasing traffic and rainfall damaging the surface and increasing positive texture. The trend that can be seen for overall OBSI and texture age is also as expected, with increasing noise as the surface is exposed to traffic and rainfall. Again, there is a tremendous amount of scatter in the plot. The plots showing the relationships between the traffic and rainfall variables indicate that they are generally uncorrelated. The traffic and environment variables shown here are per year, rather than cumulative over time, and should therefore be independent of age provided there is no correlation unintentionally built into the factorial from selection of the section locations.

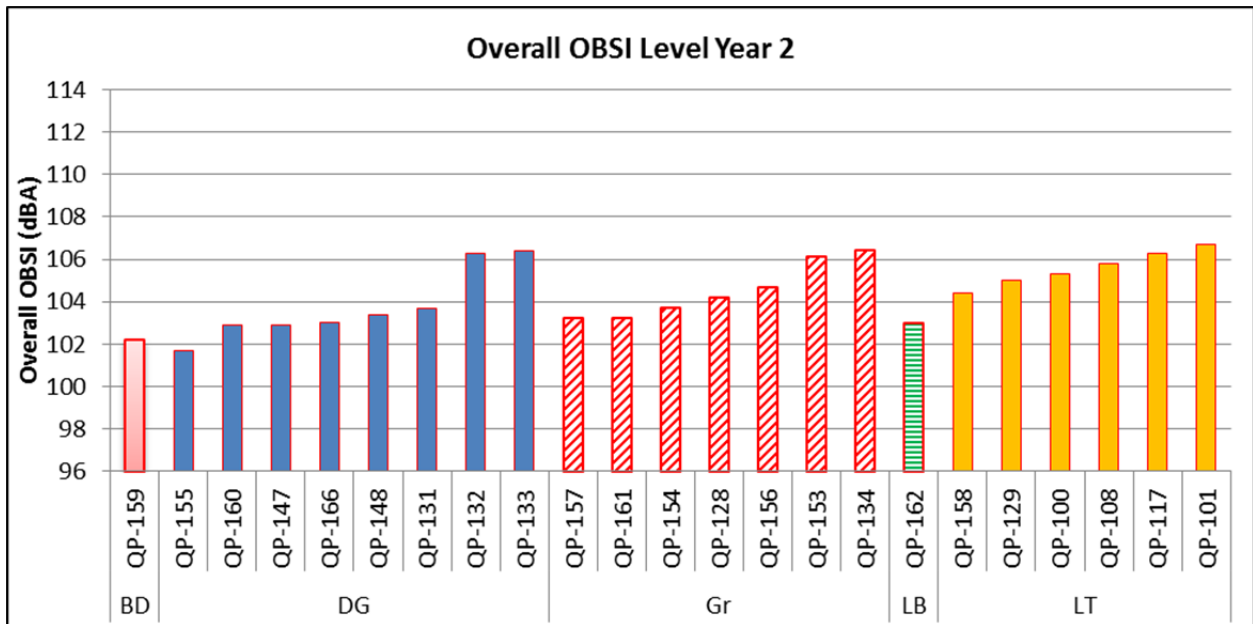
Figure C.2: OBSI for each section measured in Year 2 sorted by texture type and OBSI level, for sections with fourth year measurements.
