Wireless Sensor Network for Improving the Energy Efficiency of Data Centers

# Wireless Sensor Network for Improving the Energy Efficiency of Data Centers

Rod Mahdavi, PE, LEED AP

MARCH 2012

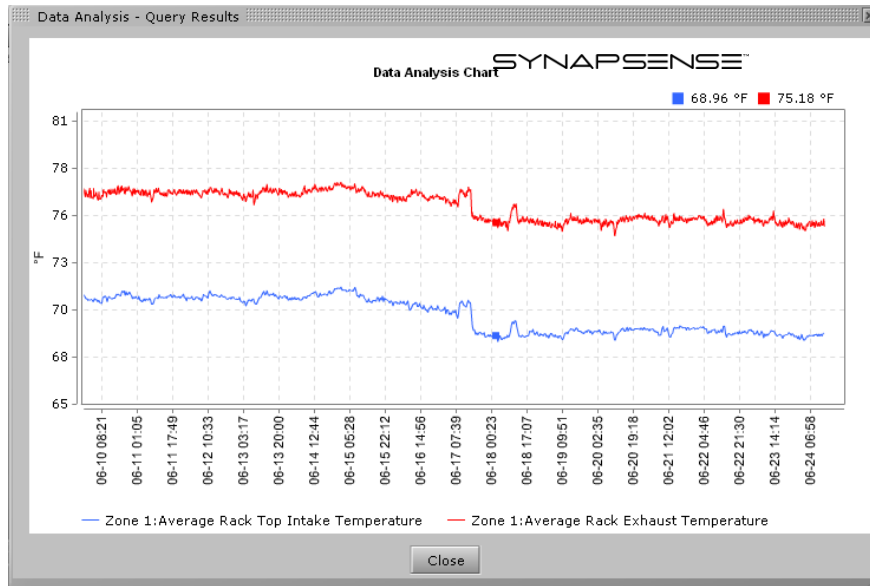
Figure 3 shows the average top rack intake and exhaust temperatures across the entire NITC data center floor, which illustrates the low temperature rise across the equipment racks:

**Figure 3. NITC Average Rack Intake-Exhaust Temperatures**

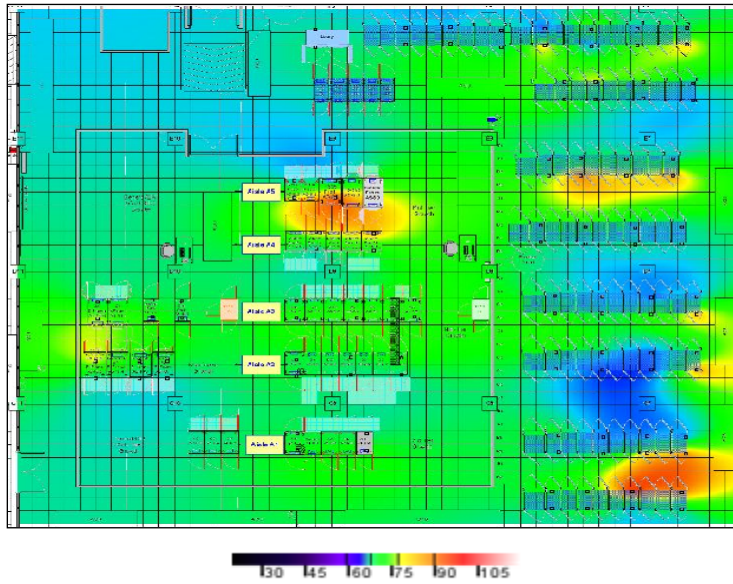
The imaging application provided four levels of thermal maps in the demo room. Maps illustrate conditions at the top, middle, and bottom of the racks and in the sub-floor. Data were refreshed every five minutes on a continuous basis. They identified areas with the highest degree of air mixing among the racks in the data center and the respective hot and cold spots. Figures 4 through 7 show representative maps for each of the four levels in the demo room during the baseline period.

**Figure 4. NITC Data Center Thermal Map at the Top of the Racks**

**Figure 5. NITC Data Center Thermal Map at the Middle of the Racks**

**Figure 6. NITC Data Center Thermal Map at the Bottom of the Racks**

**Figure 7. NITC Data Center Thermal Map in the Sub-Floor Under the Racks**

Analysis of the data, including the thermal imaging, enabled the evaluation team to determine that the root cause of overcooling was the high volume of air and the low supply air temperature delivered to the racks by the CRAC units. Similarly, using the collected data, the evaluation team determined that hot discharge air from the IT equipment was recirculating back through the racks due to the absence of blanking plates, thereby increasing server inlet air temperatures above the desired range. In addition, a high level of

stratification was observed to be occurring in front of many of the data center racks, with the bottom of the racks having the lowest temperatures.

The evaluation team therefore recommended that the data center operator remove the excess perforated floor tiles to significantly decrease the overcooling in the data center and to raise the inlet air temperature to the IT equipment to within the ASHRAE recommended range.

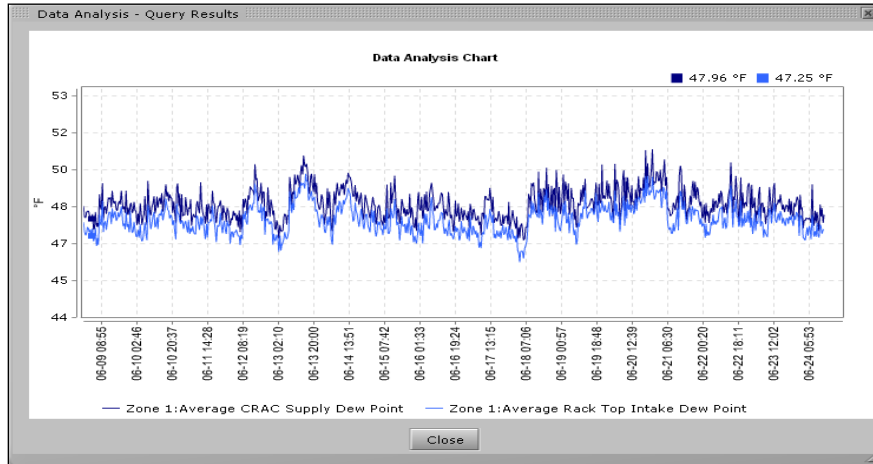
Figure 9 shows a graph of the average rack dew point, as well as the average supply air dew point temperature from the CRAC units. During the baseline period, the CRACs in the demo room were enabled for humidification and dehumidification control with return RH set points from 46%–50%,  $\pm$  5%–13% RH.

As Figure 9 indicates, the demo room operated within the recommended ASHRAE dew point range of 41.9°F–49.0°F at the inlet of the IT equipment. However, because the CRAC’s return air temperatures were different, several of the units fought each other to maintain their return air RH set points.

**Figure 9. NITC Supply Air and Rack Dew Point Temperature**

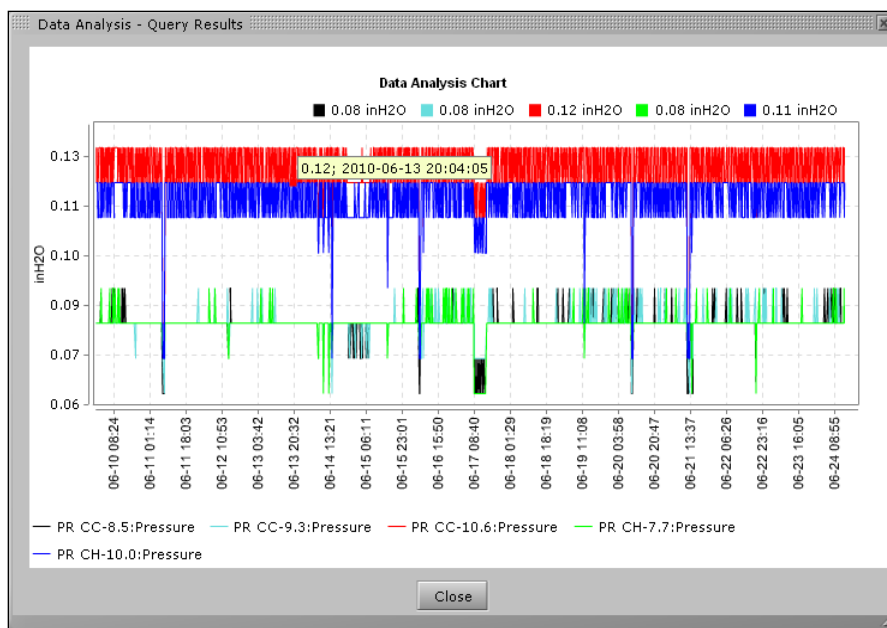
During the baseline period, the sub-floor pressure differential measured in the demo room was from 0.06–0.13 inches of water, which is significantly above the desired range of 0.03–0.05 inches of water, which provides the best energy balance between air volume and CRAC fan energy. Figure 11 is a representative graph showing sub-floor pressure in the NITC data center.

**Figure 11. NITC Sub-Floor Pressure**

The evaluation team determined that the root cause for the variation in the sub-floor pressure across the raised floor in the data center was the uneven provisioning of perforated floor tiles. In addition, the team determined that the over-pressurization was caused by running more CRAC units than necessary, based upon the cooling air flow demand in the data center. Resolution of these air flow management issues resulted in a more uniform and energy-efficient pressure differential level across the entire data center floor.

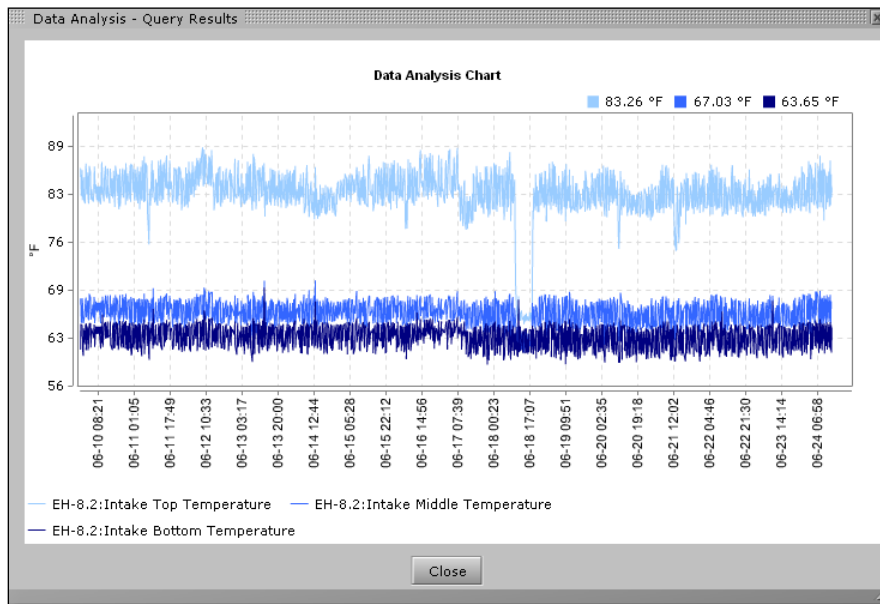
Figures 12–15 are graphs of the selected IT equipment racks that were being overcooled in the demo room.

**Figure 12. NITC Sample Rack 1**

**Figure 13. NITC Sample Rack 2**

Figure 14. NITC Sample Rack 3

Figure 15. NITC Sample Rack 4

It was determined that the largest contributor to overcooling in the NITC data center was the low supply air temperature delivered to the data center. In addition, analysis of the top, middle, and bottom rack inlet air sensors indicated that a high level of stratification was occurring in front of many of the data center racks.

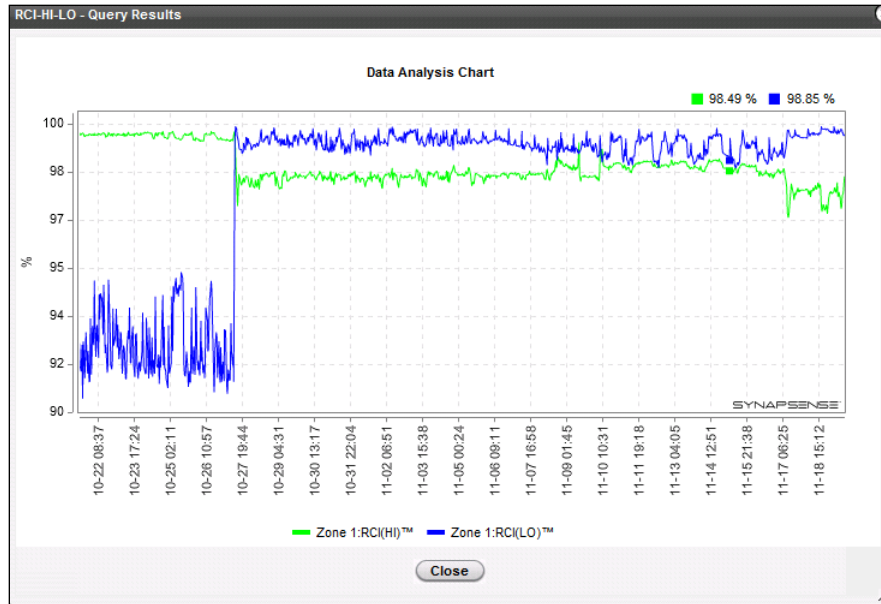
The Rack Cooling Index for the demo room, after the implementation of the recommended energy-efficiency measures, is shown in Figure 17 below. The data indicated that the data center was no longer being overcooled, as the RCI<sup>TM/SM</sup> index increased from an average of 93% (which was poor) to >96% (which is good).

**Figure 17. Post-Measures Demo Room RCI**

The evaluation team recommended installing the missing blanking plates because once the excessive air flow mixing was reduced, the hot aisle temperatures were significantly higher, and recirculation air could lead to undesirable equipment operating conditions.

This is the reason why RCI<sub>HI</sub><sup>TM/SM</sup> decreased from 100% after implementation of the recommended energy-efficiency measures. Installation of the remaining blanking plates should rectify this problem.

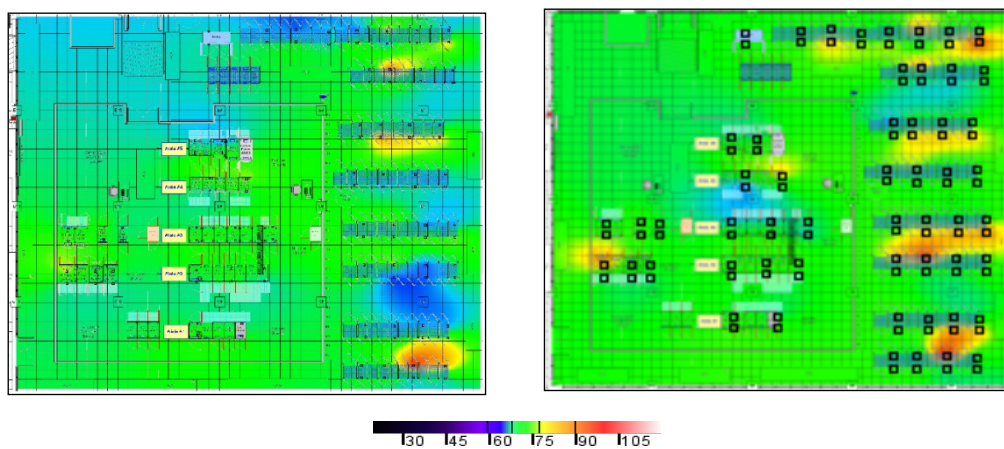
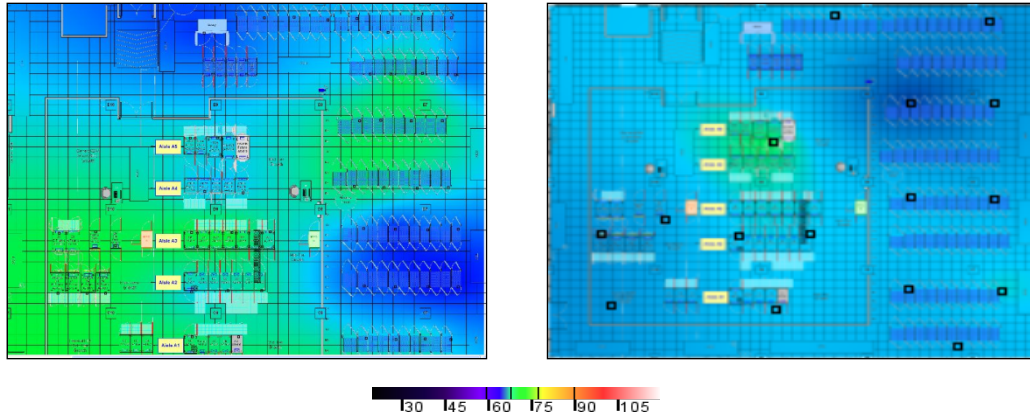
The thermal imaging maps created after implementing the recommend air flow optimization and energy-efficiency measures (figures 18–22) provide visual confirmation that it is possible to improve the environmental operating conditions in a data center while reducing cooling costs.

**Figure 18. NITC Data Center Thermal Map at Top of Racks During the Baseline (image on left) and Post-Optimization (image on right) Periods**

**Figure 19. NITC Data Center Thermal Map at Middle of Rack During the Baseline (image on left) and Post-Optimization (image on right) Periods**

**Figure 20. NITC Data Center Thermal Map at Bottom of Racks During the Baseline (image on left) and Post-Optimization (image on right) Periods**

**Figure 21. NITC Data Center Thermal Map of Subfloor During the Baseline (image on left) and Post-Optimization (image on right) Periods**

Lowering the raised floor pressure by turning off three CRACs, raising the return air temperature set points on the CRACs that remained in operation, and rebalancing the quantity and location of perforated floor tiles in the cold aisles significantly reduced the overcooling condition in the data center. Cold aisle temperatures were then more even across the data center, and the IT equipment inlet air temperature was closer to the high end of the ASHRAE-recommended range.

Similarly, rebalancing the raised floor reduced the high level of by-pass air that existed during the baseline period and resulted in hot aisle temperatures closer to the discharge temperature of the IT equipment.

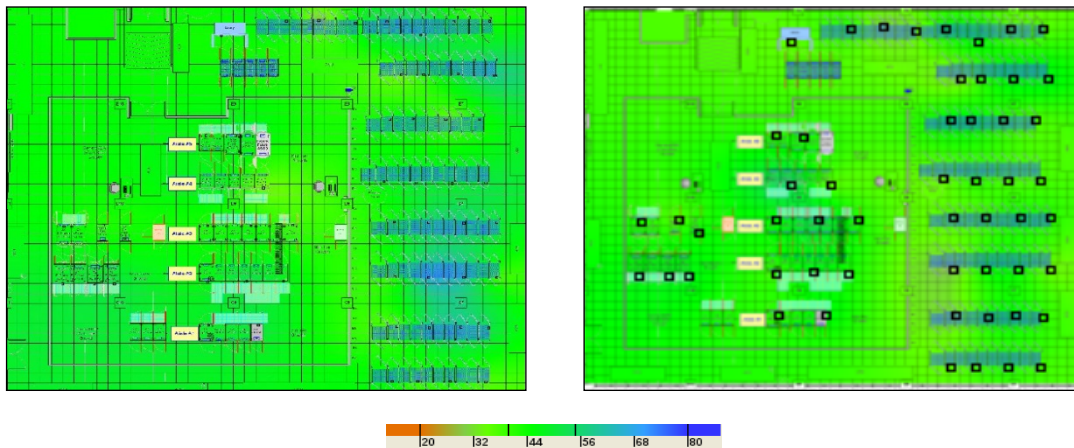
**Figure 22. NITC Data Center Map of Relative Humidity During the Baseline (image on left) and Post-Optimization (image on right) Periods**

The post-optimization relative humidity map (Figure 22) illustrates that lowering the CRACs return relative humidity set points and turning off their dehumidification and reheat modes resulted in more-even relative humidity across the data center. And even though optimization reduced CRAC energy use, it did not have an adverse impact on the NITC data center dew point. Figure 23 shows the average rack dew point, as well as the average supply air dew point temperature from the CRACs, during the baseline and post-optimization period.

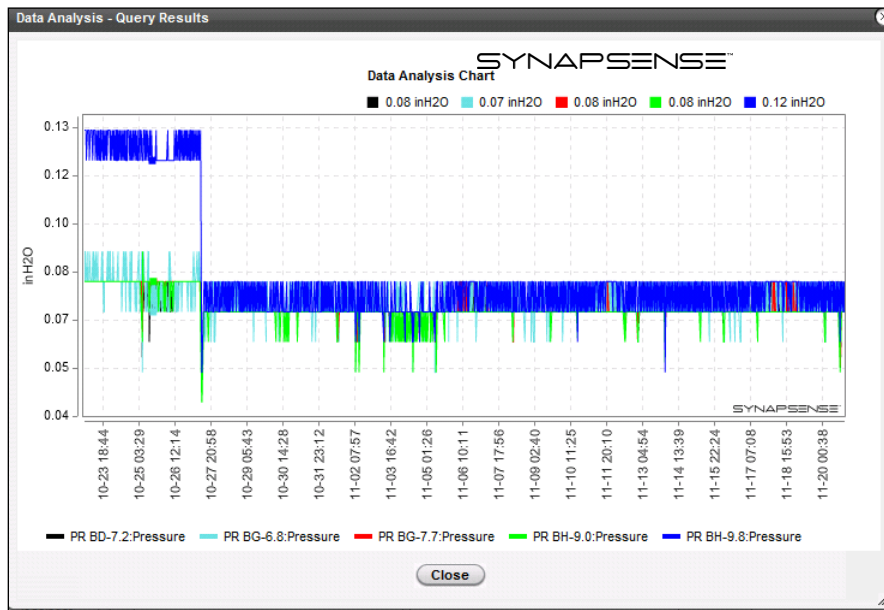
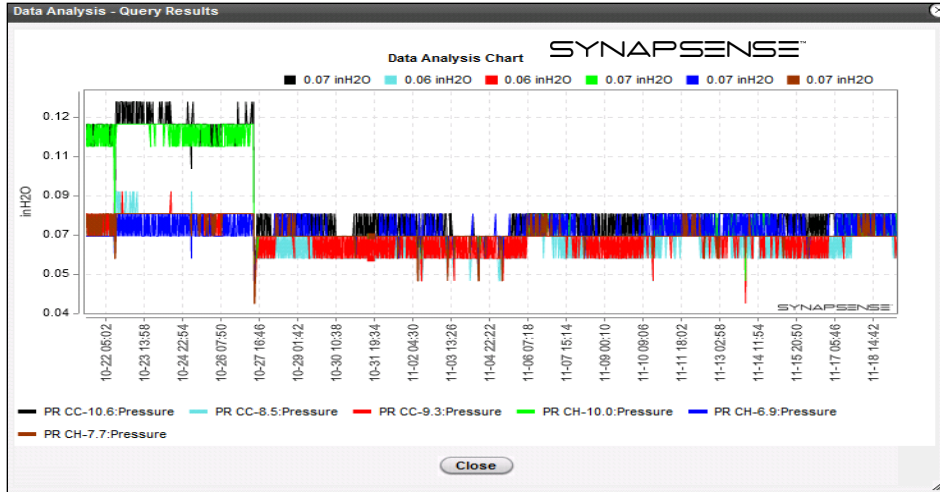
Figures 26 and 27 illustrate the positive effect of turning off the three CRACs, which resulted in a lower and more balanced sub-floor pressure.

**Figure 26. Post-Measures NITC Row B Sub-Floor Pressure**

**Figure 27. Post-Measures NITC Row C Sub-Floor Pressure**

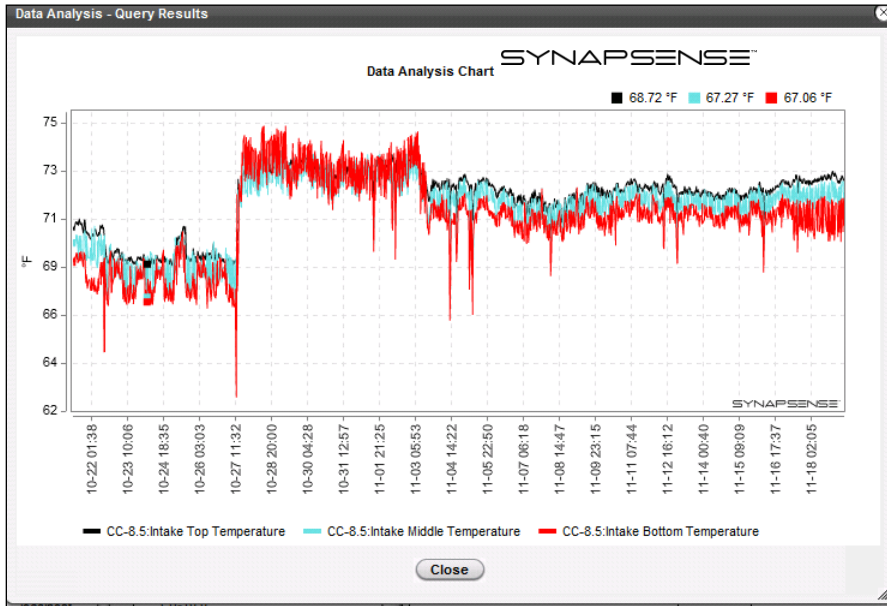
Prior to implementing the recommended air flow optimization and cooling efficiency measures, the sensor data indicated that the data center was being overcooled, with the majority of the racks operating below the ASHRAE-recommended range. Figures 28–31 are graphs of the top rack inlet air temperature for several racks and rows of racks following implementation of the efficiency measures. The graphs illustrate that the rack inlet air temperatures were within the target range of 72°F–79°F.

**Figure 28. Post-Measures NITC Sample Rack 3 Inlet Air Temperatures**

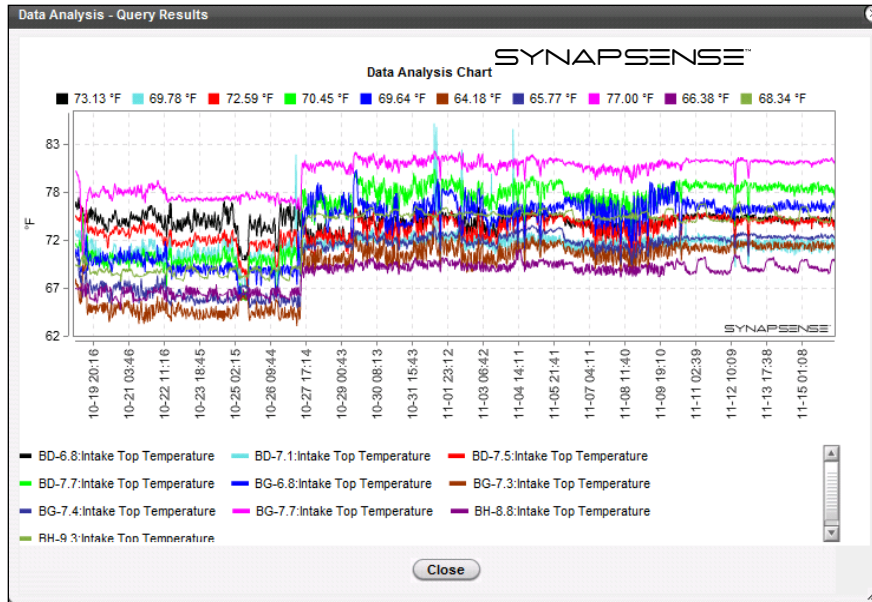
**Figure 29. Post-Measures NITC Row B Top Inlet Air Temperatures**

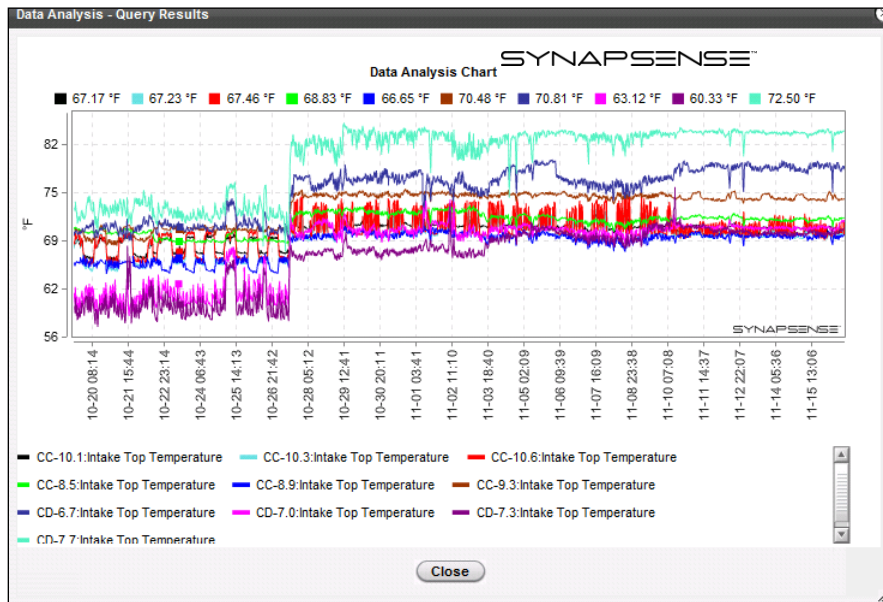
**Figure 30. Post-Measures NITC Row C Top Inlet Air Temperatures**

Visual inspection after implementation of the air flow optimization of the demo room confirmed that the one rack, CD-7.7 (shown in Figure 30) did not have any equipment mounted in the top third of the rack.

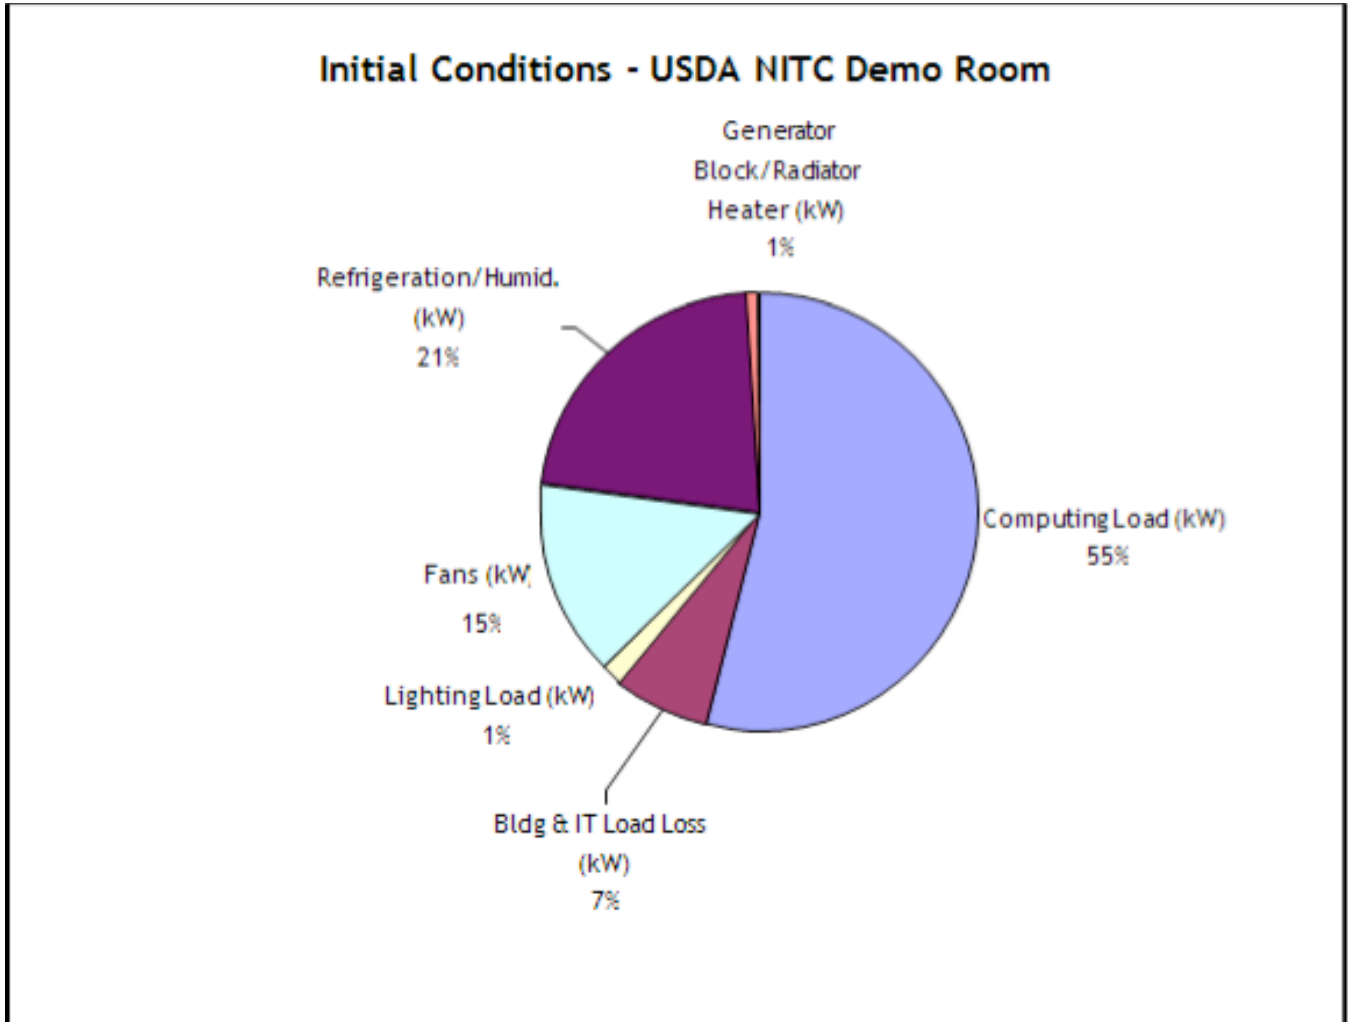
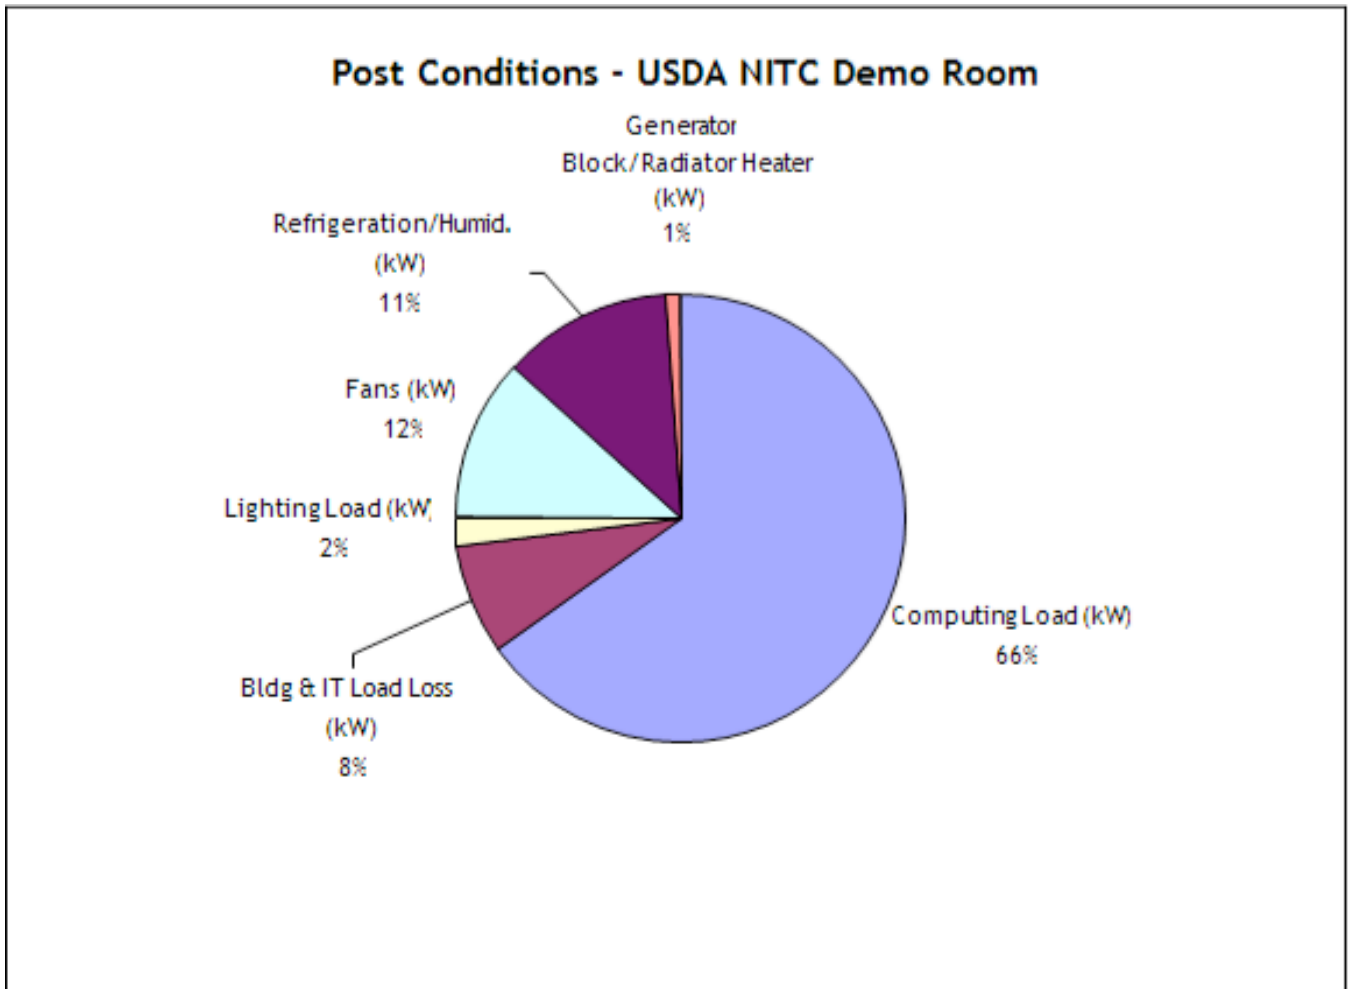
Figures 32 and 33 show the baseline energy breakdown for the NITC data center and the same breakdown after implementation of the air flow remediation and cooling efficiency measures.

Figure 32. Baseline NITC Data Center Energy Use Breakdown

**Figure 33. Post-Optimization NITC Data Center Energy Use Breakdown**

For the data center demo room, the result was a reduction in PUE from 1.83 to 1.51, based on a 17% reduction in total data center power. This represented a 657 megawatt-hour savings annually. These measures also resulted in approximately \$29,900 in annual energy cost savings, based on current local utility rates, and a carbon footprint reduction of 542 metric tons.
