A preliminary assessment of potential steelhead habitat in Sinbad Creek, Alameda County

University of California at Berkeley  
Paper submitted for LA222: Hydrology for Planners  
Professor G. Matthias Kondolf  
May 12, 2004

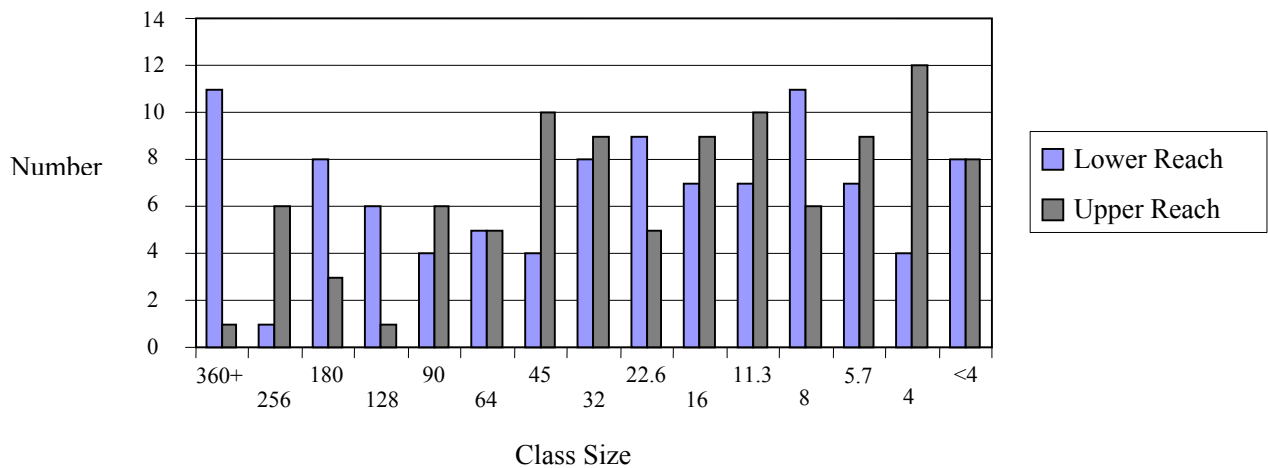
## Results of Pebble Count

The results of our pebble count reveal a smaller median particle size ( $d_{50}$ ) and geometric mean ( $d_g$ ) at the upper reach ( $d_{50} = 16\text{mm}$ ;  $d_{16} = 4\text{mm}$ ;  $d_{84} = 90\text{mm}$ ;  $d_g = 18.97\text{mm}$ ) than at the lower reach ( $d_{50} = 22.6\text{mm}$ ;  $d_{16} = 5.7\text{mm}$ ;  $d_{84} = 180\text{mm}$ ;  $d_g = 32.03\text{mm}$ ). The percent of embedded stones was the same at both reaches (8%). At the upper reach, however, all embedded stones were greater than 45mm, while at the lower reach embedded stones were greater than 128mm. Bed material in both reaches was relatively homogenous, consistent, and poorly sorted. In other words, bed materials varied in size and were not sorted by size across the bed, but rather mixed together throughout the bed. The results of the pebble count are presented in Tables 4 and 5, and in the histogram below.

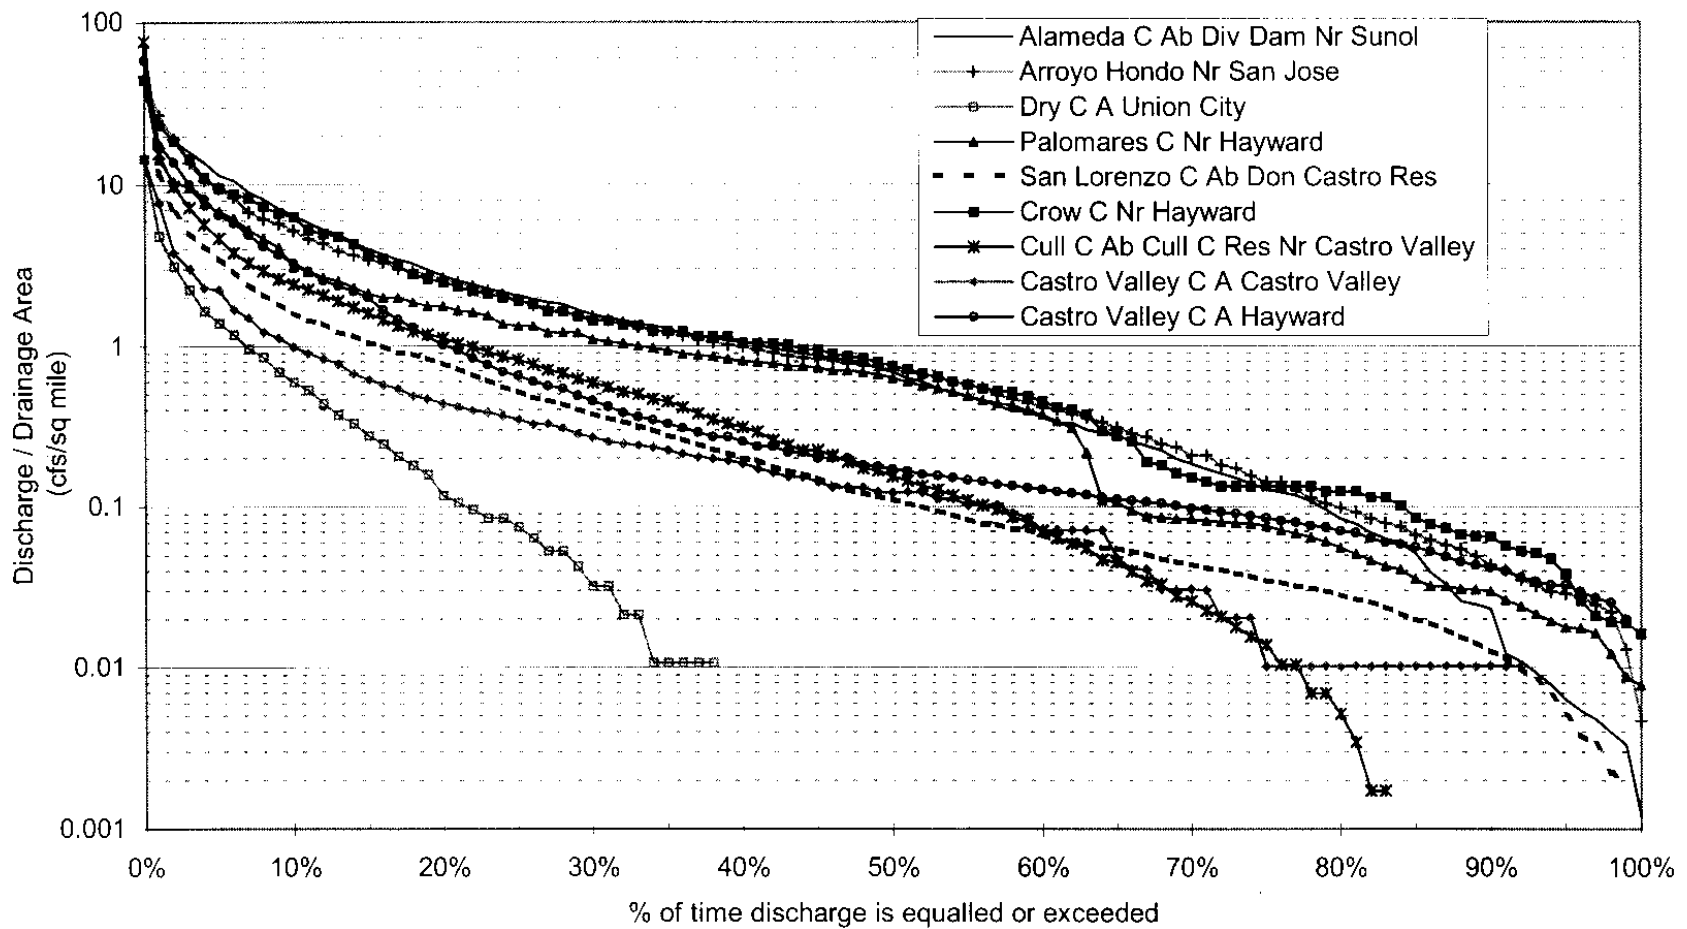
Figure A-1: Flow Duration Curves for November through April, Streams Within Alameda County

Source is Figure B-4 Appendix B-6 in Love 2001.

Flow duration curves constructed using flow data from November through April, the assumed period of steelhead and rainbow trout upstream migration. Some of the gauge stations have only two years of recorded flows.

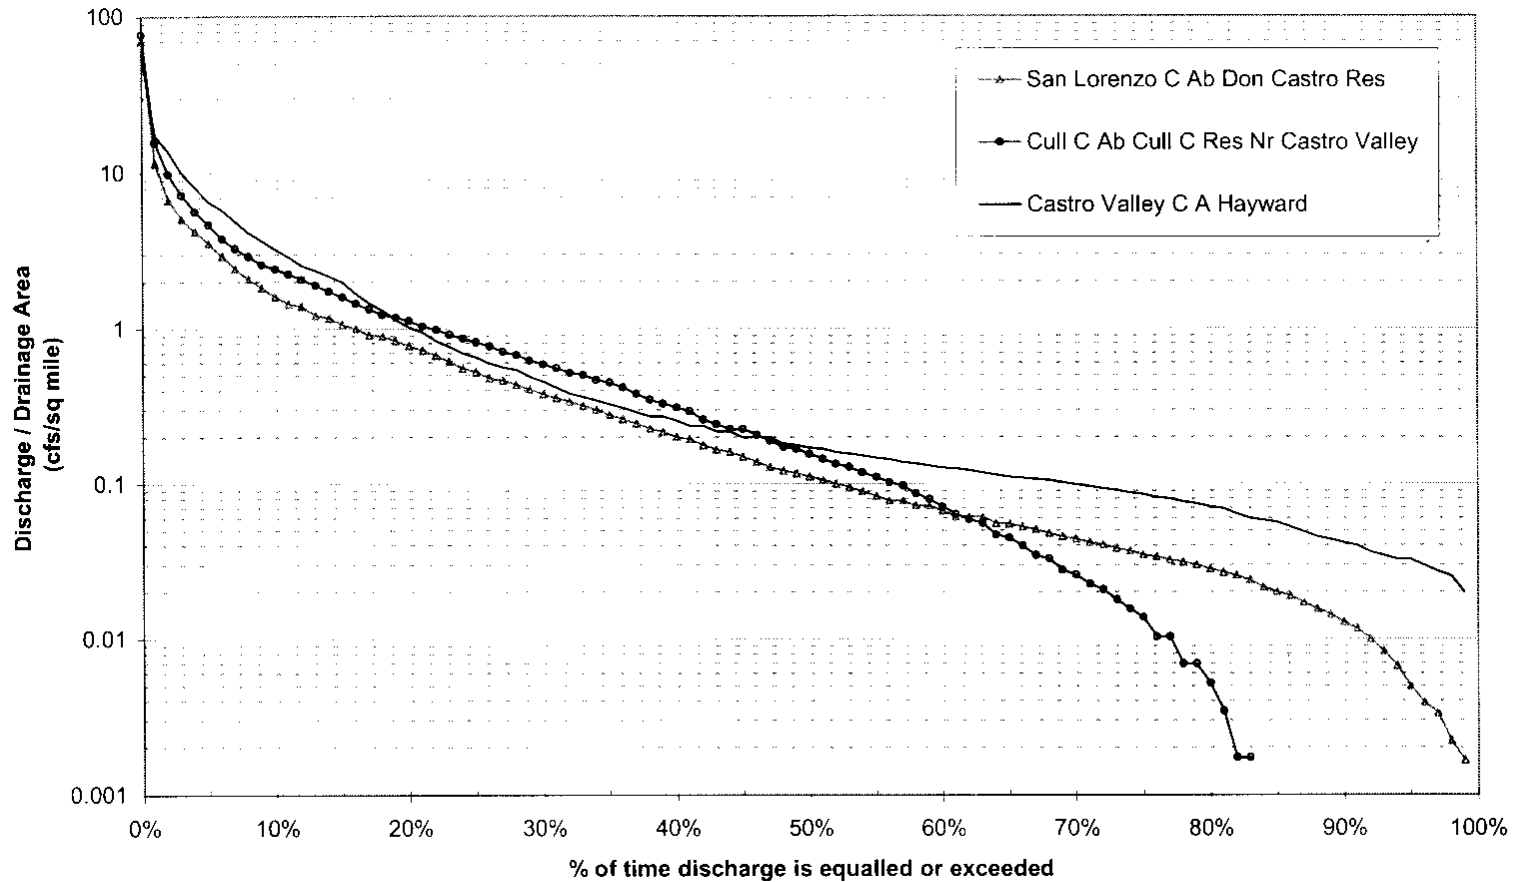
**Figure A-2: Flow Duration Curves for November through April from Long-Term Gauge Sites in the San Lorenzo Creek Watershed**

Source is Figure B-5 Appendix B-6 in Love 2001.

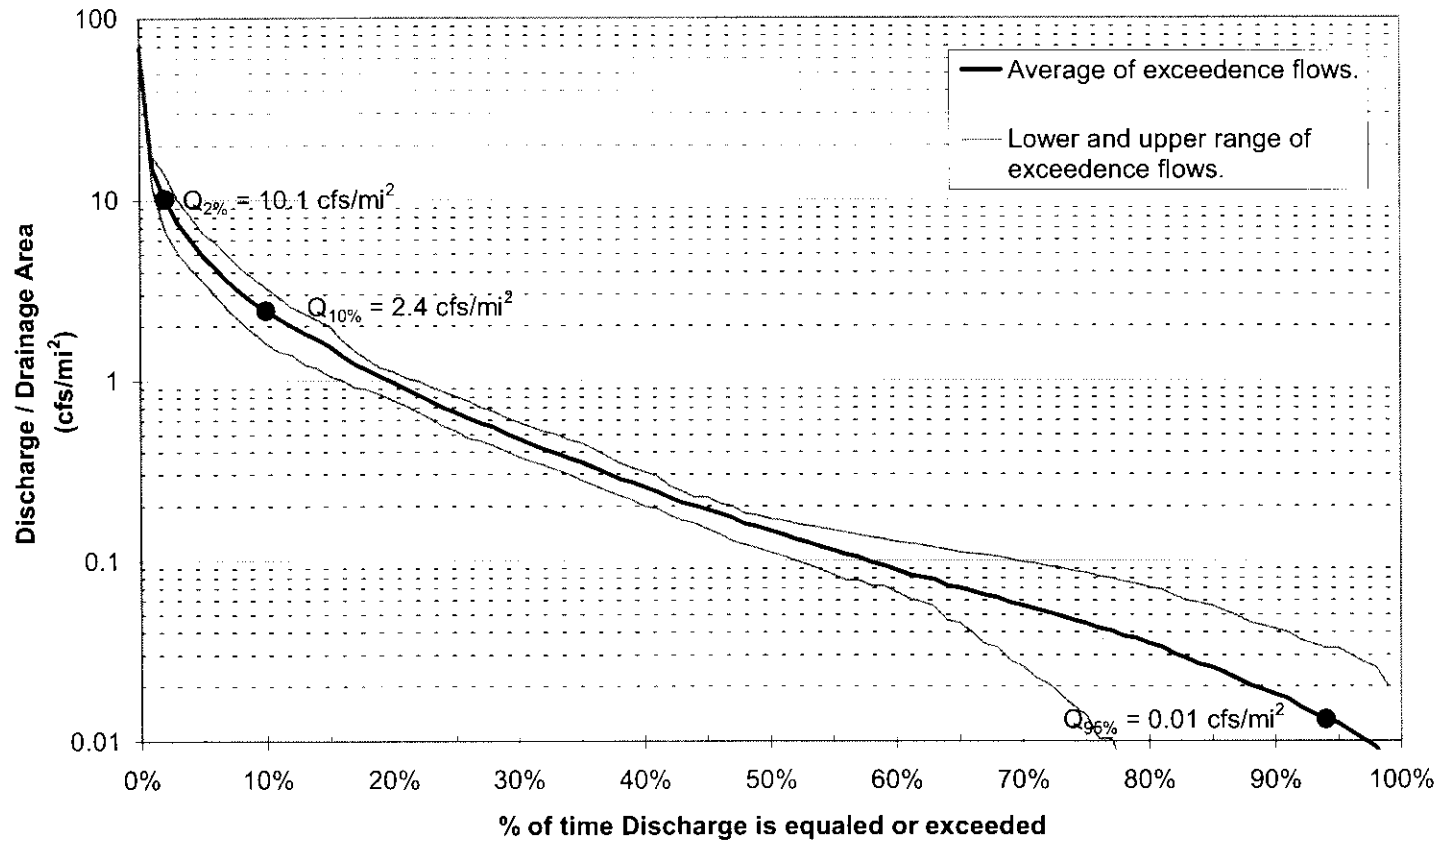
**Appendix B: Regional Flow Duration Curve for the Period of Salmon Migration  
(from Love 2001)**

Source is Figure B-5 Appendix B-6 in Love 2001.

Love's 2001 regional flow duration curve for the November through April migration period (Appendix B), we calculated the exceedence flow range during which steelhead migrate upstream in Sinbad Creek to be between 0.06 cfs and 65 cfs.
