Warm-Mix Asphalt Study: Field Test Performance Evaluation

Partnered Pavement Research Center (PPRC) Contract Strategic Plan Element 4.18:
Warm Mix Asphalt

DOCUMENT RETRIEVAL PAGE		Technical Memorandum: UCPRC-TM-2013-08			
Title: Warm-Mix Asphalt Study: Field Test Performance Evaluation					
Authors: D. Jones					
Technical Leads: T. Joe Holland (Caltrans) and Nathan Gauff (CalRecycle)					
Prepared for: Caltrans and CalRecycle		FHWA No.: CA142385D	Work submitted: 04/05/2014		Date December 2013
Strategic Plan Element No.: 4.18		Status: Final		Version No.: 1	
Abstract:					
<p>A number of warm-mix asphalt test sections were constructed in California between 2007 and 2010 to assess long-term performance under selected traffic and climate conditions. A range of pavement designs were assessed, but the six projects evaluated in this report focused on open-graded friction courses with polymer-modified (PG 58-34) and rubber-modified (PG 64-16) binders (three projects each). The main purpose of these experiments was to monitor performance under actual conditions and to quantify any benefits associated with using warm-mix asphalt under specific situations, such as with long hauls, in cool

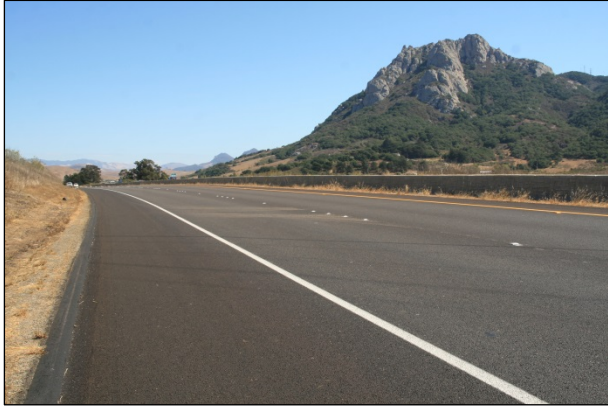
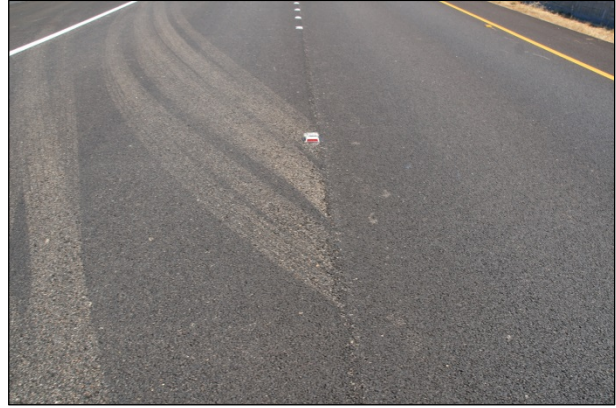
Figure 3.5: Morro Bay Advera, May 2007 (0 months).

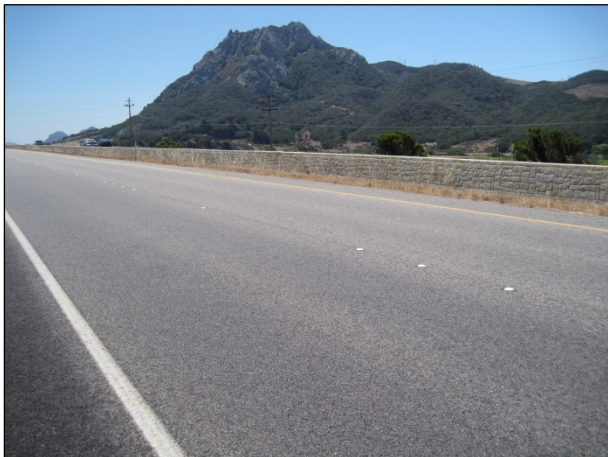
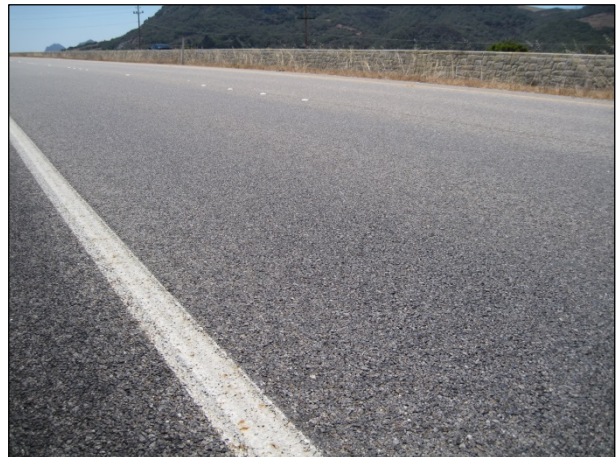
Figure 3.7: Morro Bay Advera, June 2013 (73 months).

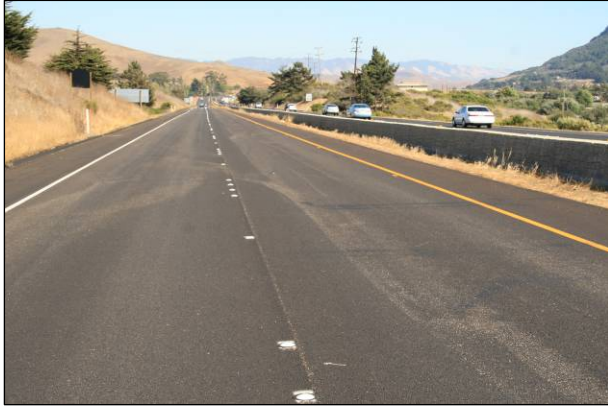
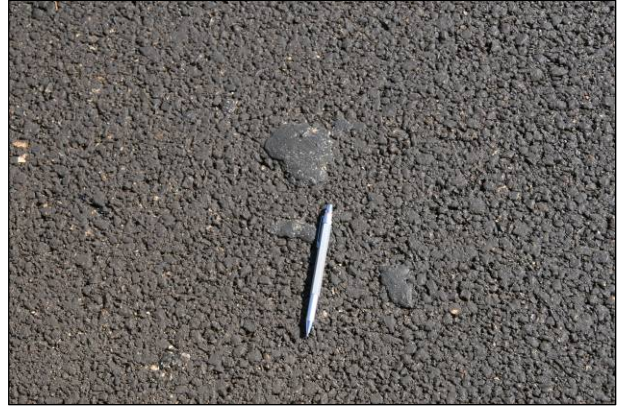
Figure 3.8: Morro Bay Evotherm, May 2007 (0 months).

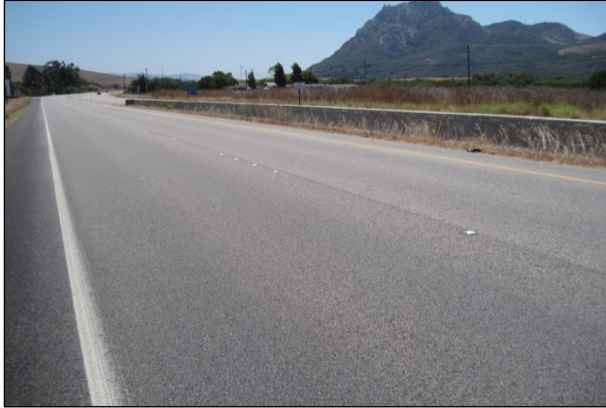
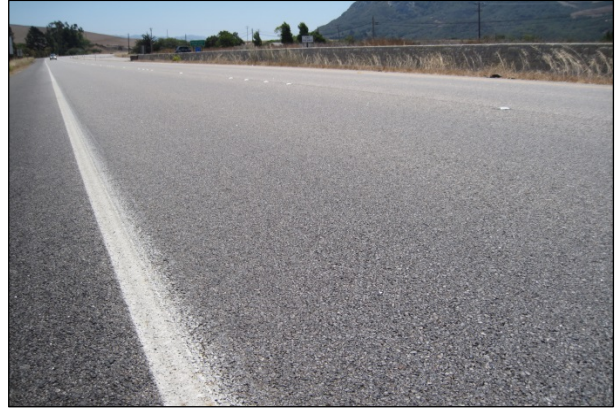
Figure 3.11: Morro Bay Evotherm, June 2013 (73 months).

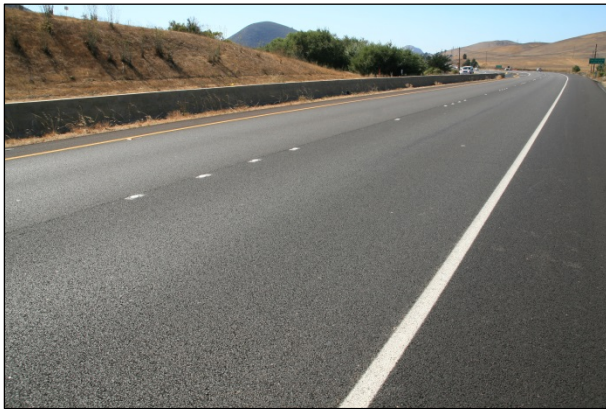
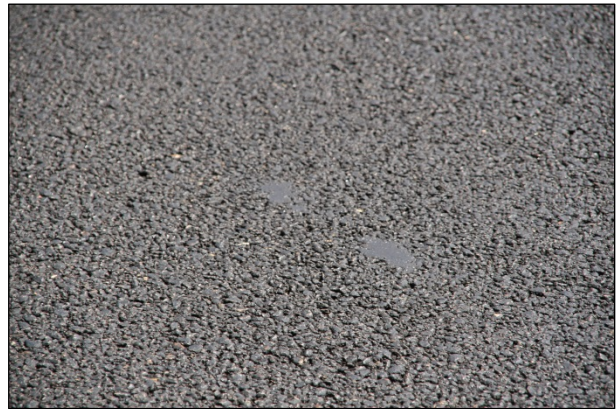
Figure 3.12: Morro Bay Sasobit, May 2007 (0 months).

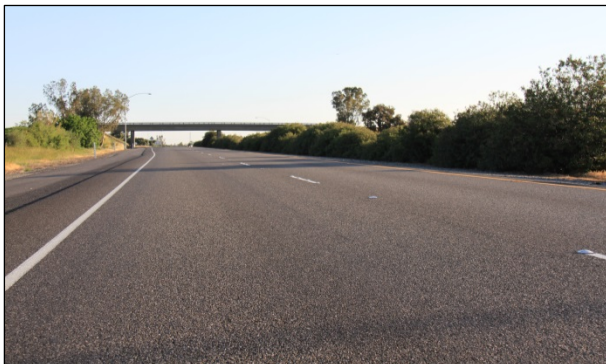
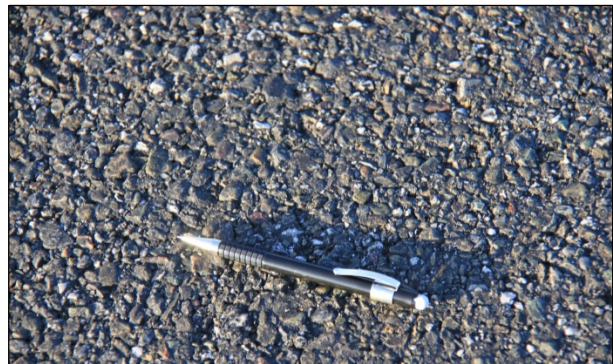
Figure 5.1: Orland Control, June 2009 (1 month).

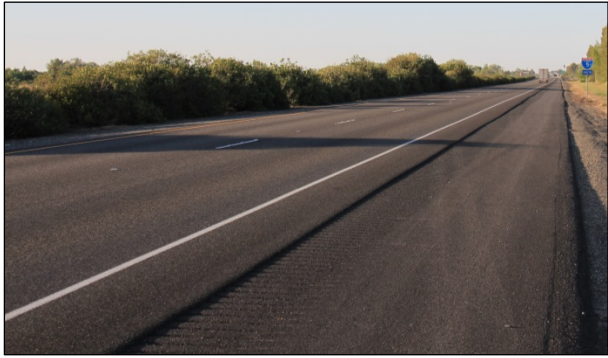
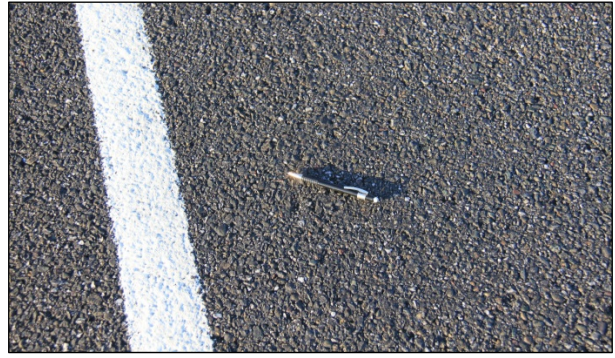
Figure 5.3: Orland Evotherm, June 2009 (1 month).

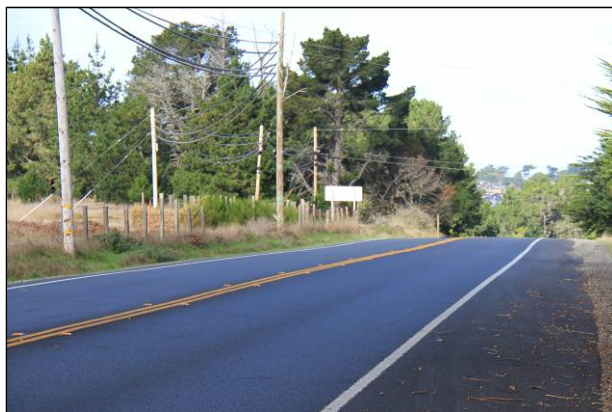
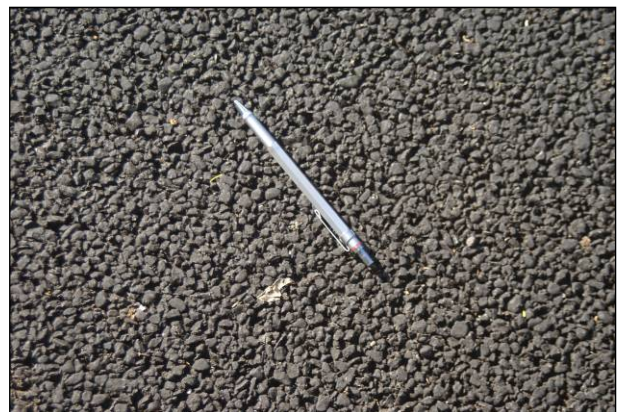
Figure 7.1: Mendocino Control, July 2010 (0 months).

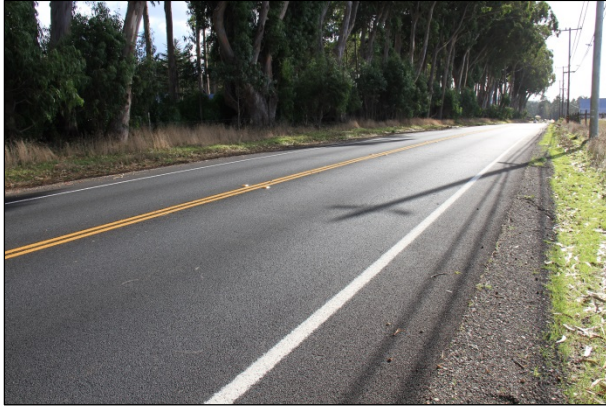
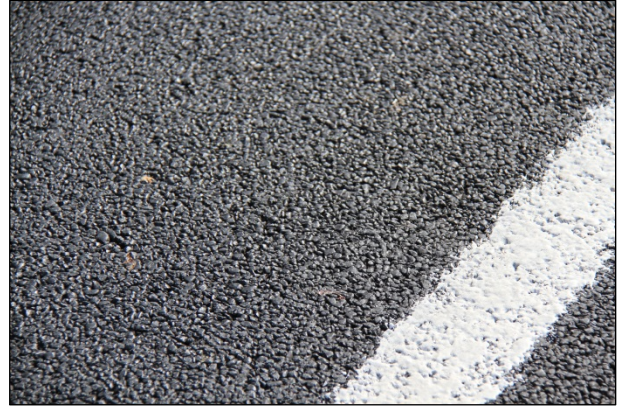
Figure 7.3: Mendocino Advera, July 2010 (0 months).

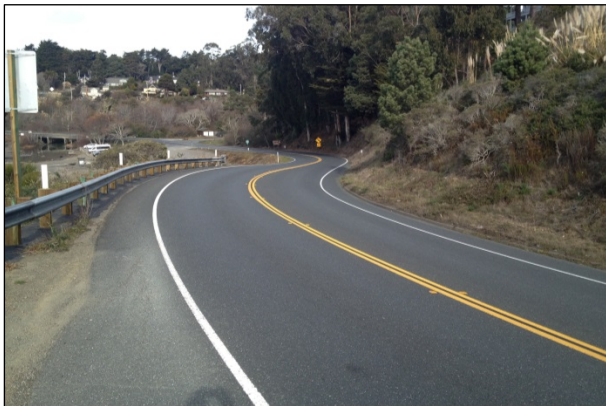
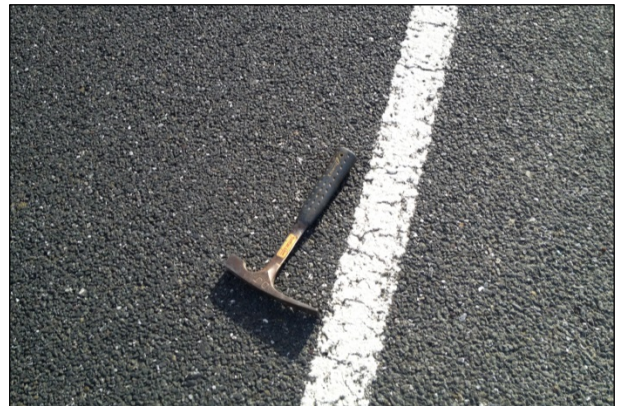
Figure 7.5: Mendocino Gencor, July 2010 (0 months).

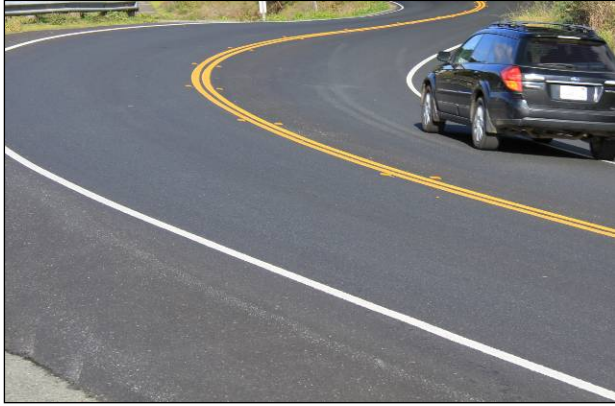
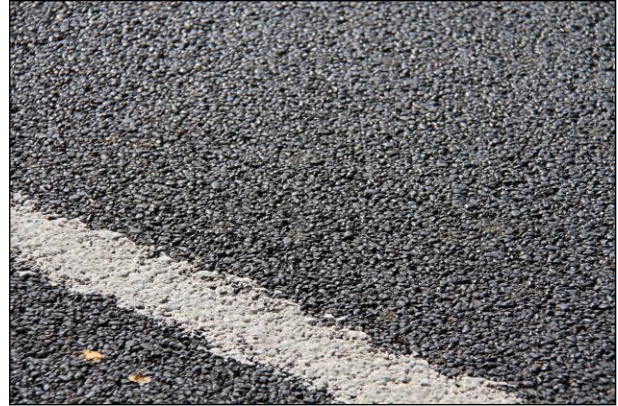
Figure 7.6: Mendocino Gencor, December 2013 (42 months).

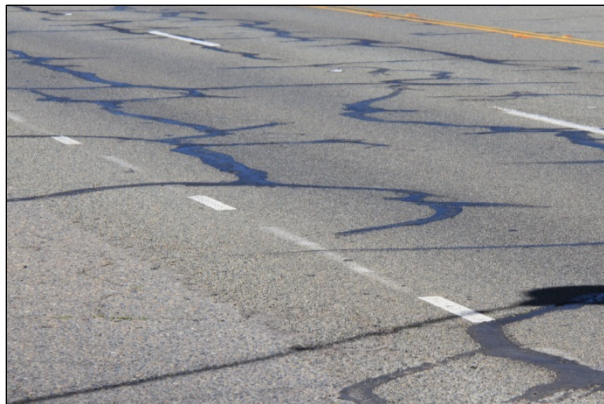
Figure 8.1: Auburn Evotherm, July 2010, one month prior to paving.
