Hail Ice Damage of Stringer-Stiffened Curved Composite Panels

A Thesis submitted in partial satisfaction of the requirements

Structural Engineering

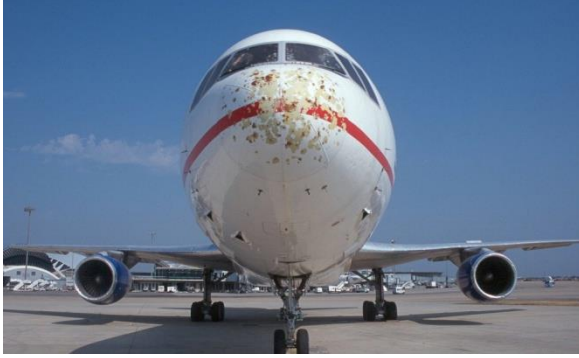
With a terminal velocity of approximately 30 m/s while falling to the ground, and 200 to 250 m/s while an aircraft is in flight, hail ice impact is a major threat to aircraft (see Figure 1 [2]). In 1995, Dallas Fort Worth experienced a major storm involving hailstones up to the size of grapefruits (approx. 100 mm diameter). Over 100 aircraft parked outdoors were damaged[3]. More recently in July 2011, visible hail damage caused flight cancelation out of Denver International Airport (see Figure 2 [4]).

Figure 1. Hail Damage on Lockheed TriStar 150 [2].

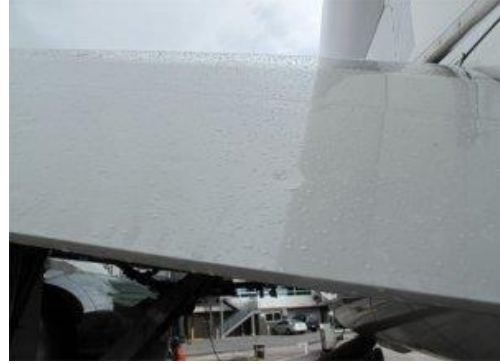
Figure 2. Hail Damage on a Frontier Airlines Aircraft [4].

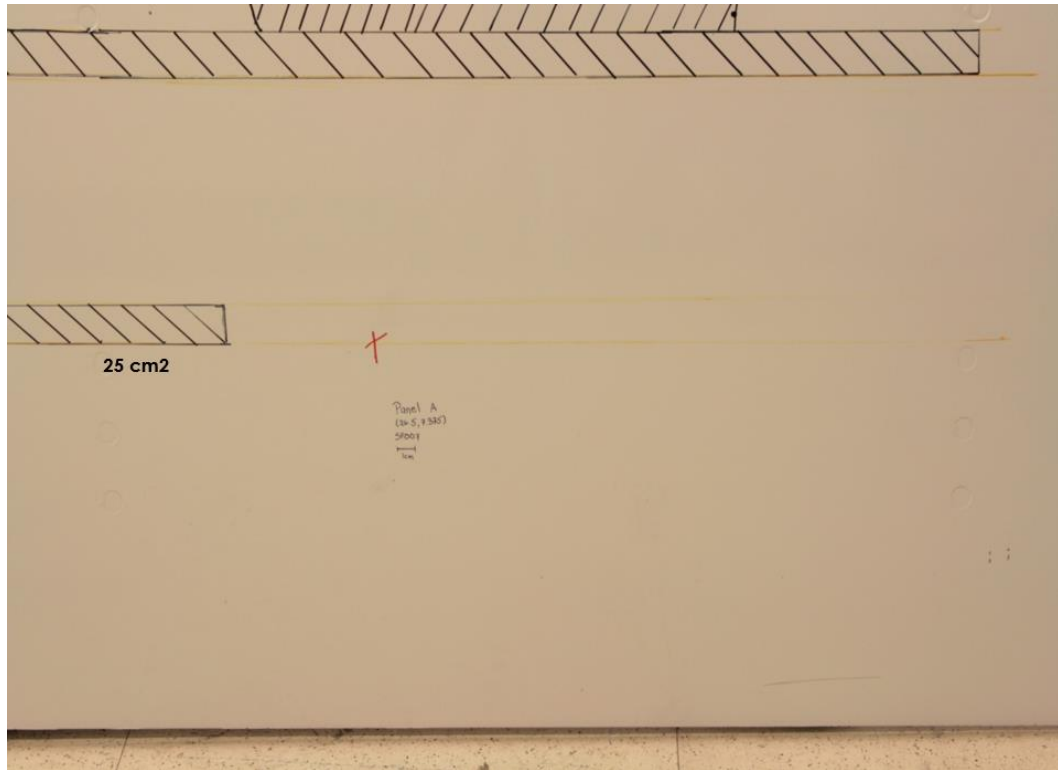
Figure 53. Type IIb: Front of SP007 (277.1 J).

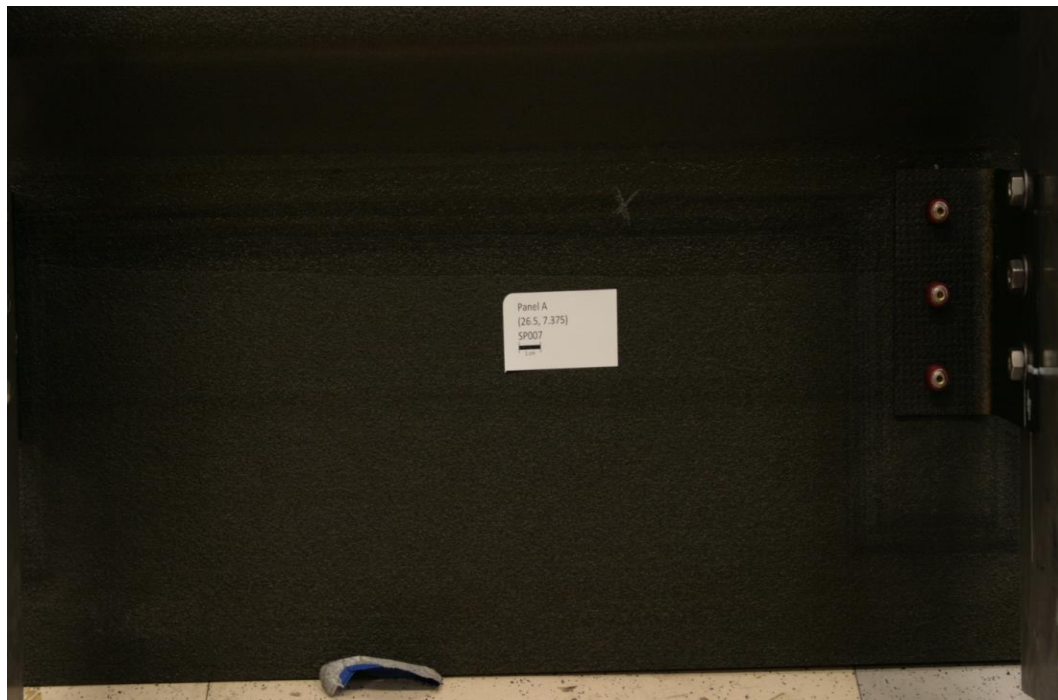
Figure 54. Type IIb: Back of SP007 (277.1 J).

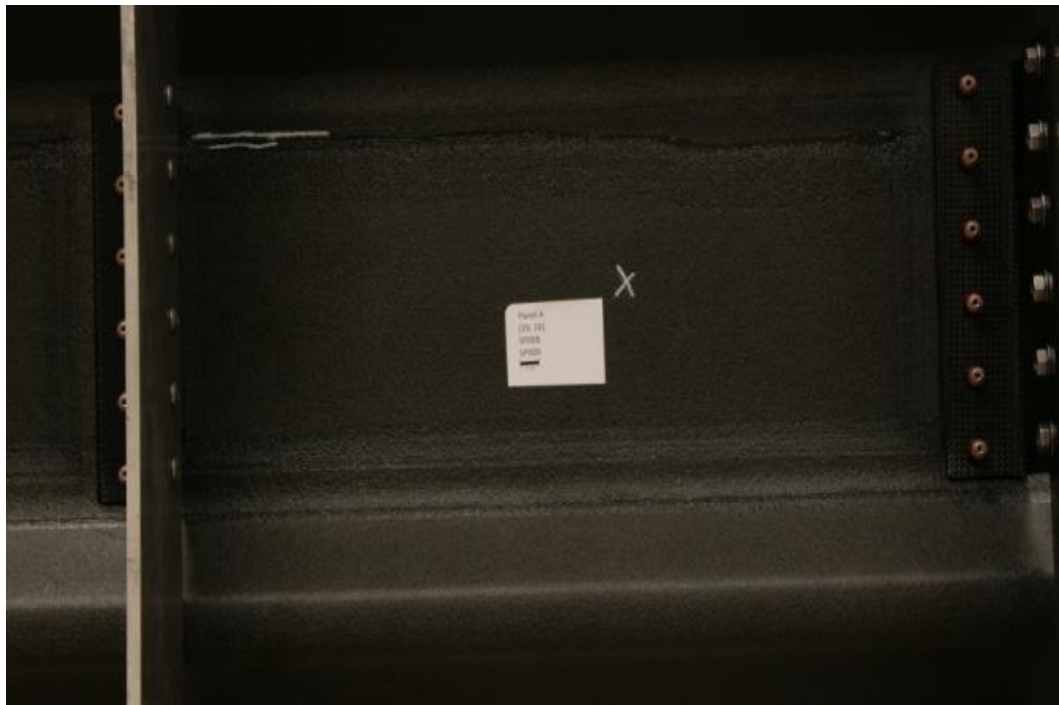
Figure 56. Type I: Back of SP008 (566.5 J) and SP009 (720.5 J).

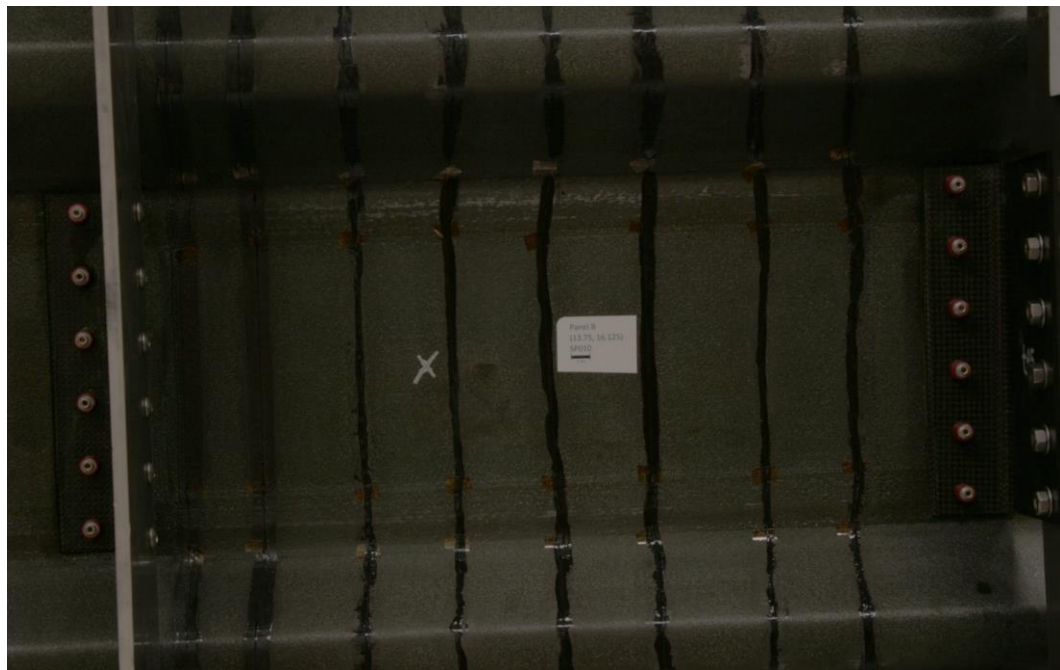
Figure 58. Type I: Back of SP010 (562.3 J).

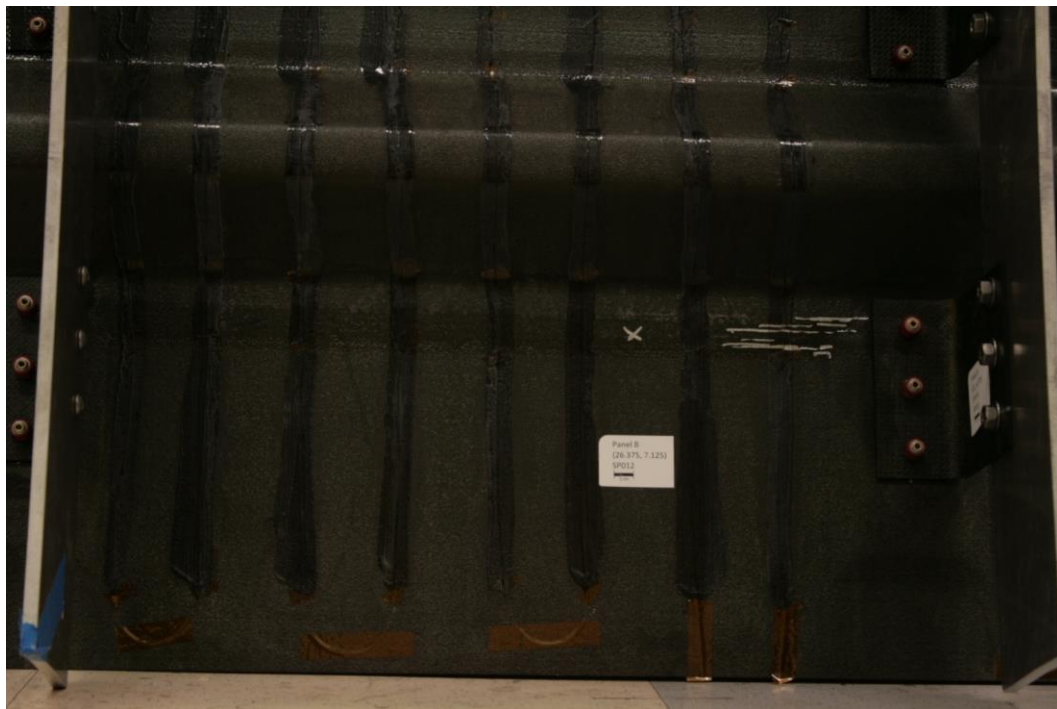
Figure 62. Type IIb: Back of SP012 (284.5 J).

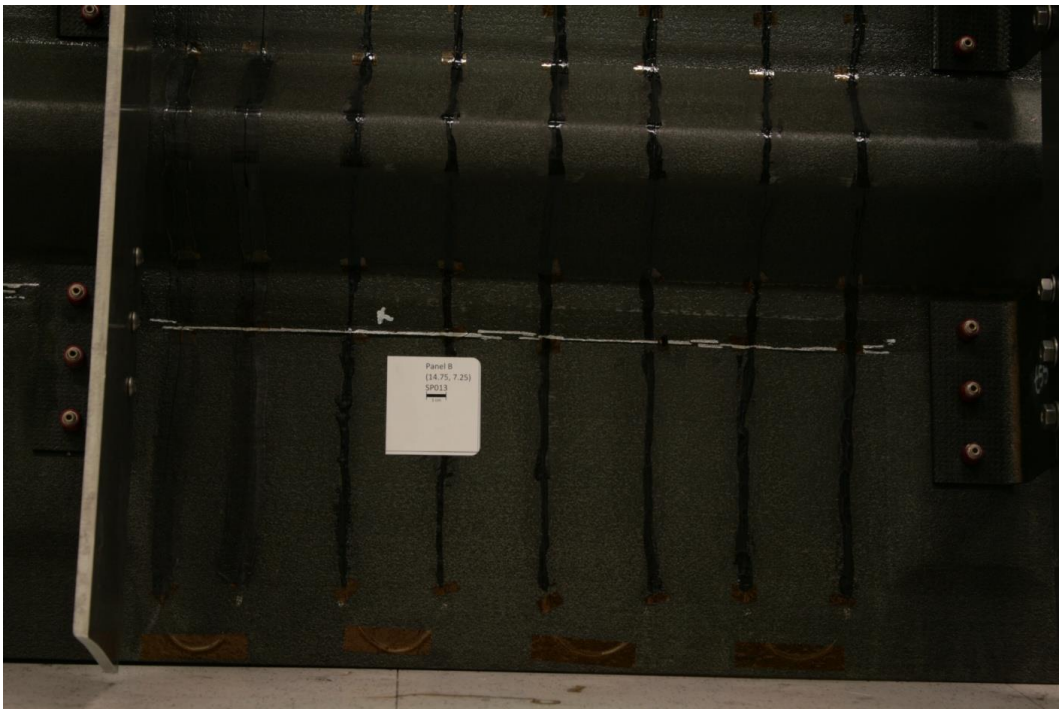
Figure 64. Type IIb: Back of SP013 (279.1 J).

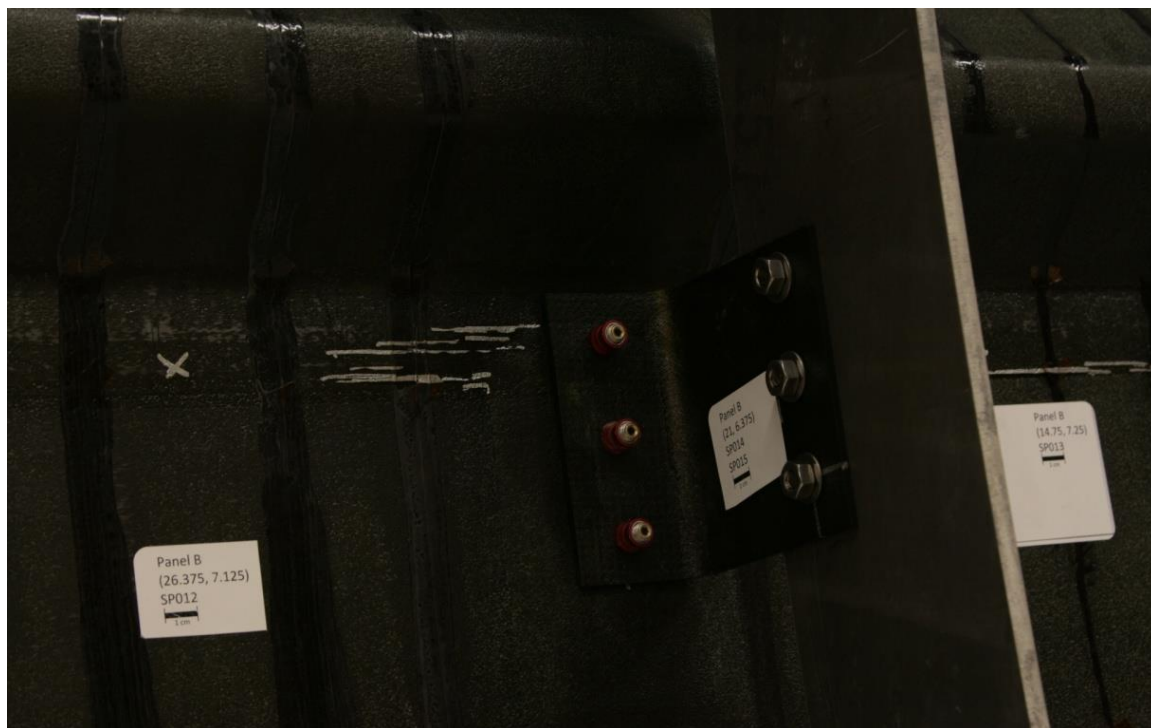
Figure 66. Type IV: Back of SP014 (348.0 J) and SP015 (728.0J).

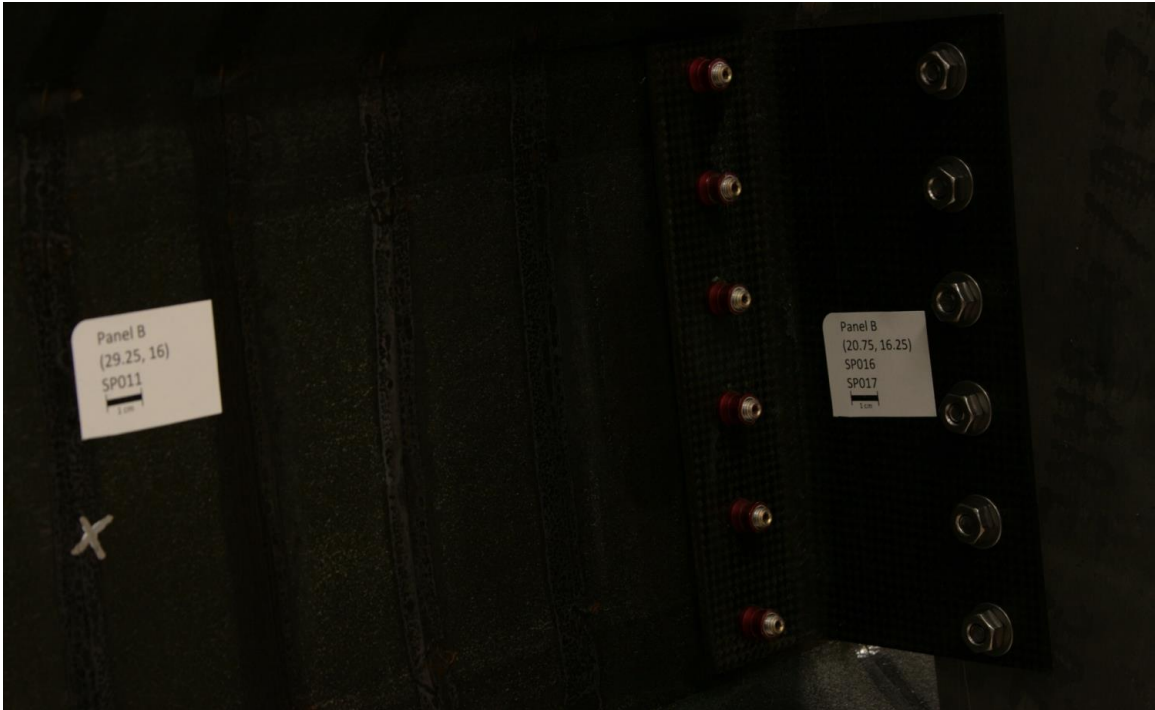
Figure 68. Type IV: Back of SP016 (476.5J) and SP017 (738.1J).

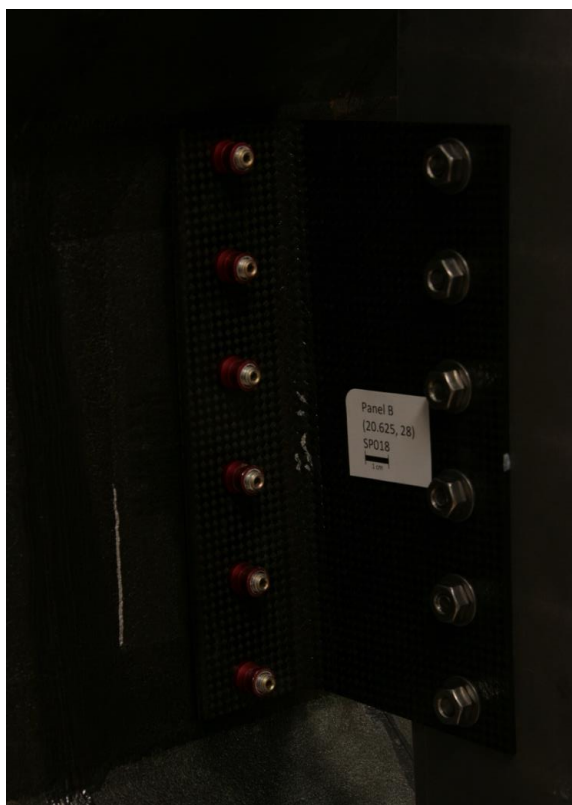
Figure 70. Type IV: Back of SP018 (669.6 J).

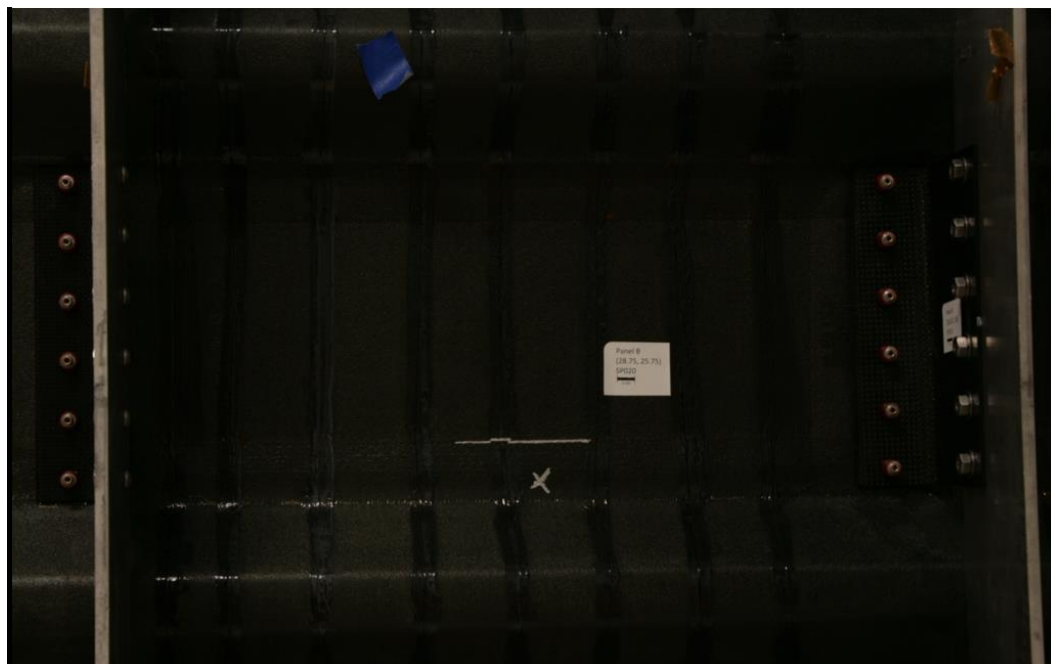
Figure 74. Type IIa: Back of SP020 (172.3 J).

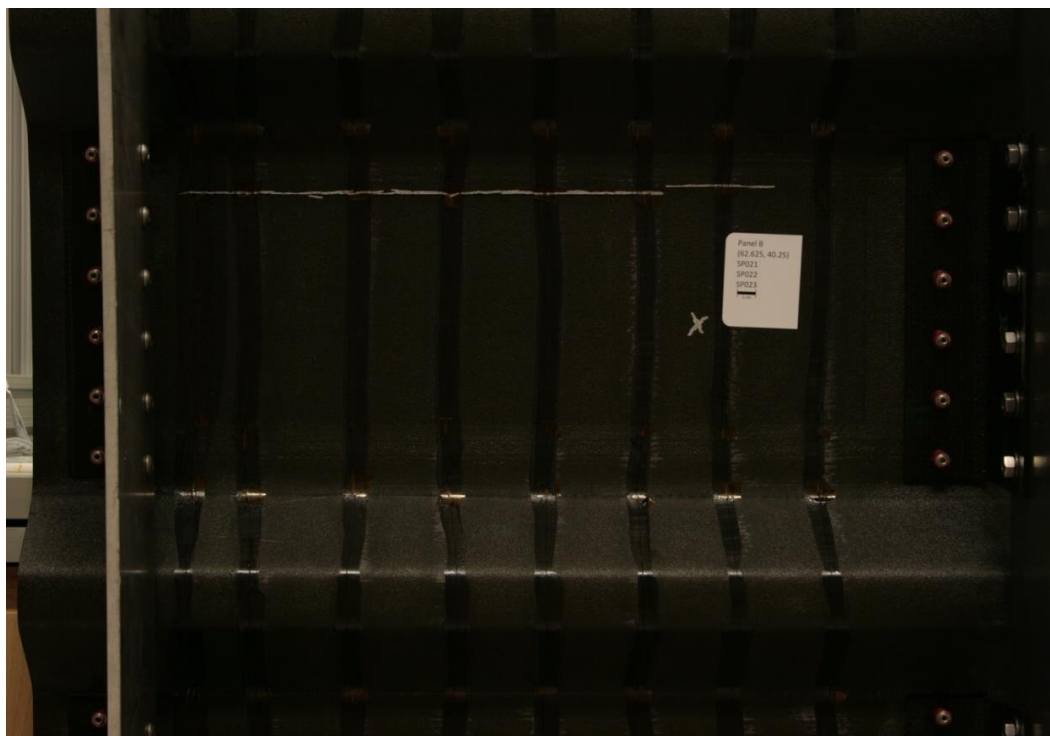
Figure 76. Type I: Back of SP021 (445.0 J), SP022 (540.0 J), and SP023 (665.5 J).

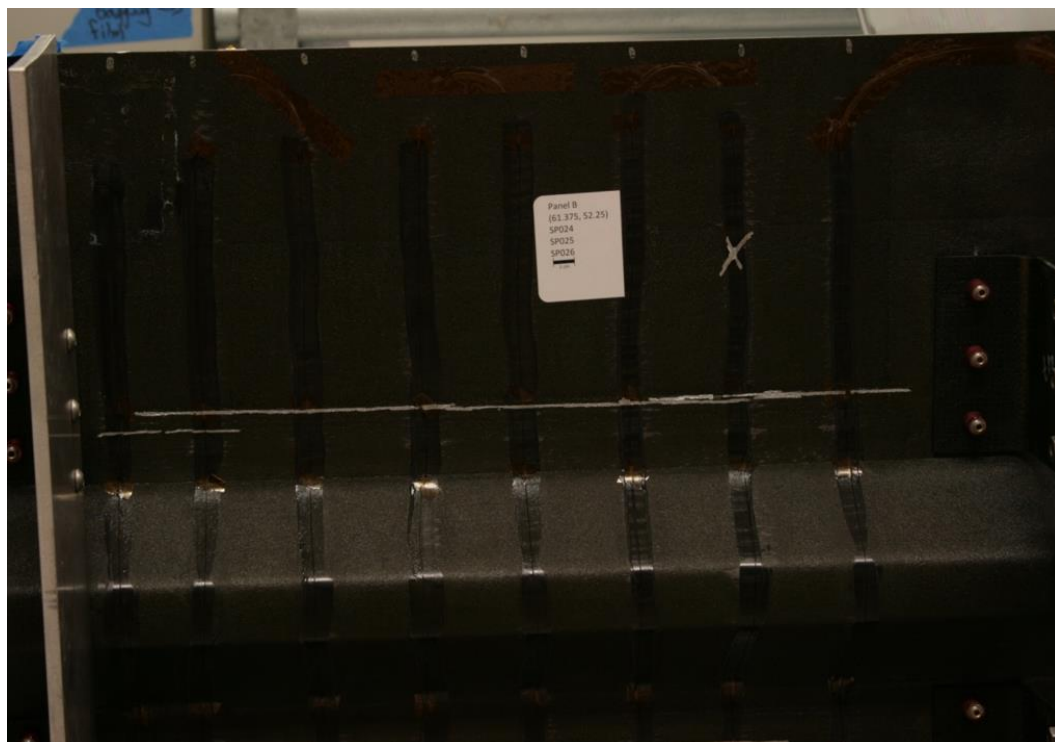
Figure 78. Type I: Back of SP024 (432.9 J), SP025 (550.2 J), and SP026 (734.8 J).

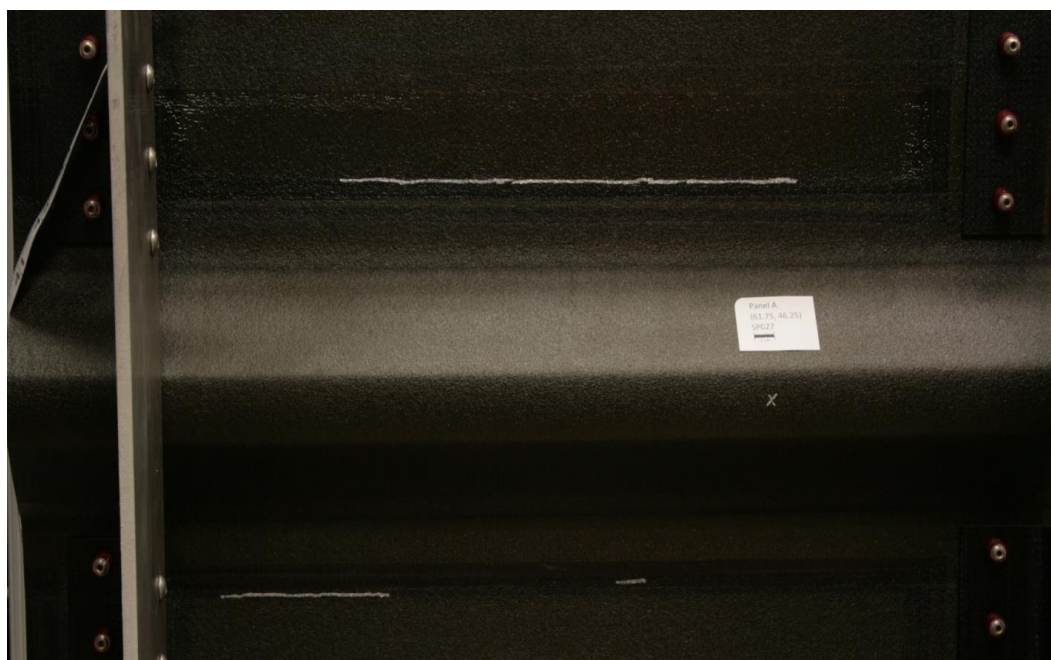
Figure 81. Type III: Back of SP027 (442.3 J).

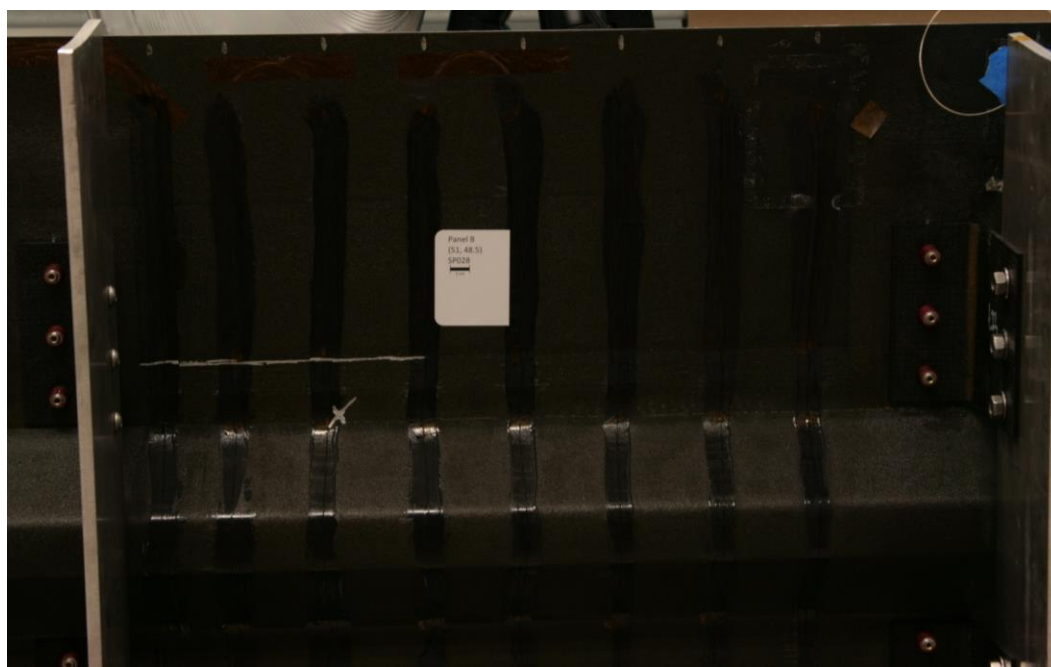
Figure 83. Type IIb: Back of SP028 (383.4 J).

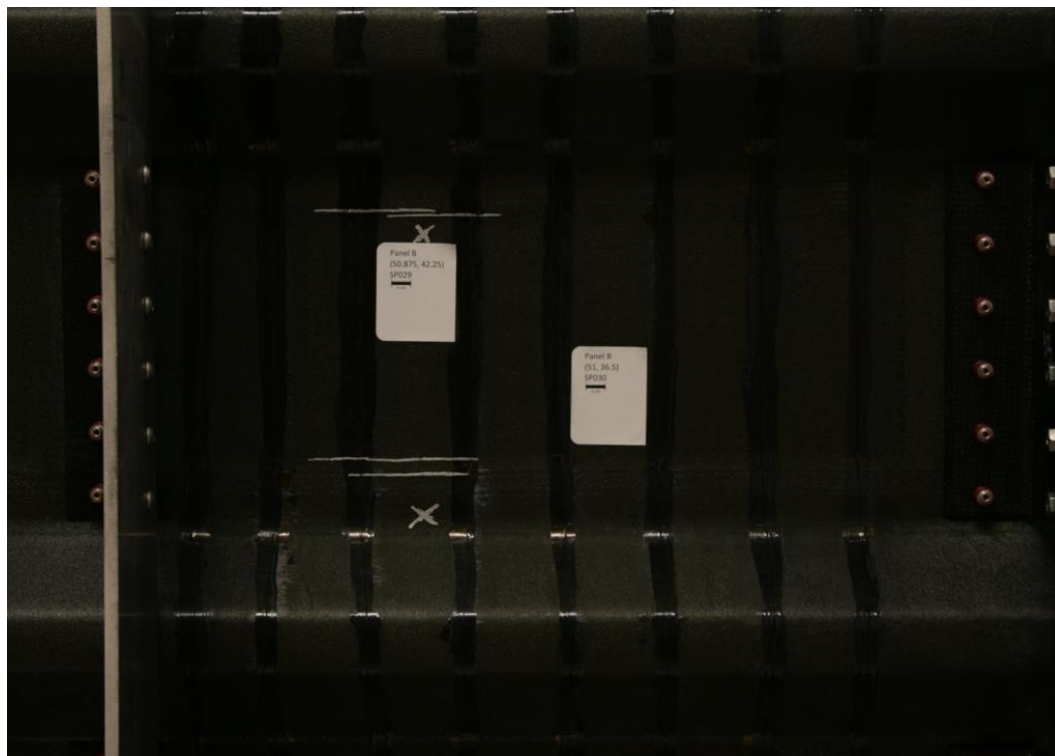
SP028	3/26/12	B-B3.SK1.ST1-I2b	(51, 48.5)	102.1	204.3	102.2	1472	223	Y	100	86.6	383.4	Bad ice
SP030	3/26/12	B-B3.SK2.ST2-I2b	(51, 36.5)	100.2	203.4	103.2	1434	224	Y	100	88.9	407.9	Delam stringer. Tactile. Partially unzipped
SP006	2/27/12	A-B1.SK5.ST4-I2a	(13.75, 7.25)	99.7	204.5	104.8	1423	221	Y	75	89.6	420.7	Impact on mid stringer flange; Damage - zippered delam on stringer, nothing visible on paint side; cracked through tapered flange point of impact; Flange unzipped from shear tie to shear tie; Damage very visible on back side

Figure 85. Type IIa: Back of SP029 (423.3 J) and SP030 (407.9 J).

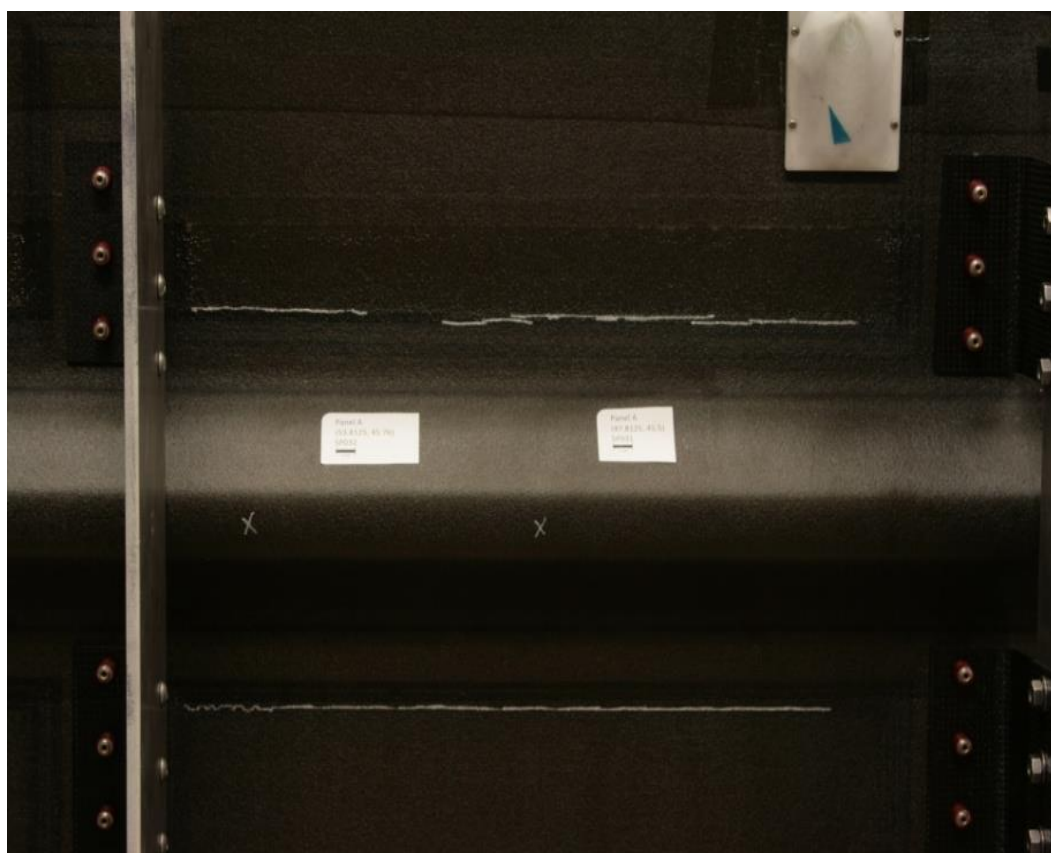
Figure 87. Type III: Back of SP031 (394.8 J) and SP032 (560.8 J).

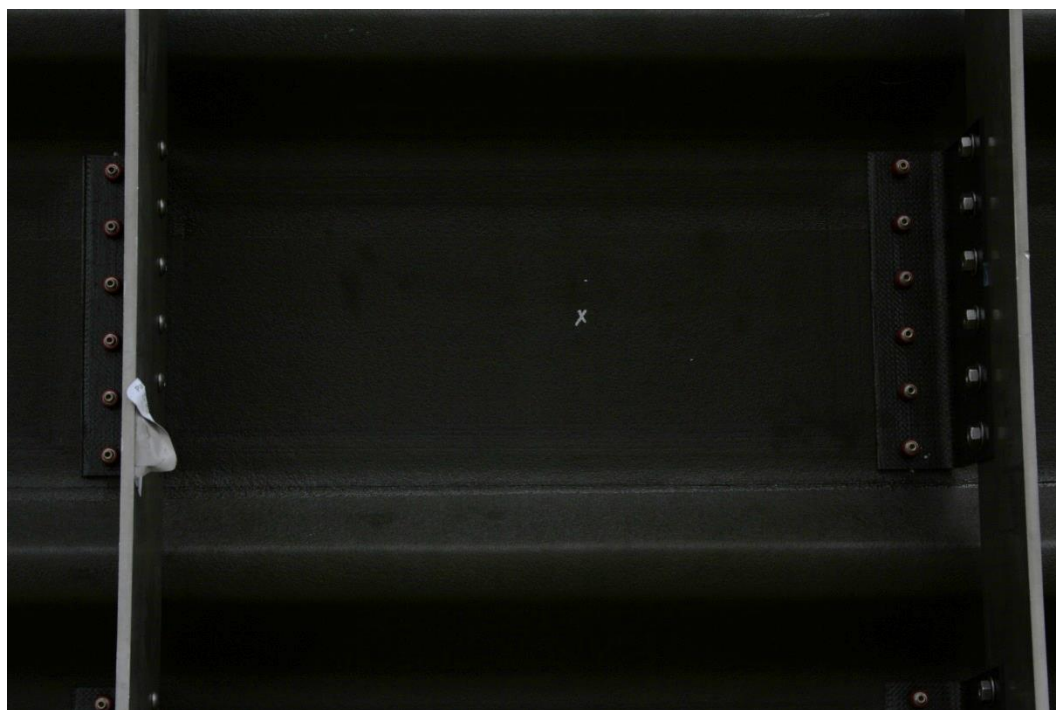
Figure 93. Type I: Back of SP042 (295.4 J).

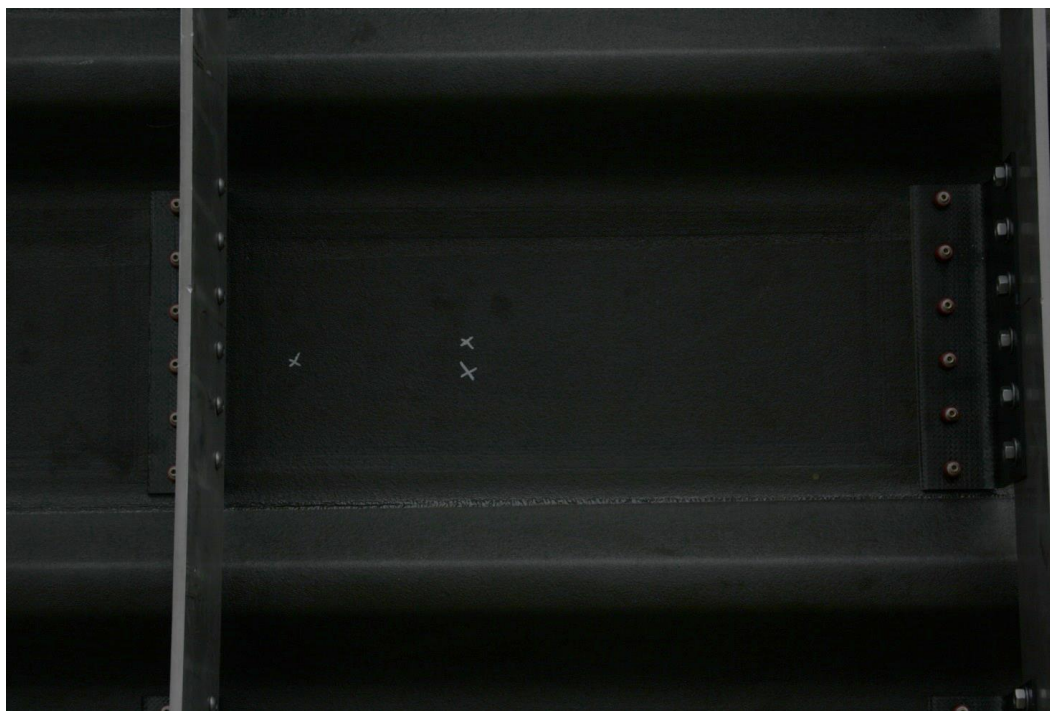
Figure 95. Type I: Back of SP043 (161.2 J), SP044 (227.0 J), and SP045 (347.1J).
