**REPORT NO.
UCB/SEMM-97/04**

**CYCLIC TESTING OF
FOUR FULL-SCALE STEEL
BEAM-COLUMN CONNECTIONS
WITH "DOGBONES"**

Report to DASSE Design, Inc.

FEBRUARY 1997

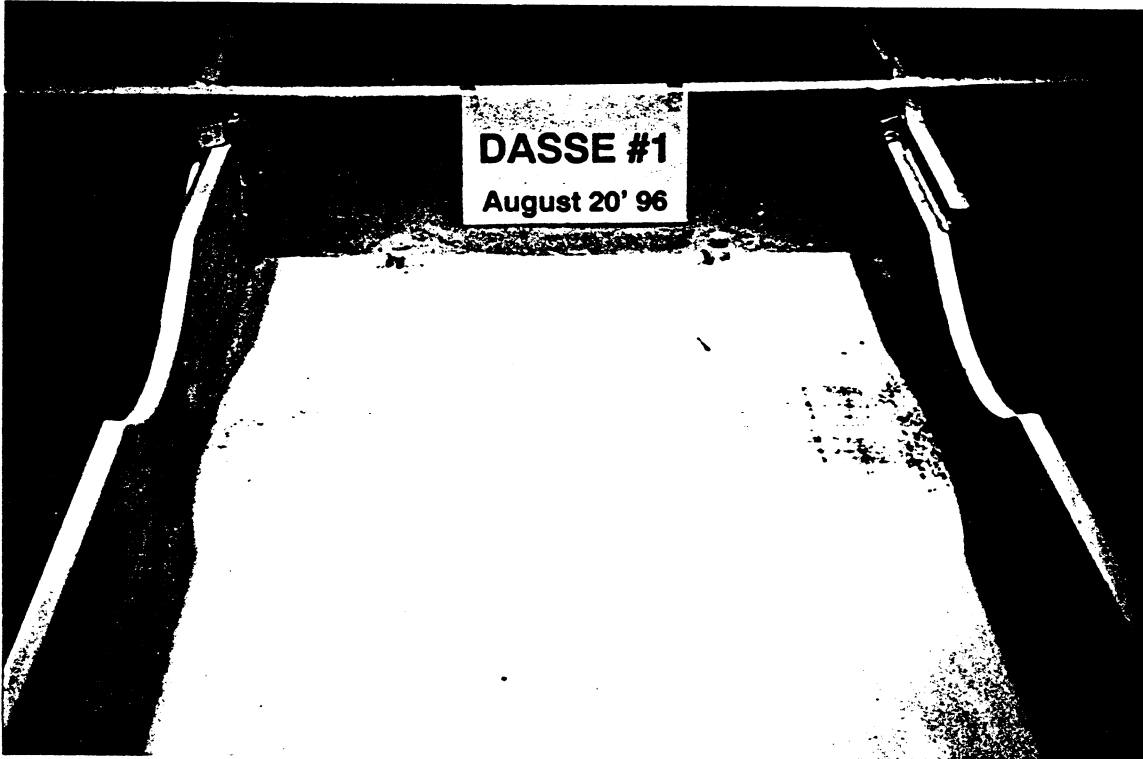
FIGURE 32: SPECIMEN 1 -- BEAM AFTER 2" CYCLES

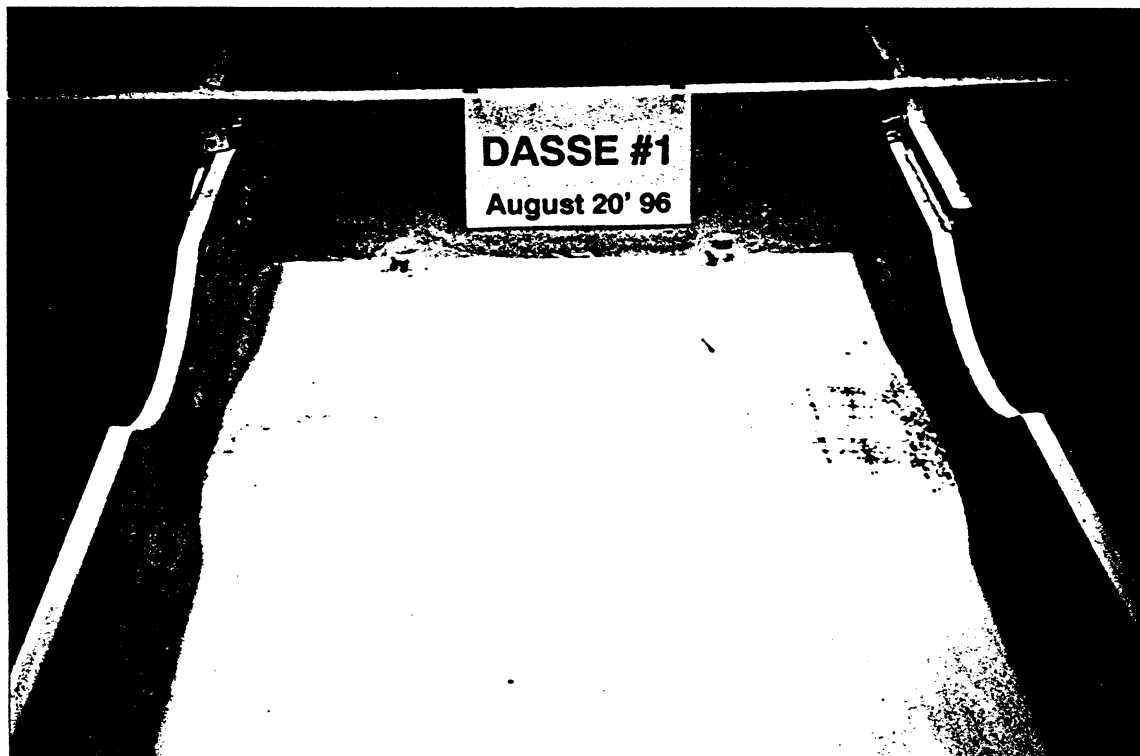
FIGURE 32: SPECIMEN 1 -- BEAM AFTER 2" CYCLES
